**NB DEPARTMENT OF TOURISM,
HERITAGE and CULTURE**

**Parlee Beach Sewerage System
Condition Assessment**

PRELIMINARY DESIGN REPORT

Revised July 25, 2017

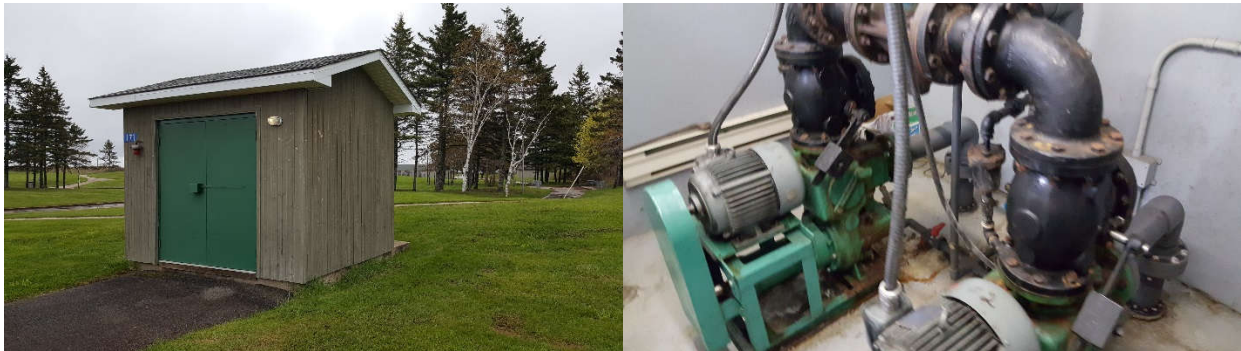
Figure 2-1 Existing Parlee Beach Lift Station

- The lift station includes two (2) self-priming sewage pumps in a duplex pump arrangement. The pumps alternate and the pump start and stop are determined by float switches in the wet well;
- The wet well is pre-cast concrete. It was difficult to determine its condition, but visually it did not show obvious signs of structural failure. It was found to provide a very “short” active volume however;
- Over time, the pumps have been adjusted to their maximum; therefore, pump wear plates and possibly impellers will need to be replaced the next time the pumps require clearance adjustment to maintain performance;
- Air valves do not seem to be functioning properly;
- No pressure gauge is installed in the building;
- PVC internal piping seems to be in good condition;
- A majority of the metal hardware is in poor condition (i.e. rails, ladders, supports, baffling of the inlet, etc);

- The access hatch does not have modern safety measure, such as a grating door;
- The float switch support bracket should be replaced;
- The building is in fair condition with signs of mold and evidence previous piping leaks;
- Alarms for pump failure are done with a red light on the outside of the building with no remote indication (autodialler or SCADA).

In general, the lift station is showing signs of age and typical wear a deterioration of aging lift station. It also lacks modern instruments and safety features found in present day lift station design such as flow meters, SCADA system (communications), pressure sensors, safe wet well access, accurate level sensors, backup of power and floatable baffle control device for the overflow pipe.

The existing lift station is dated and needs upgrading. The NBDTHC would have the option to upgrade the various components, including the building, pumps, piping and controls or to replace the facility completely with more state of the art components. In both cases, the recommended upgrades will be significant and the cost of a new facility will be close to upgrading using the existing components. **A facility replacement would allow using submersible pumps which are easier to operate and maintain. This would likely be the preferred pump type of the GSSC should they be asked to operate the facility.** As explained in 3.2, a new generator should be added.

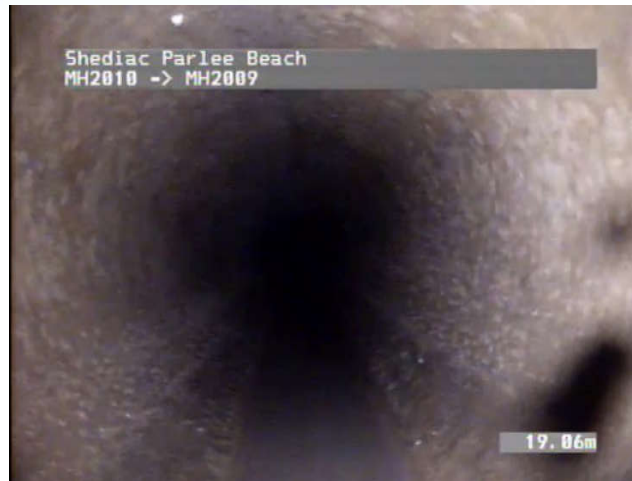
Figure 2-3 Sewer video sample of section in the dunes.

A review of the video reports does not show significant signs of any pipe deterioration or infiltration. There are indications of sags in areas of the pipe and this could also be why silt and debris has accumulated in areas that can't be accessed, in particular given the system apparently has never been flushed (according to the Parlee Beach operations personnel).

Figure 2-3 is a snapshot from the video reports of a section in the dunes near the center. Figure 2-4 is a snapshot from the video reports of a section near the existing lift station. Figure 2-4 also show sign the pipe has been surcharged as stains and sludge is all the way to the top of the pipe.

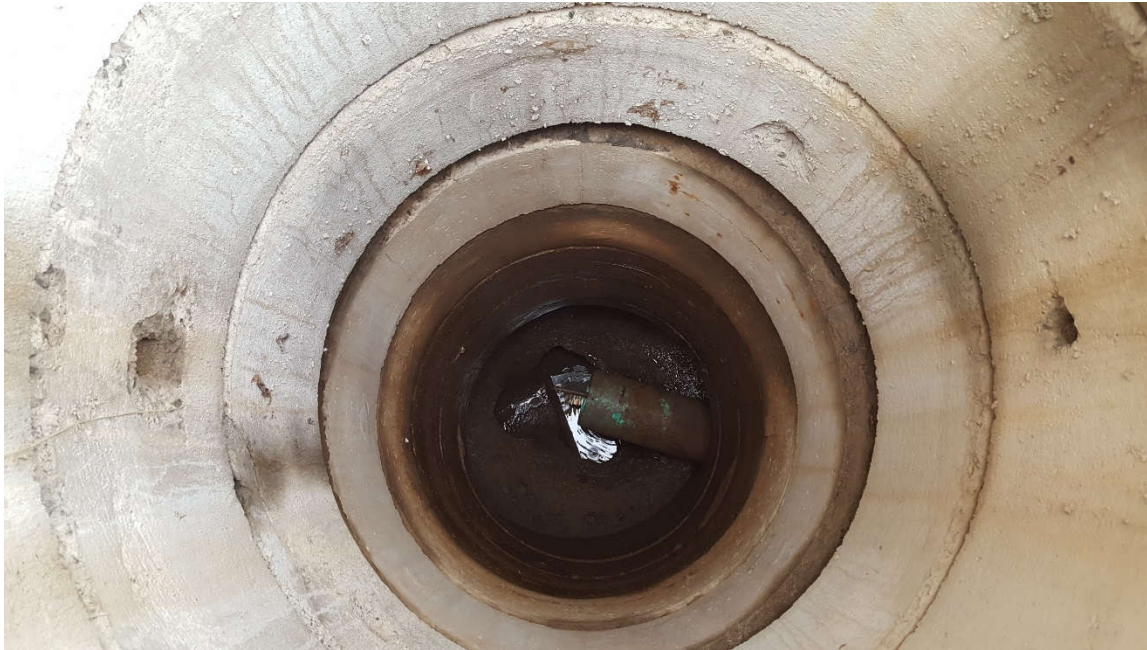
Figure 2-5 Typical Manhole at Dunes (MH2008)

Identified manholes were all constructed similar to the above Figure 2-5. Manhole construction appears to be a “dog house” style poured base with the top half of the pipe removed. Construction of the existing manhole sections are not typical to today’s standards as they have many joints leaving the system more susceptible to infiltration and/or exfiltration.

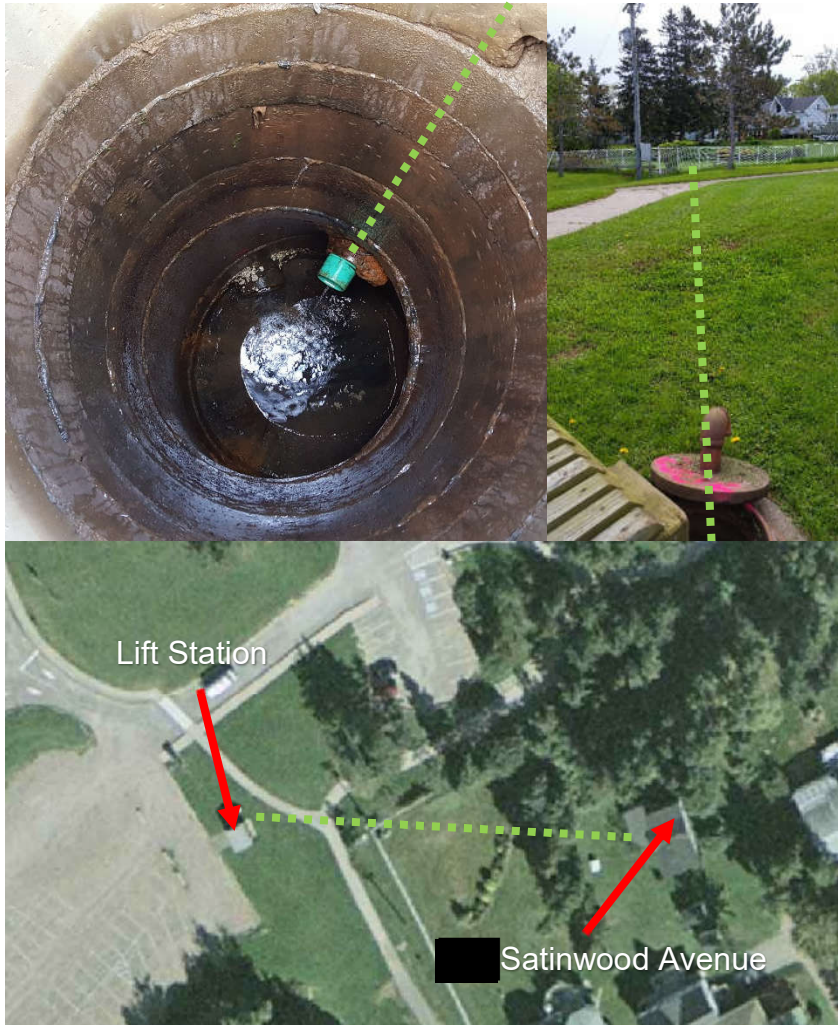
Figure 2-6 Residential Service

Based on the intrusive manhole inspection, it was determined that a residential 100mm diameter service is connected to the Parlee Beach System from a residence in the Bluff area. The service discharge’s into MH2006 adjacent to the lift station, shown in Appendix A, Drawing 17161-1P-C100.

Where the Parlee Beach Sewer System is a private system (in particular if it were intended for seasonal operation only and is shut down in the winter), this residence should be removed from the Parlee Beach sanitary sewer system. **The residence appears to be of seasonal use, but this was not confirmed.** If the home were in service year-round, we estimate that approximately 200,000L of untreated wastewater could be directed to the coastal wetland via the overflow pipe.

During our inspection, the overflow pipe was plugged and the sewer system was not filling, and this would lead us to believe that the residence was unoccupied through the winter months. It was not occupied on the day of inspection. Even if the Parlee Beach system were to operate year-round, we would recommend that this residence be removed from the private system.

As described in Section 2.3.5, it is recommended that the residential service connected to the Parlee Beach system be relocated to the GSSC sewer system along Satinwood Avenue.

A preliminary field investigation of the residential service indicated that this could be done either with a shallow insulated service or a private sewage pump for the resident to pump the residential flows to the above noted sanitary manhole location. This would depend on the plumbing inside the home and this should be defined at the detailed design stage.

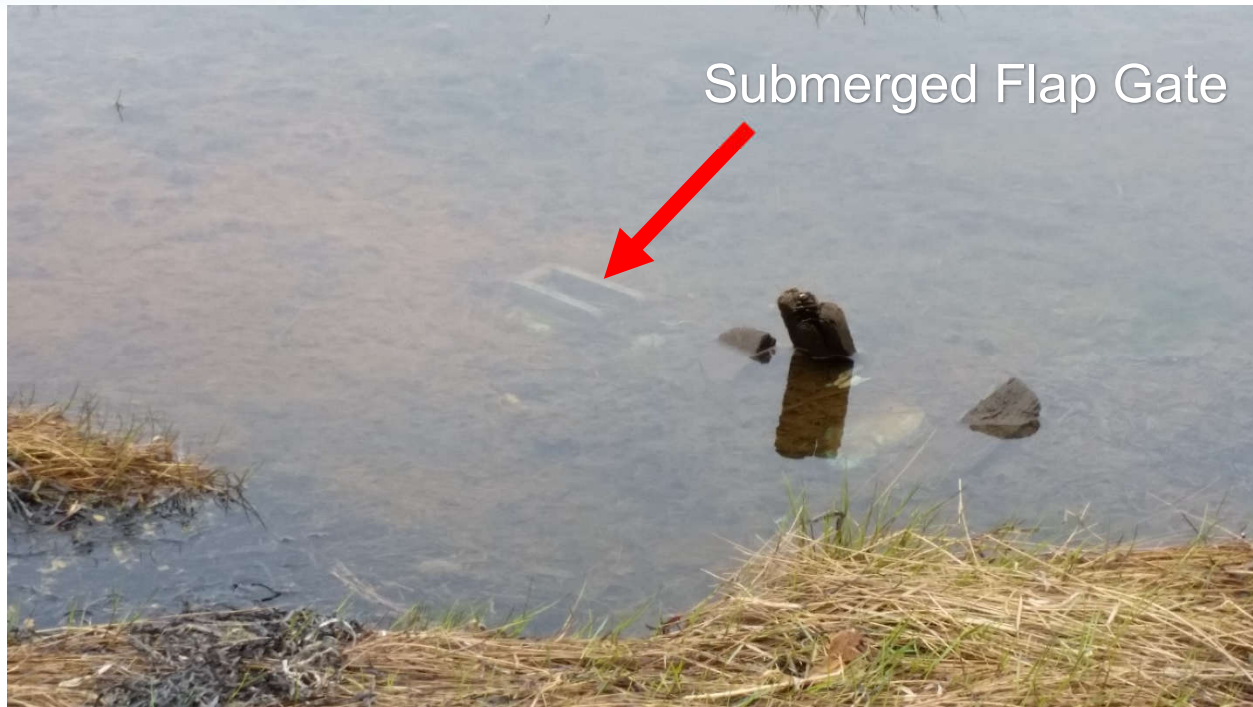
Figure 2-7 Overflow Discharge

The lift station overflow pipe is a 250mm diameter corrugated metal pipe (CMP) that enters the lift station at an elevation of -0.251m geodetic and discharges into the adjacent watercourse at the coastal wetland. At the end of the submerged overflow pipe there is a flap gate installed to prevent any backflow from the watercourse to enter the lift station. Upon first inspection of the overflow pipe inside the wet well it was dry. Therefore, the flap gate is not leaking. Further inspection of the submerged overflow pipe indicated that the discharge end is almost completely buried in sediment and clay material.

Given the age and materials of this pipe, it is highly likely that it is corroded (despite attempts, we were unable to CCTV video inspect the line and it could not be seen from the surface). This can be seen in figure 2-7 below.

It is recommended that the existing overflow pipe from the lift station to the adjacent wetland be removed or at least filled with concrete and abandoned, but only if done with a major lift station upgrade. As a minimum, a new stand-by generator, a larger wet well and new controls would be required at the lift station to maintain it in operation during power outages. Crandall considered having a single generator set that could operate the Parlee Beach water system and sewage lift station, but due to the distance between both systems, this would not be feasible.

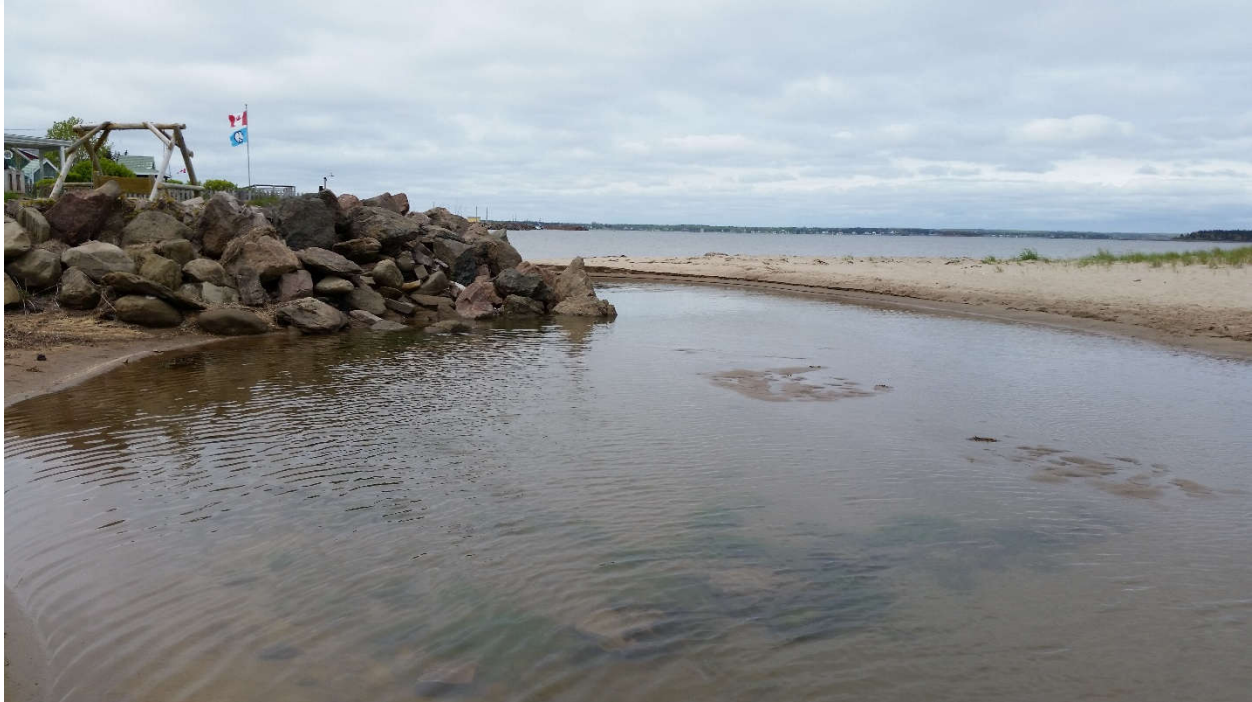
Figure 2-8 Watercourse Inlet

The existing condition of the water course appears to be stagnant water with very little tidal flushing. The water enters and discharges depending on the tide from the Northumberland Strait through a series of narrow channels and a culvert near the lift station outfall that discharges into the watercourse. It was observed that the inlet of the watercourse appears to have been narrowed by a combination of Rip Rap along the shore and sand dunes that have formed as seen in Figure 2-8.

It is also recommended that the NBDTHC contact the NBDELG to further study possible impacts on the tidal inlet of this watercourse noted in section 2.3.6. It is presently not clear if the restriction at the inlet was caused by the rip-rap and development in this area or by natural causes. This is outside of the scope of this study. In any case, we recommend removing the sewer overflow to eliminate any sewage connection at this wetland, but only if done in conjunction with a major improvement / upgrade of the lift station.

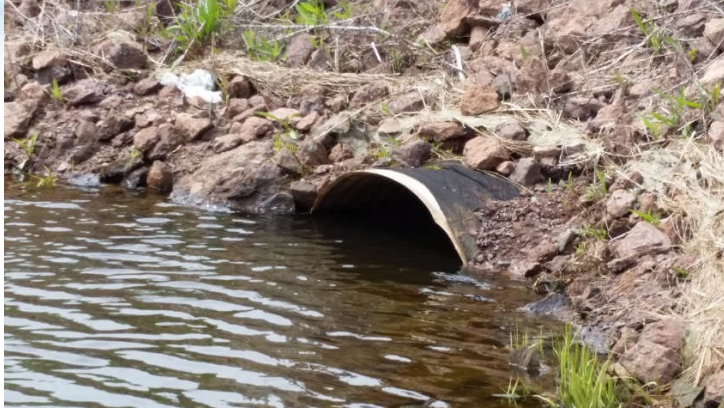
Figure 2-9 Culvert at Tidal Watercourse

Within the watercourse in the provincially significant wetlands there is a 1500mm diameter corrugated steel pipe (CMP) culvert. The culvert location can be seen on Drawing 17161-1P-C100 and Figure 2-9 shown bellow.

Crandall performed a preliminary sizing of the culvert and have determined that the 1500mm diameter culvert is undersized. The preliminary sizing was based on the surrounding drainage area using LiDAR information.

The culvert is presently half full of sediment that is potentially restricting its capacity as a full 1500mm diameter pipe as modeled. As a result, it is limiting the flow from the incoming and outgoing tides within the watercourse and the surrounding drainage basin. It is also assumed, as for most CMP culverts of this age, that the bottom of the pipe may be corroded and deteriorating. We were unable to confirm this based on the site observations.

It is recommended that the existing 1,500 mm diameter culvert be replaced with two (2) 1800mm diameter culverts and that the design of this upgrade be done to minimize siltation and to improve tidal flow and flushing of the watercourse. This work would require WAWA (if not EIA) permitting and would be recommended to be completed in the off season as it would affect vehicle traffic through the park. The full analysis of the flushing of the watercourse is outside the scope of this report.

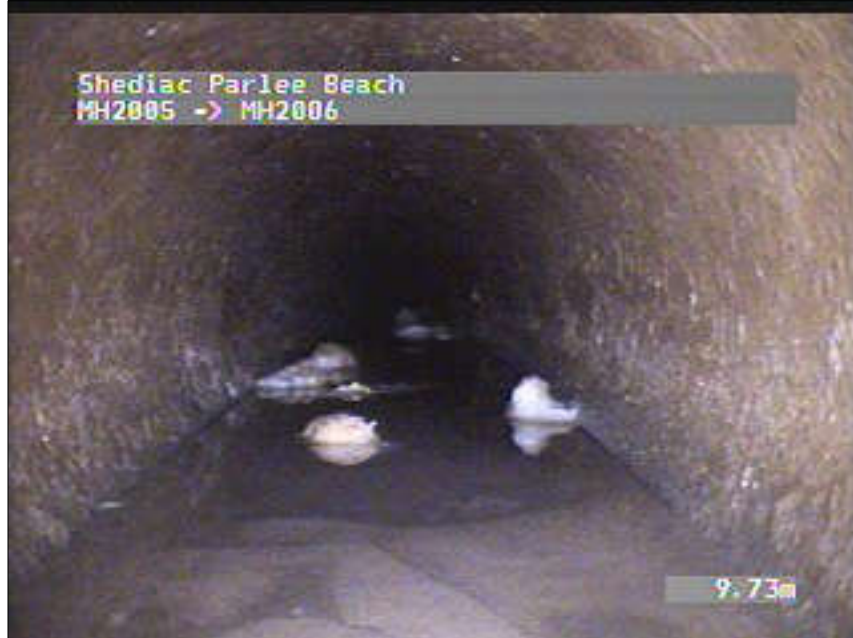
Photo: 5_5_37_A.JPG, VCR No.: 2
9.73m, Deposits Settled Fine, 15 %of cross sectional area, from 05 to 07 o'clock, ,
within 200mm of joint: NO, Start

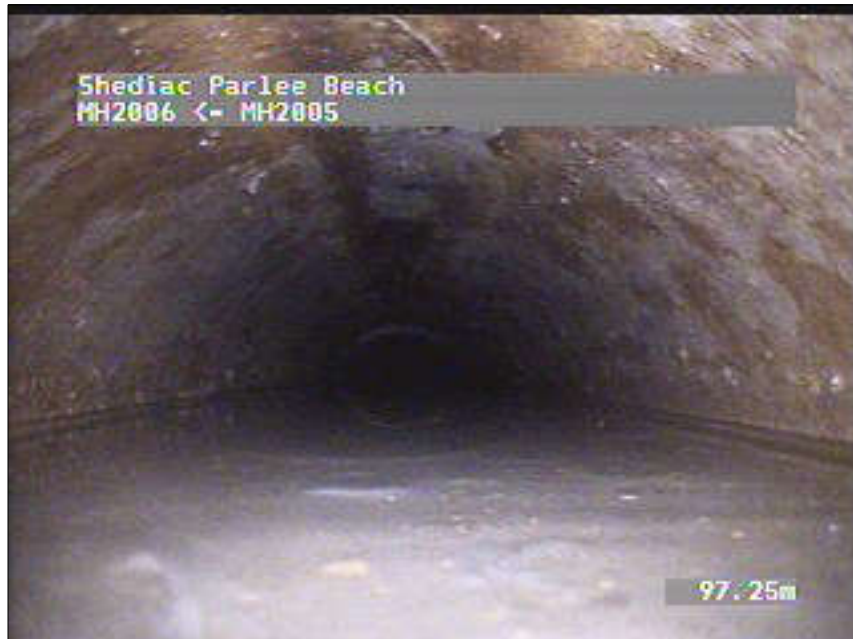
Photo: 4_4_33_A.JPG, VCR No.: 2
16m, Deposits Settled Fine, 25 %of cross sectional area, from 04 to 08 o'clock, ,
within 212mm of joint: NO

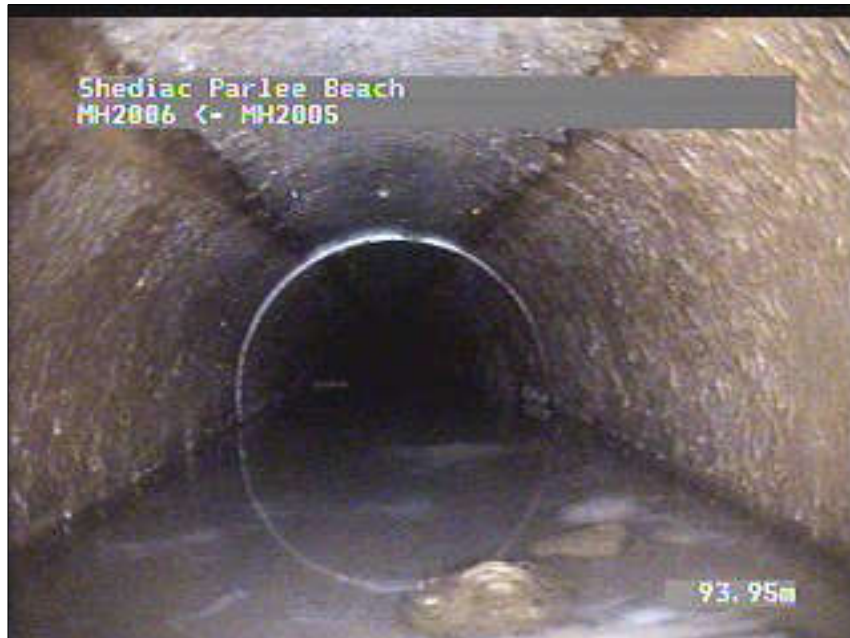
Photo: 4_4_31_A.JPG, VCR No.: 2
21.89m, Deposits Settled Fine, 10 %of cross sectional area, from 05 to 07 o'clock, ,
within 212mm of joint: NO

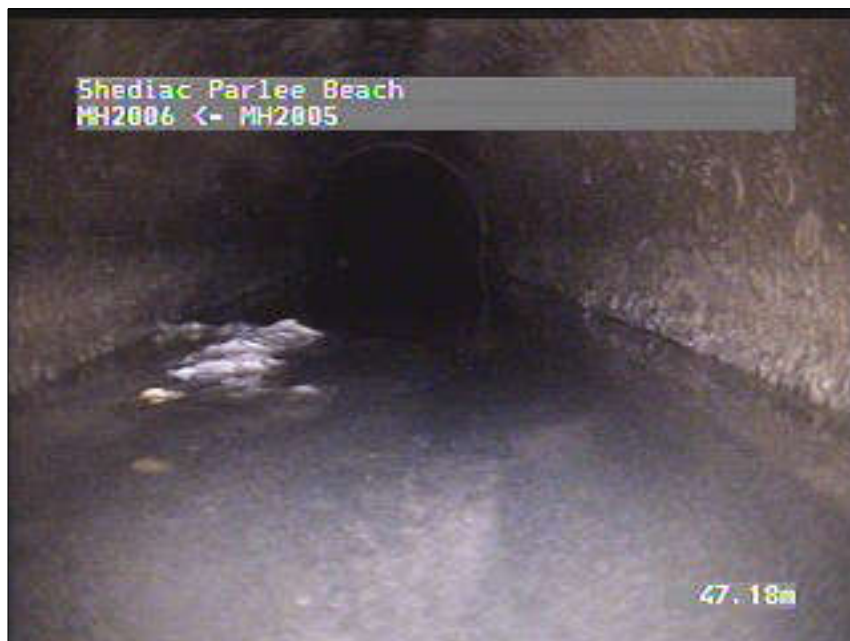
Photo: 4_4_28_A.JPG, VCR No.: 2
65.92m, Deposits Settled Fine, 15 %of cross sectional area, from 05 to 07 o'clock, ,
within 212mm of joint: YES

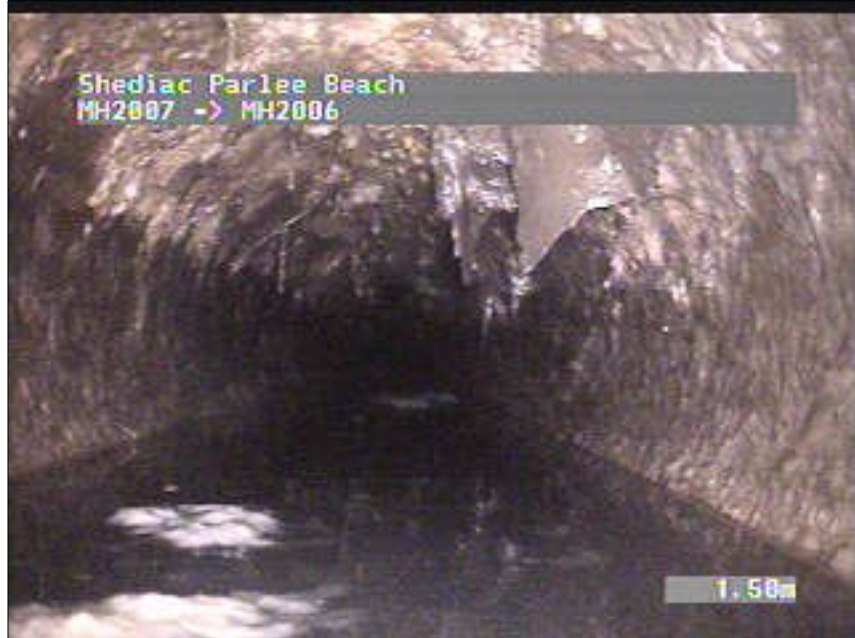
Photo: 7_7_63_A.JPG, VCR No.: 2
1.5m, Survey Abandoned

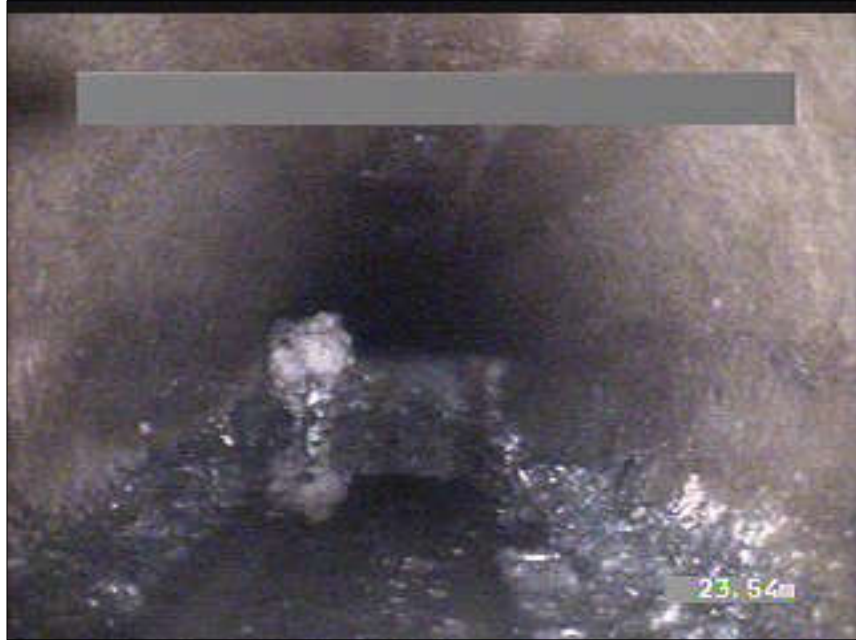
Photo: 9_9_73_A.JPG, VCR No.: 2
92.38m, Deposits Settled Fine, 15 %of cross sectional area, from 05 to 07 o'clock, ,
within 212mm of joint: NO, Start

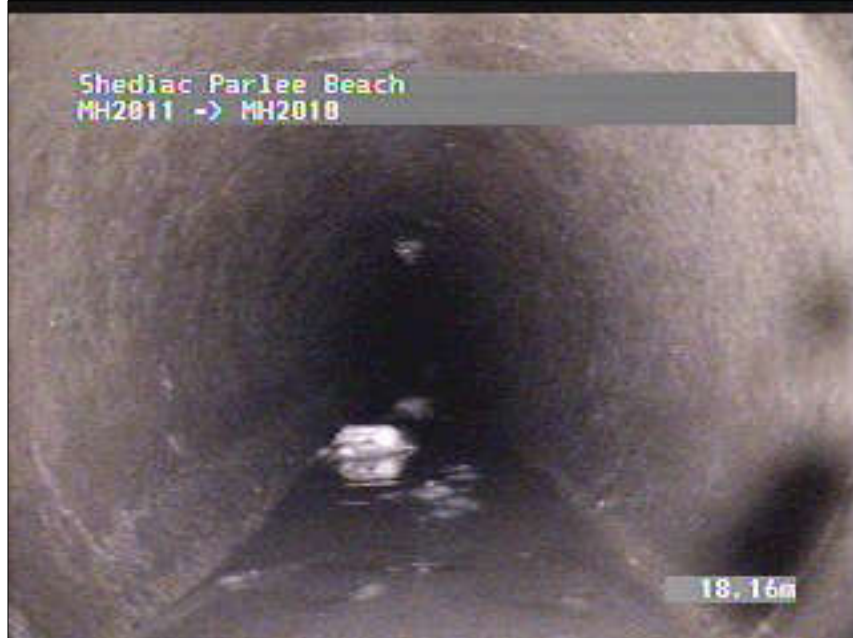
Photo: 11_11_84_A.JPG, VCR No.: 2
17.25m, Deposits Settled Fine, 10 %of cross sectional area, from 05 to 07 o'clock, ,
within 200mm of joint: NO, Start

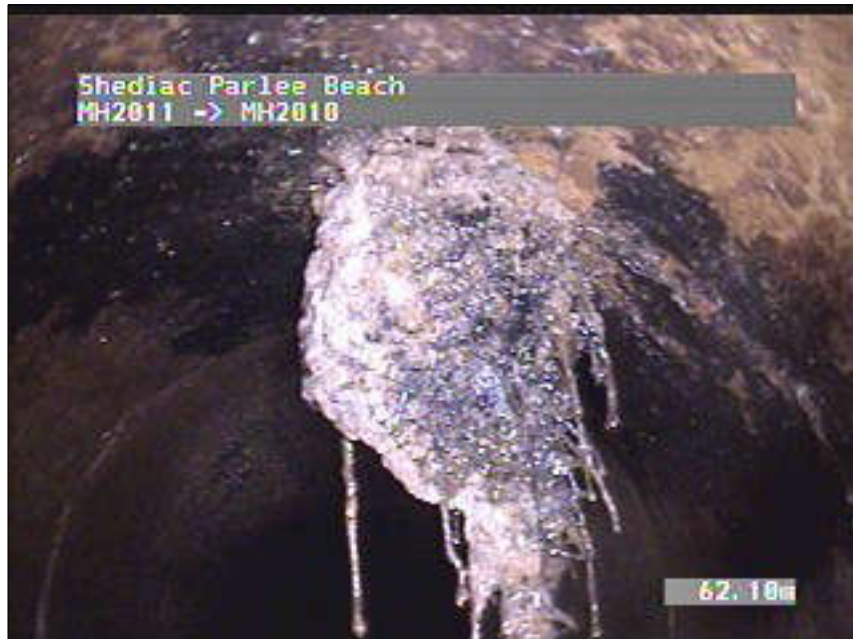
Photo: 11_11_86_A.JPG, VCR No.: 2
62.1m, Roots Medium Joint, from 12 to 01 o'clock, 15 %, within 200mm of joint: YESR
