**2019 Intensive Stormwater Sampling Program**  
**in the**  
**Shediac Bay Watershed**  
**Analysis and Interpretation of Results**

Prepared by: Robert N. Hughes

Consulting Service in Environmental Sciences  
Upper Kingsclear, New Brunswick

November 2020

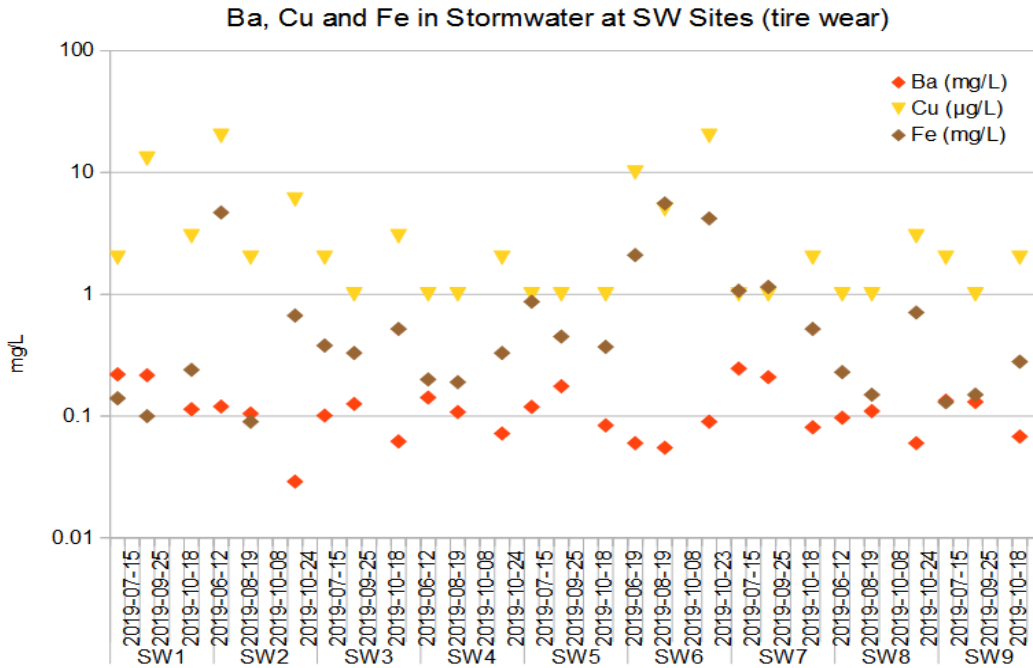
In Figure 7, there is evidence for a correlation between results for all the metals, especially between iron and copper, which are highest at sites 1, 2 and 6. In Figure 8, the highest values for lead and zinc both occurred in the same samples (SW1 and SW2), although there is scatter across the rest of the results. SW1 is an open creek receiving street runoff and SW2 is a storm outfall. Given that all the SW sites are affected by stormwater contributed from street drains it is probable that all are liable to the effects of brake and tire wear, and the results for the indicator metals are consistent with this. In terms of absolute values, an examination of results for a range of rivers in New Brunswick suggests that the metal results in stormwater in this study are about 3-10 times higher than those typically seen in the lower reaches of major rivers such as the Saint John River. Smaller tributaries have much lower results for these metals, often below detection (NB Surface Water Quality Data Portal, 2020).

Figure 7. Barium, copper and iron in stormwater at SW sites.

Considering the trace metals associated with vehicle tire and brake wear (Figures 7 and 8), highest values were seen at sites 1, 2 and 6. Considering the relative proportions of land cover discussed above, site SW1 would be expected to have higher results given the large area of road and parking lots in its watershed. Taits Creek, as represented by the data at site SW1, can be expected to have a more significant impact on the receiving environment given the much greater discharge at this location compared to discharge at sites SW2 or SW9.

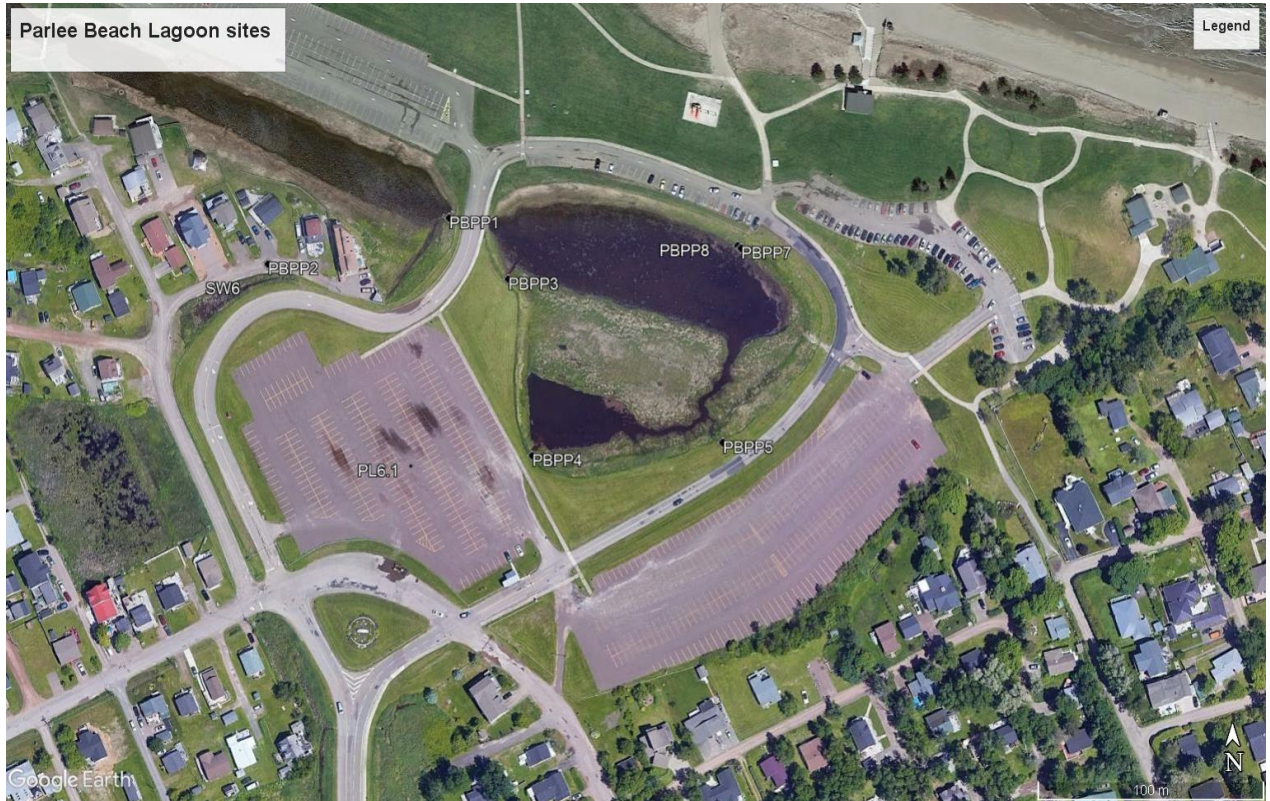
Samples were collected at seven locations around the Parlee Beach Lagoon, where different pipes discharge into the lagoon. Sample locations are shown in Figure 12. Note that PPPB 2 is in the same gully that is sampled as site SW6. These outfalls were also investigated by Crandall Engineering as part of their 2018 study of the lagoon (Crandall Engineering, 2019). The numbering system used by Crandall in their study has been carried over to the sites sampled in 2019 in this study. Crandall (2019) found that the pipes discharging at PPPB 3,4,5,7 and 8 all convey water drained from adjacent parking lots into the lagoon. PBPPP1 is a culvert connecting the lagoon to its discharge channel towards Shediac Bay. PPPB 2 is the same swale sampled as site SW6 and was sampled a short distance to the NE by Crandall. Previously there was a sewage lift station overflow discharging to the lagoon at its easterly end, but this has been removed.

Figure 12. Sample site locations around the Parlee Beach lagoon.

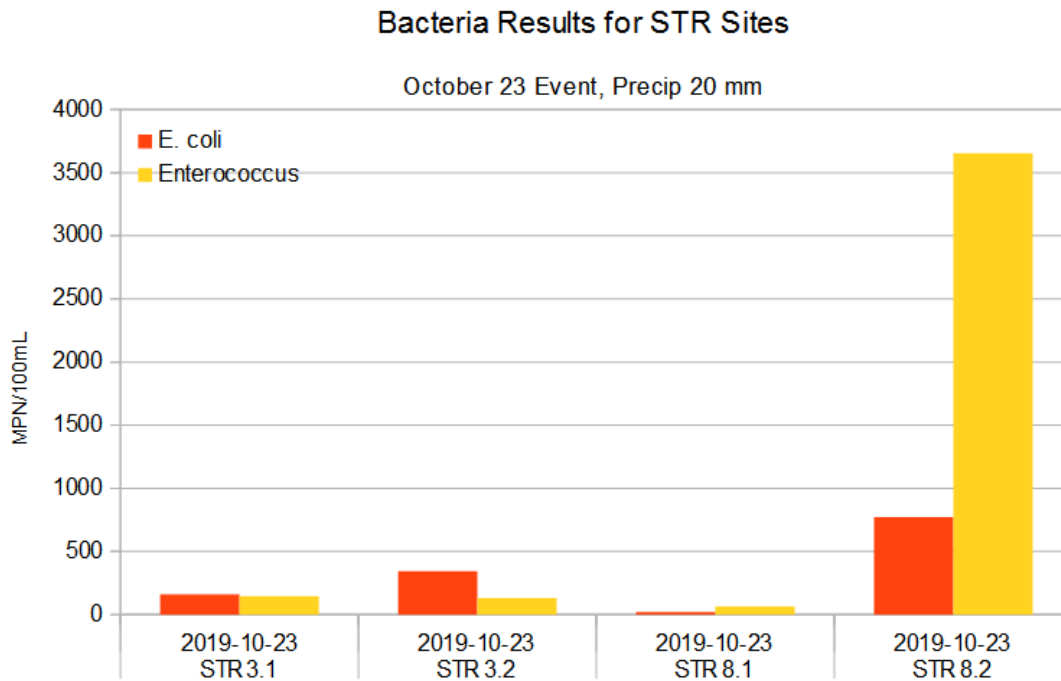
Figure 19. Bacteria results at stream (STR) sites on October 23, 2019.

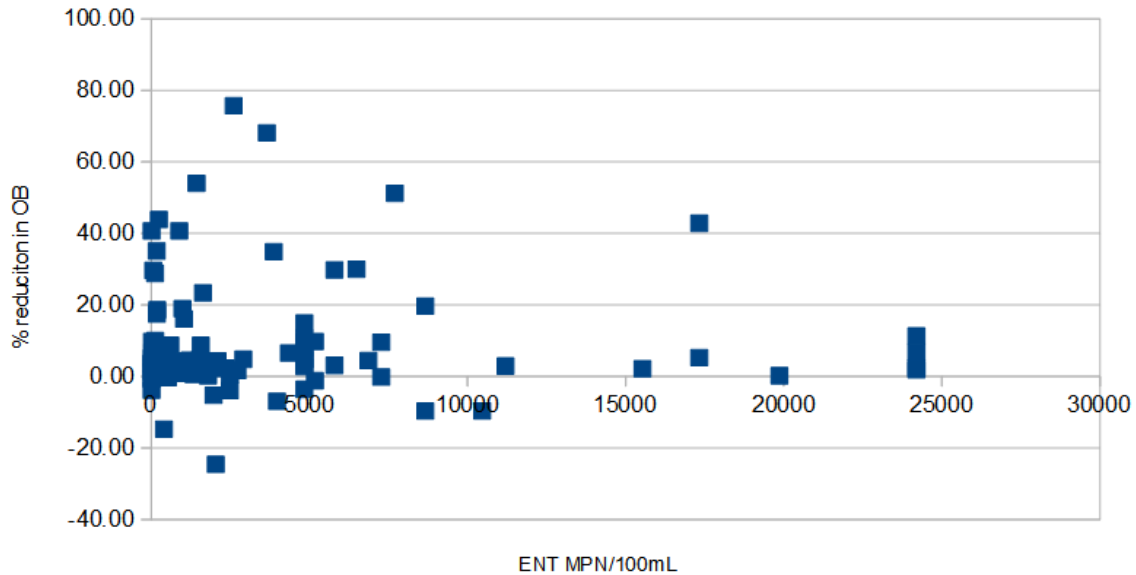
For example Figure 22 is a plot of reduction in OB value versus enterococci values across all sites. High enterococci values occur across a wide range of OB reduction results (many near zero) and conversely a significant number of high results for OB reduction are associated with low enterococcus numbers.

Figure 22. Reduction in OB result following irradiation versus enterococci.

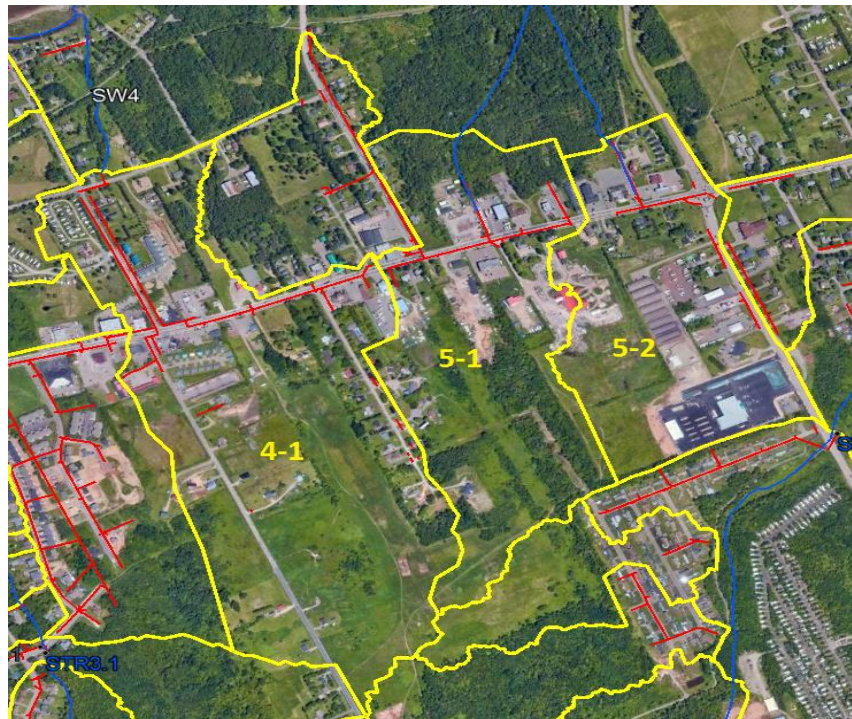
*Figure 25. Example watersheds showing relative extent of development and impervious cover. Watershed boundaries in yellow, stormwater pipes in red.*

Inspection of aerial imagery shows that the SW1 watershed has the greatest proportion of impervious surface - parking lots, roads and housing development (roughly 50%). The SW3 watershed has considerably less impervious cover, and the SW8 watershed a still lower level. For SW4, watershed 4-1 has less than 50% impervious cover. Watershed 5-1 has less than 50%, but 5-2 appears to be slightly over 50%. This can be seen in Figure 25. Watershed 5-2 is quite small and recent development at its southeastern end covers a significant area.
