Anqotum
Resource Management

Fisheries and Oceans
Canada

Small Craft Harbours

**Little Southwest Miramichi River
Bank Restoration Design
Plan View**

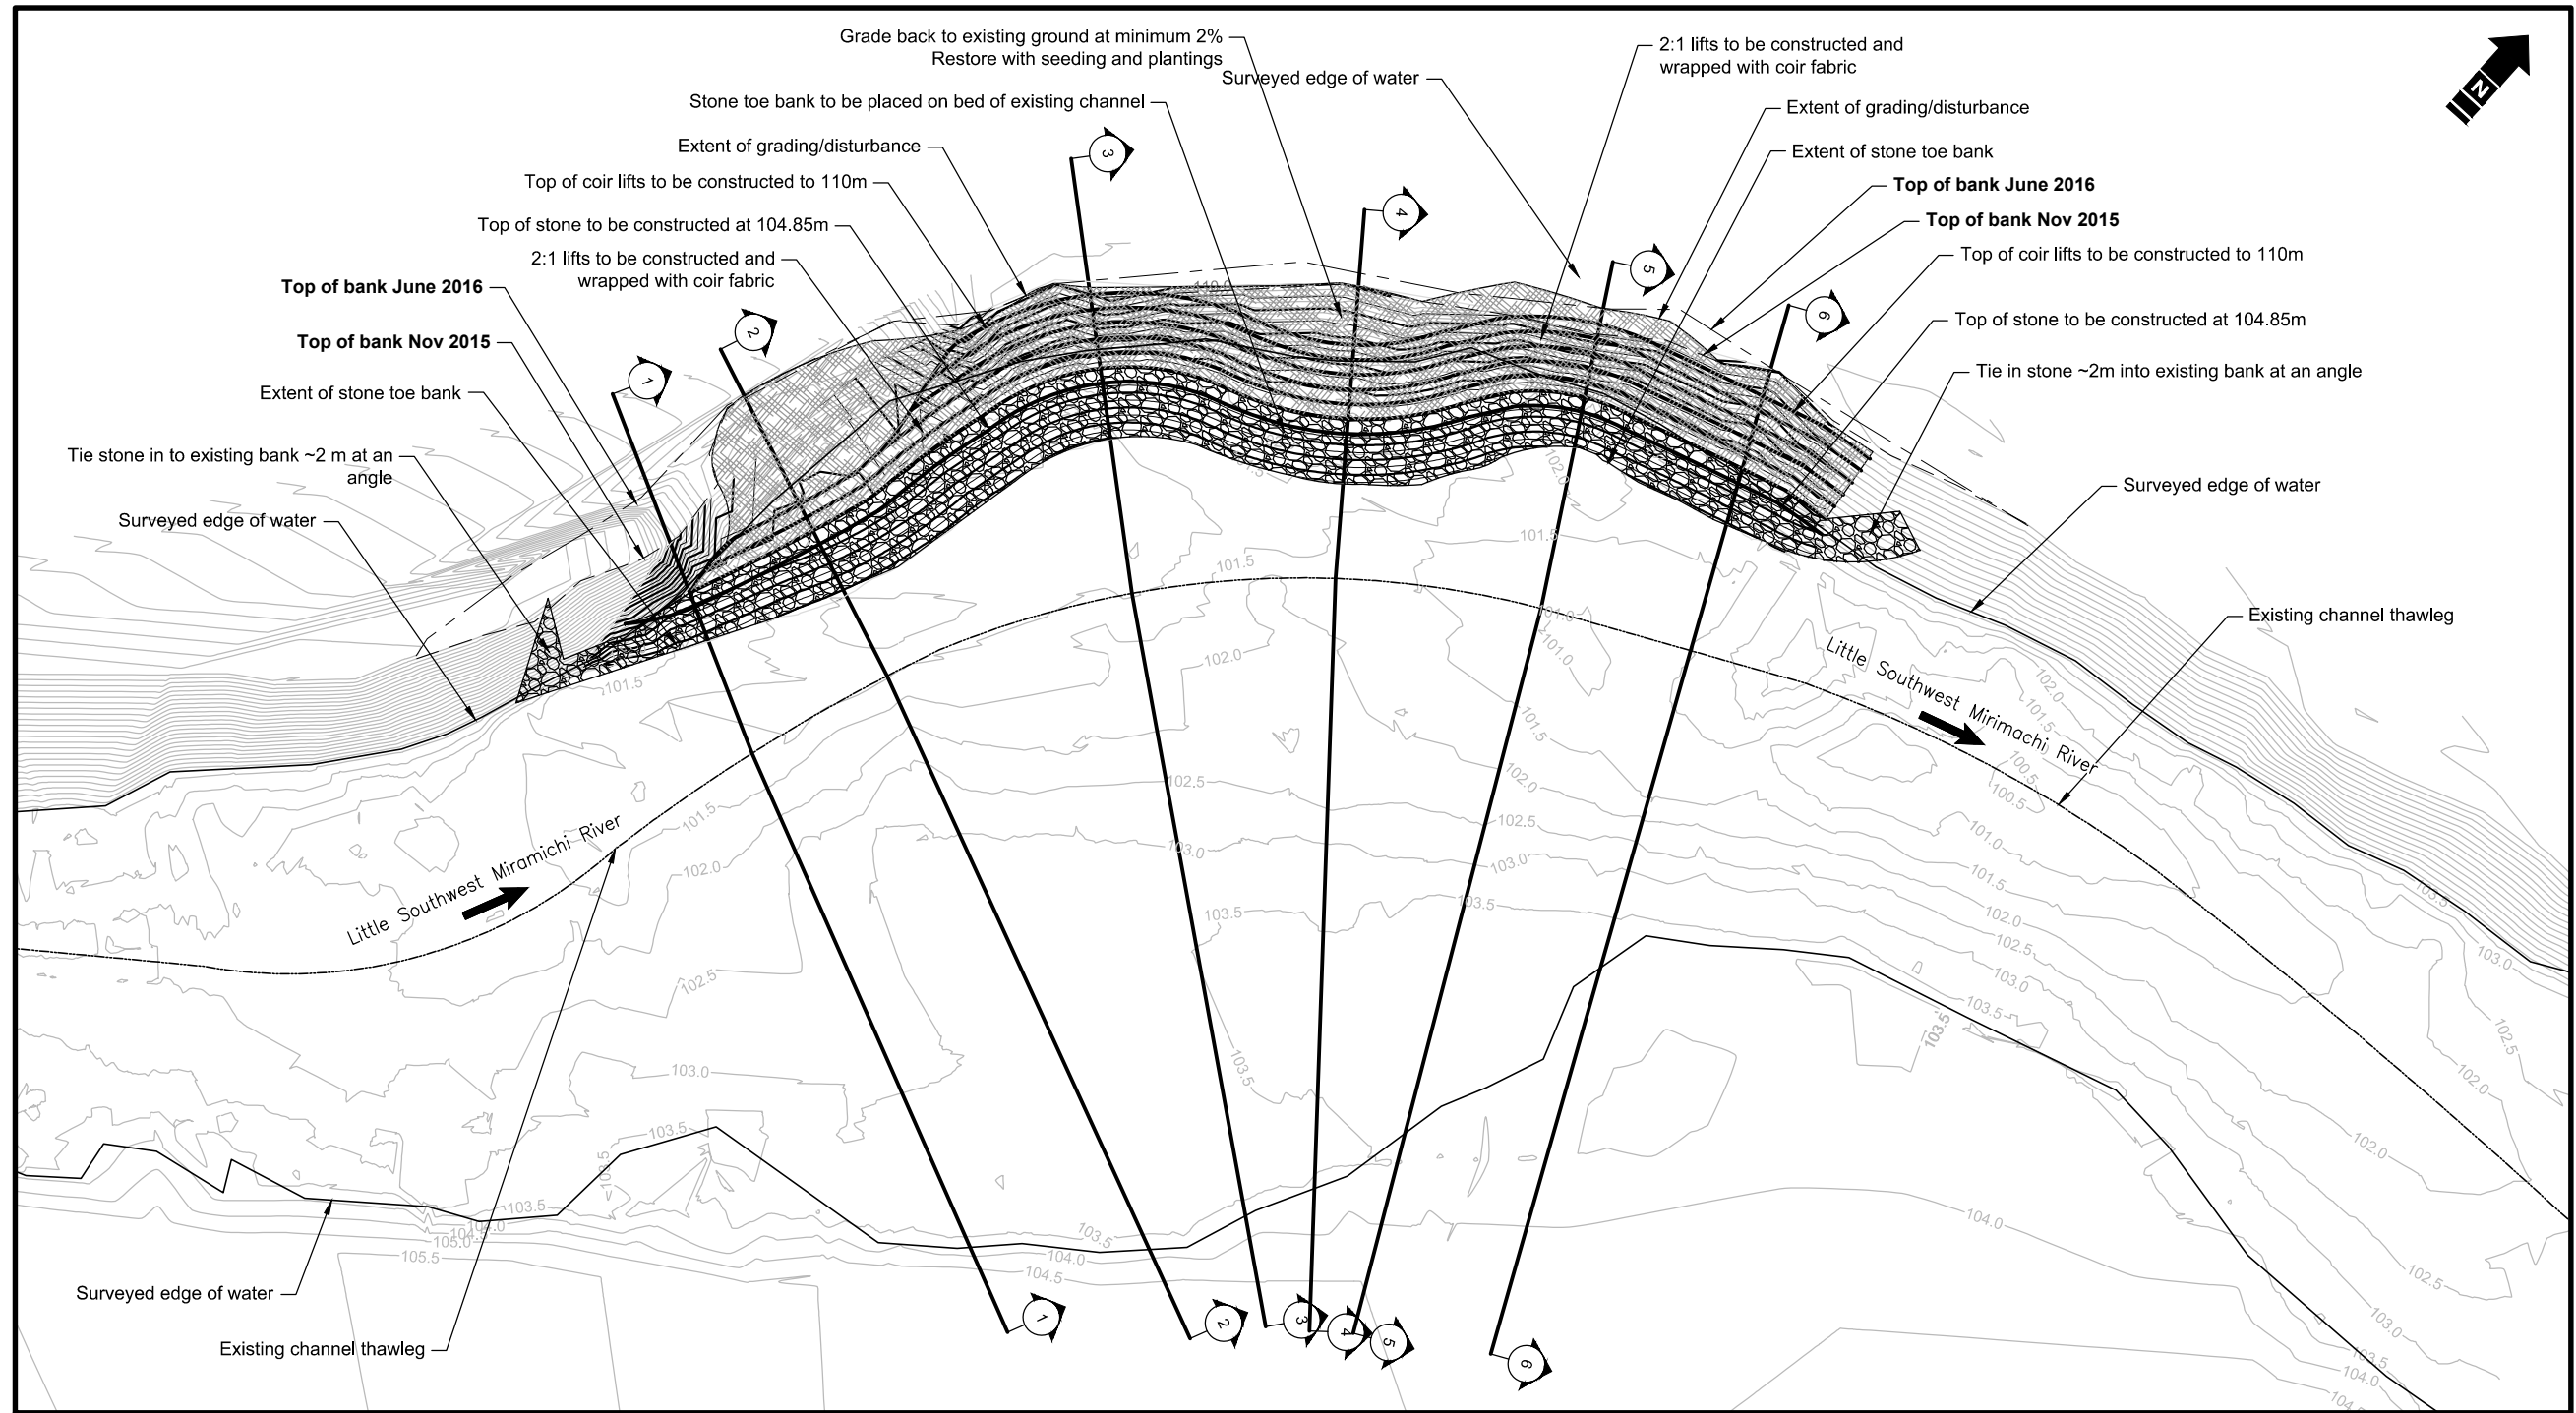
01

Legend	
	Surveyed edge of water
	Existing contour
	Cross section
	Proposed bank
	Coir lift bank protection
	Rock toe bank protection

- Notes:
- Total Station survey of shore and top of bank completed by Matrix Solutions Inc. on November 3, 5, 2015 and June 1, 2016
 - Bathymetric survey completed by Matrix Solutions Inc. on November 3, 4, 5, 2015.
 - Elevations displayed on figure are based on meters above sea level +100m.
