Stewart Vertical Farms Inc.

Environmental Impact Assessment Registration Document St. Stephen, NB

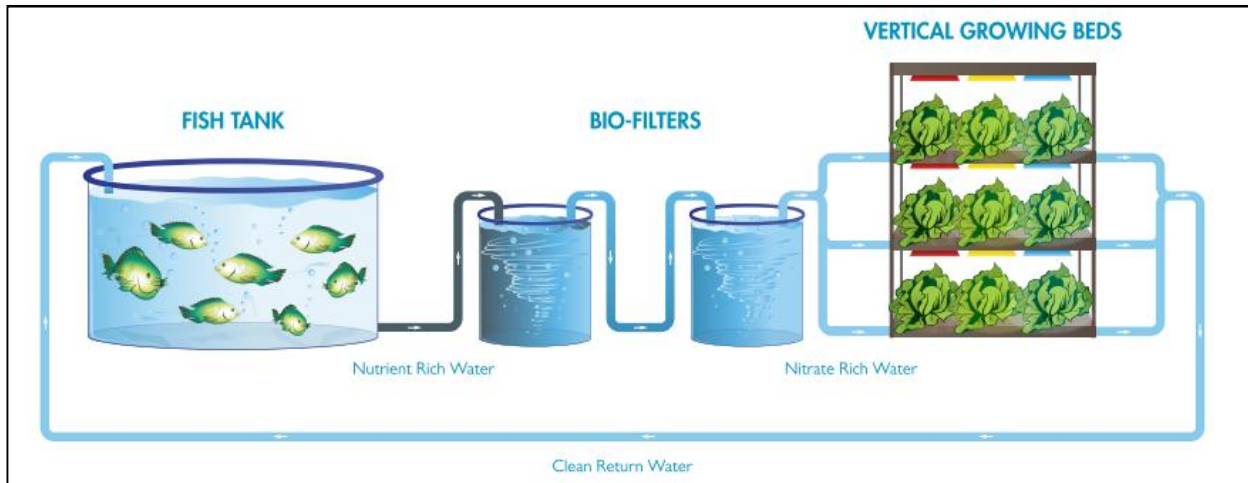
Figure 1: Simplified aquaponics process

have been developed into a proprietary technology called NutraPonics that has been implemented near Edmonton, Alberta for the past 4 years. A schematic representation of the aquaponics system is shown on **Figure 1**.

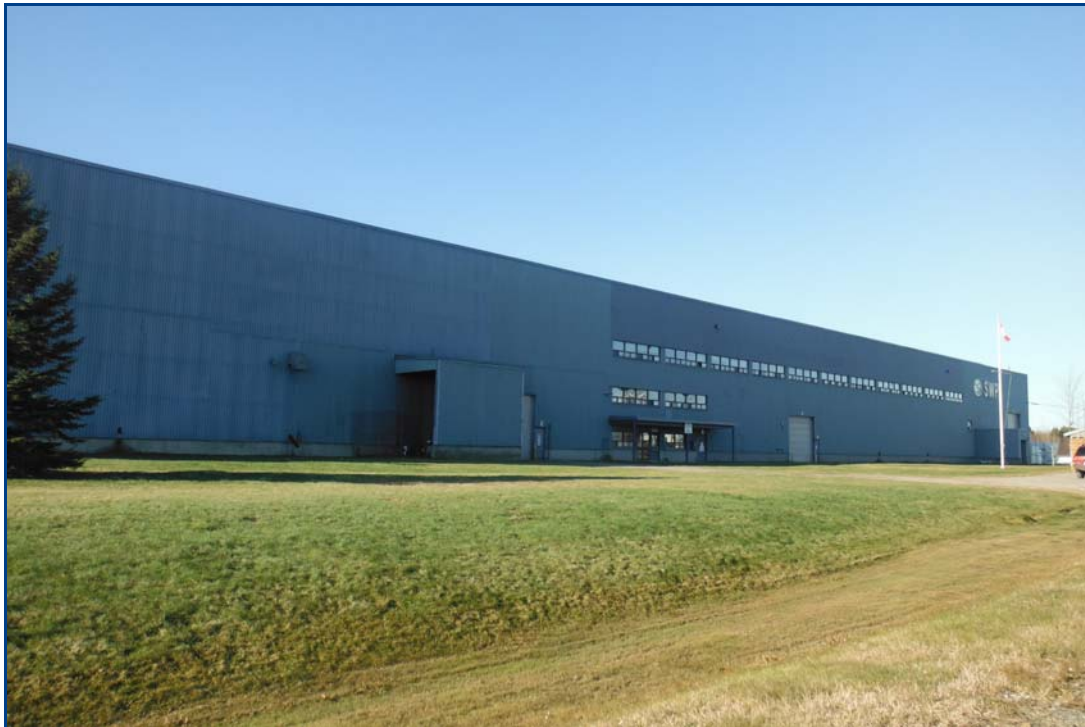
Figure 2. View of the subject property on 30 Progress Drive, St. Stephen, NB.
Photograph taken on 26 November 2012.

The building located at 30 Progressive Drive is a steel framed building with metal clad siding founded on a concrete slab on grade. The building does contain a second level that houses offices with the remaining area being open for the manufacturing plant. The original building was constructed in 1974 and additions were added to each end of the building after a major fire.

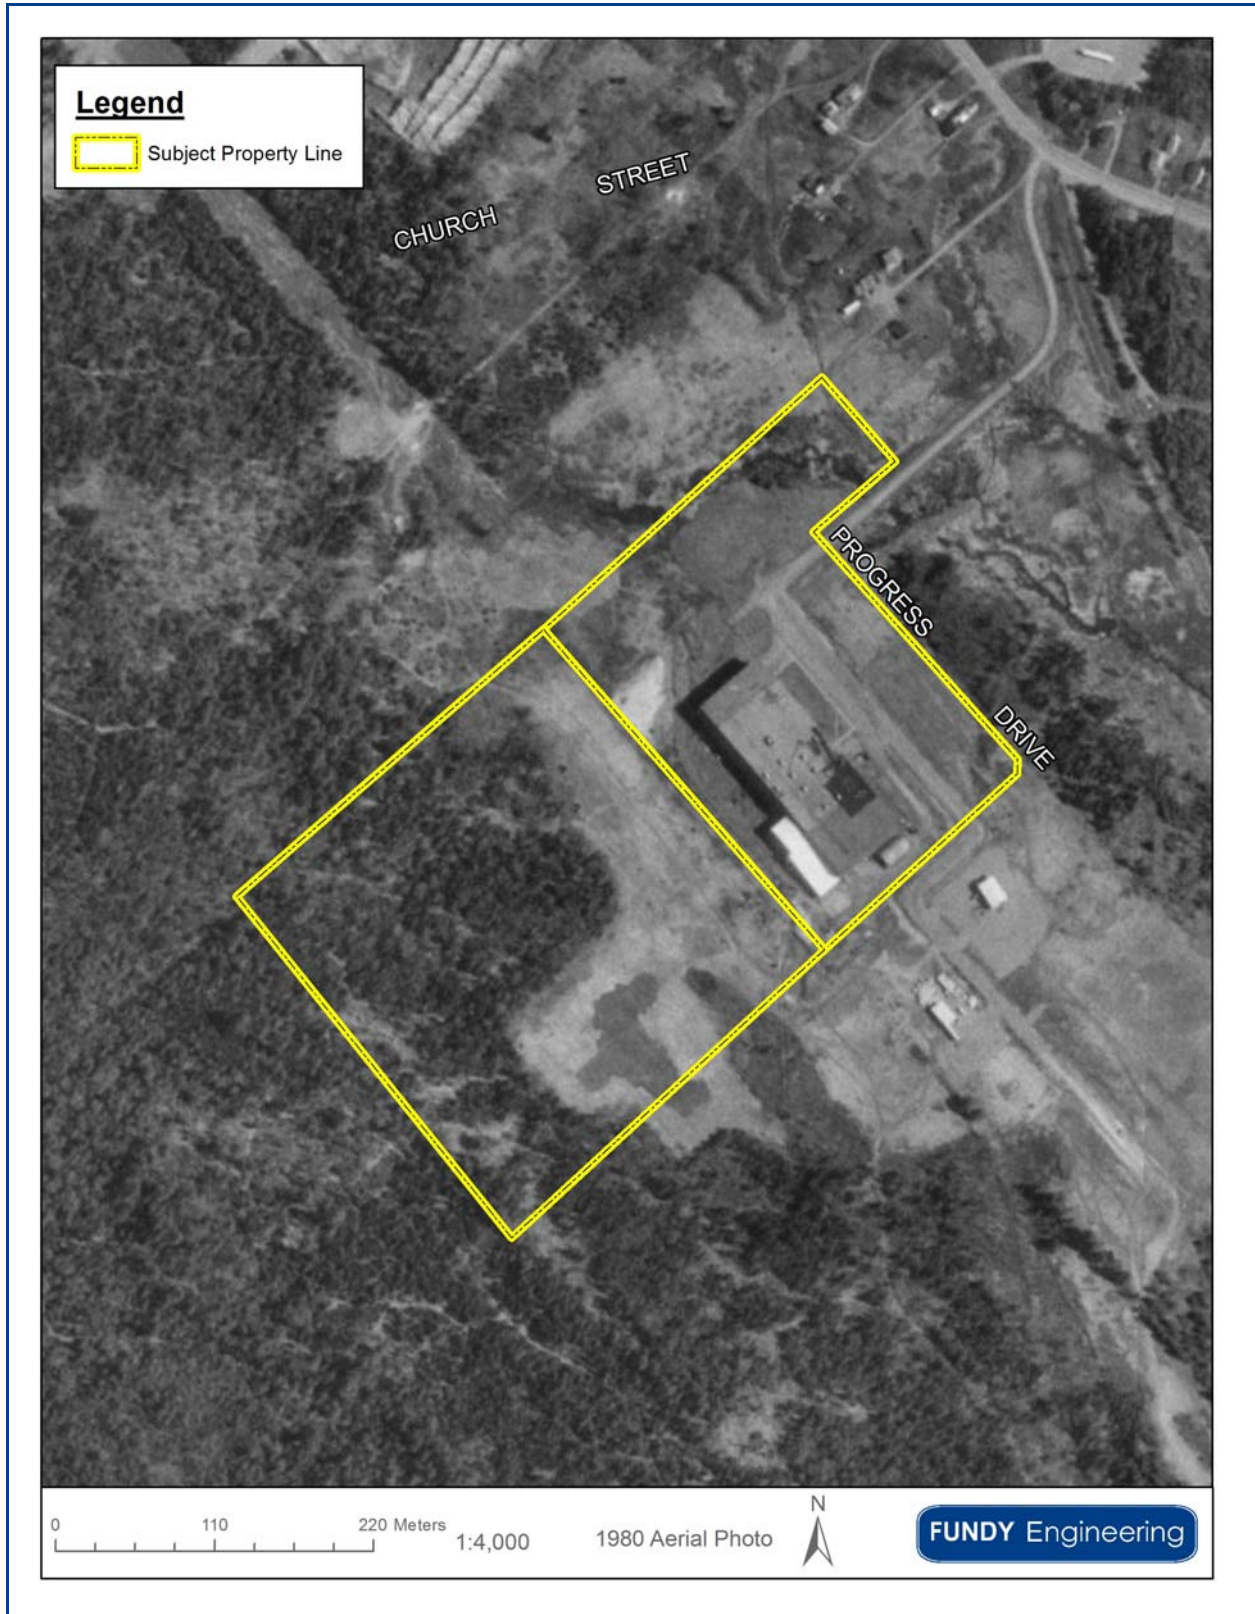
Figure 4. Aerial photograph, circa 1980, showing Property Identification Number 01332683 & 15031099 at 30 Progress Drive in St. Stephen, NB.

Prior to the site visit, property maps and aerial photographs were retrieved from the Service New Brunswick database. The property boundaries were found by super-imposing the property lines onto a 1976, 1980 and 2010 aerial photographs (refer to Figures 3 to 5, respectively).

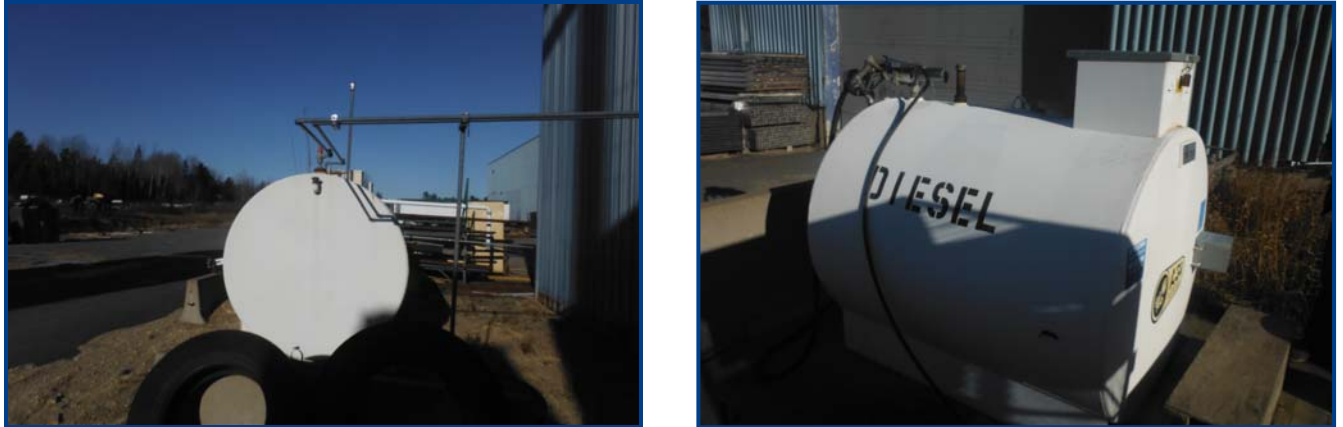
Figure 6. View of the 9092 L AST (left) and the 1980 L AST (right) located at 30 Progress Drive, St. Stephen, NB. Photograph taken 26 November 2012.

According to the NBDENV record search there was a former 45,460 L underground storage located on the subject property. This tank was removed and investigated by the NBDENV as mentioned in the previous section. **This is not considered a significant, immediate concern at this time.**

removed and replaced than it must be done by a licensed tank installer and registered with the NBDENV. **It is recommended that further inquiry about the petroleum storage tanks records registered at the subject properties be looked at and updated. This is not considered a significant, immediate concern at this time.**

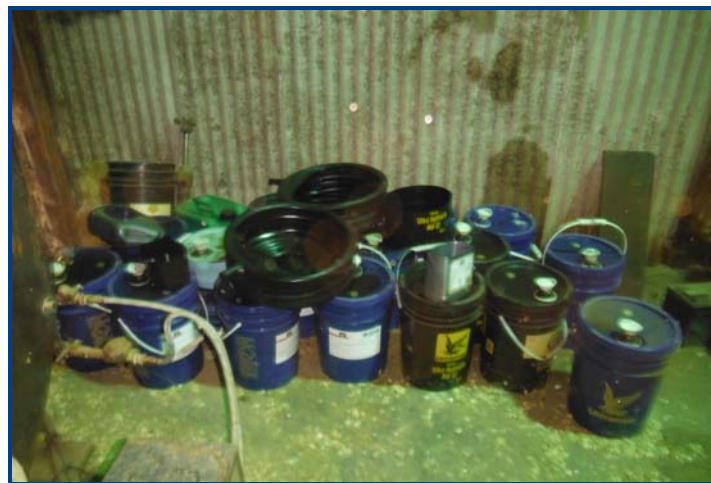
Figure 7. View of several waste oil storage containers at 30 Progressive Drive, St. Stephen, NB. Photograph taken 26 November 2012.

During the site visit it was noted that there were several containers in the boiler room that contained used hydraulic oil. **These containers and their contents should be removed from the subject property and disposed of properly at an approved handling facility. This is not considered a significant, immediate concern at this time.**

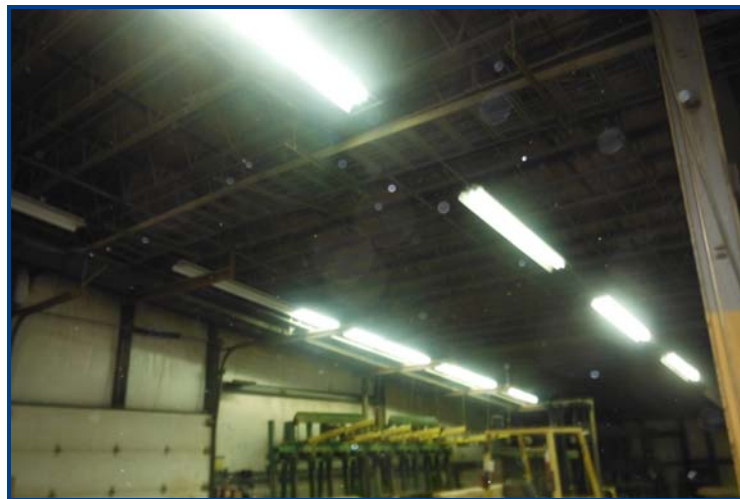
Figure 8. View of some light fixtures that may contain PCB light ballasts at 30 Progressive Drive, St. Stephen, NB. Photograph taken 26 November 2012.

During the site visit it was noted that there were light ballasts which contain transformers that potentially have PCBs given the age of the building. The fixtures were noted in all areas of the subject buildings. **When the light ballasts are no longer functional they should be checked and properly disposed of at an approved handling facility if they contain PCBs. This is not considered a significant, immediate concern at this time.**

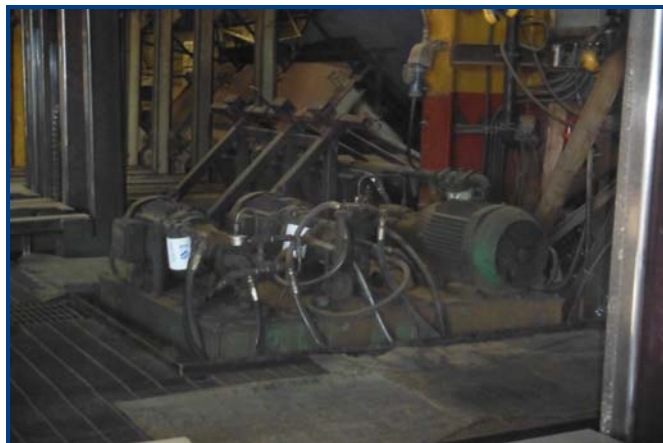
Figure 9. View of the hydraulic machinery at the subject site at 30 Progressive Drive, St. Stephen, NB. Photograph taken 26 November 2012.

There is some hydraulic equipment used at this facility. All hydraulic equipment appears to be in good condition, and no stains or leaks were visible at the time of the site visit. The hydraulic equipment is therefore not considered a concern at the present time. **Nonetheless, these pieces of equipment use hydraulic oil to function properly and it is recommended that a regular maintenance schedule be put place to inspect all hydraulic equipment to ensure that there are no leaks. If the equipment is not in use then it should be removed from the site.**

- It is recommended that a regular maintenance schedule be put place to inspect all hydraulic equipment when in use to ensure that there are no leaks. If the equipment is not in use then it should be removed from the site.
