Environmental Impact Assessment

Registration Document – 2009 08 12

Ocean Surf Campground Extension, Pointe-du-chêne, N.B.

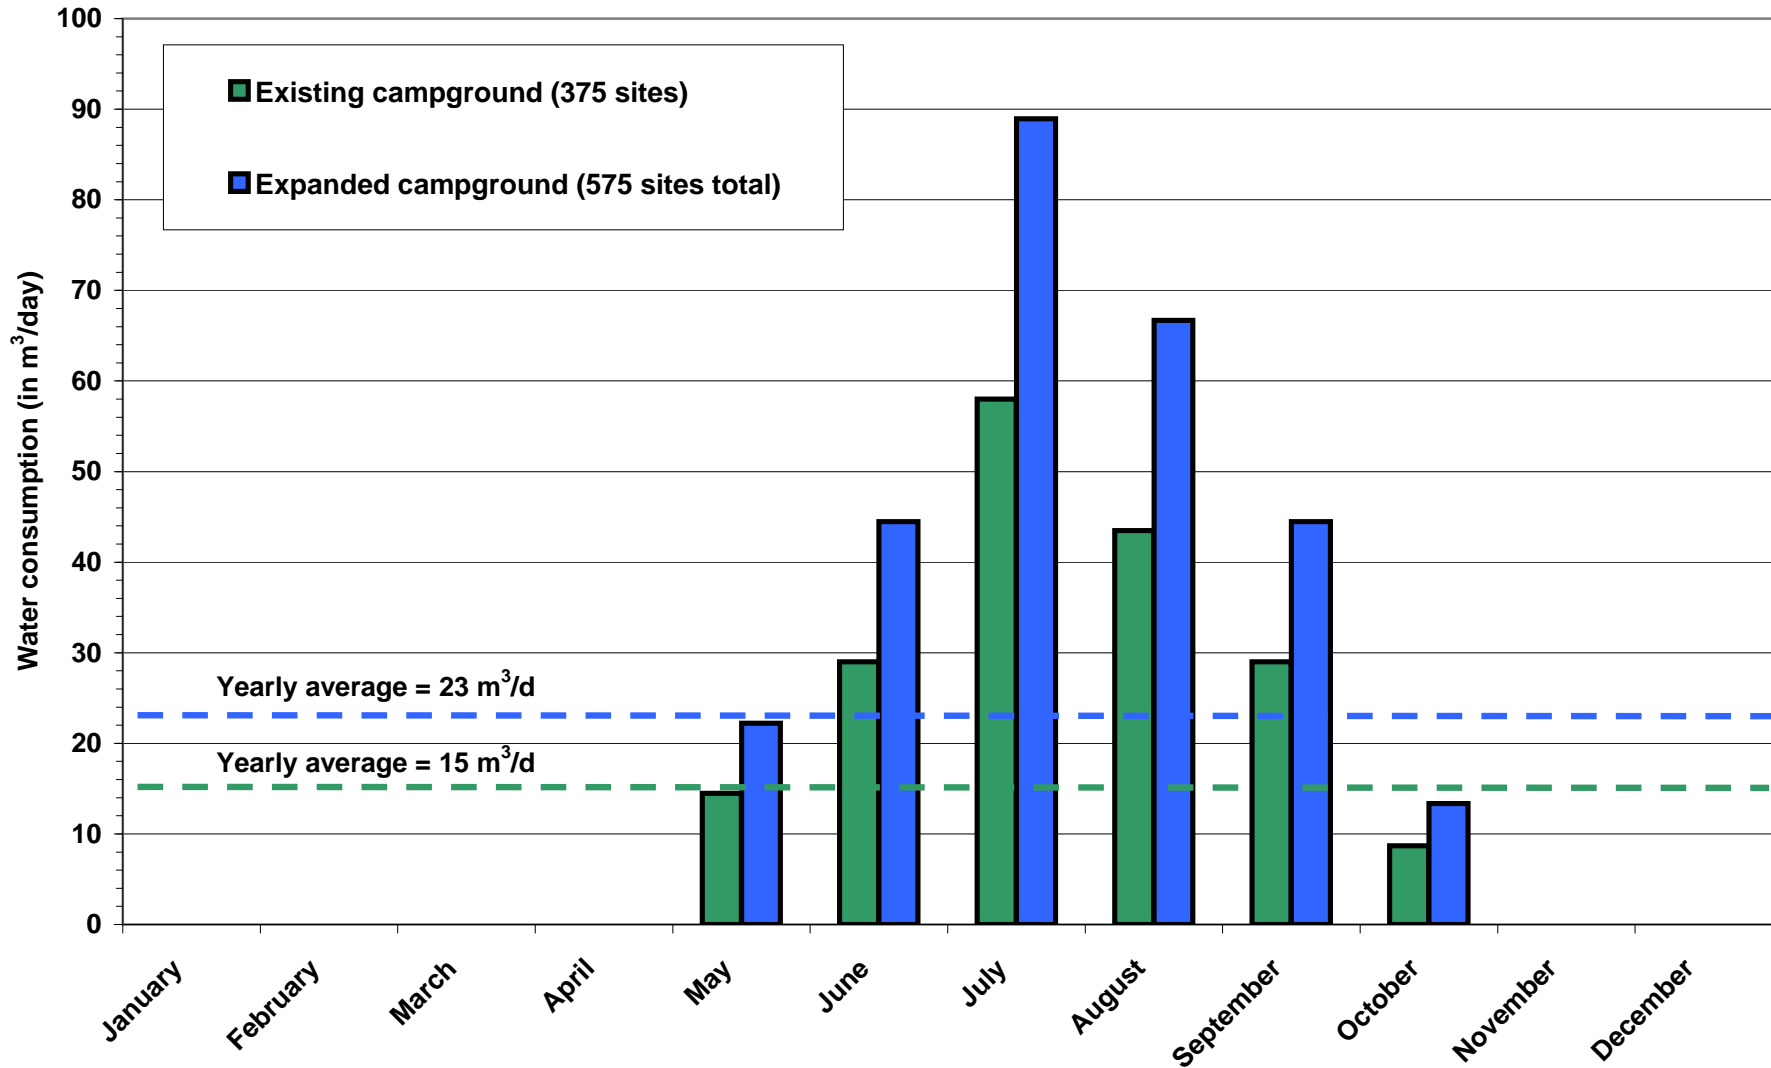
Estimated Water Consumption - Ocean Surf Campground

Water supply: four wells currently supply the existing campground. Water meters were installed in June of 2009, and it was found that only three of the wells are actually being used (wells A, H and M). The consumption of the existing campground (375 fully serviced sites) was measured to be 58 m³/day in the busiest week of the year (at 100% occupancy), and is estimated to be 15 m³/day on average over the year, based on the seasonal site occupancy. The design peak demand for the new 200 sites is estimated to be 31 m³/day during the peak season (8 m³/day yearly average). Figure 2-2 illustrates the water consumption pattern. A Water Supply Source Assessment including a pump test is planned for mid-September of 2009, as part of the EIA process, to determine whether the existing wells will be sufficient to provide water for the expansion (the application form is attached in Appendix D).

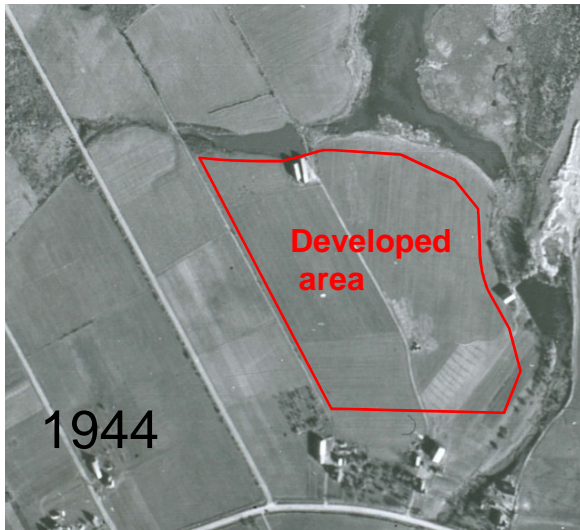
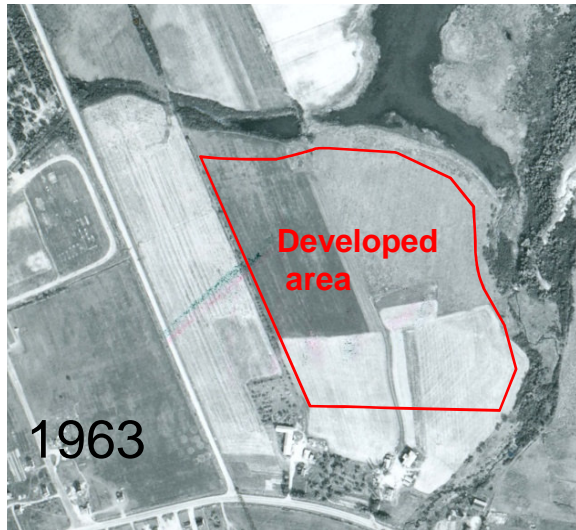
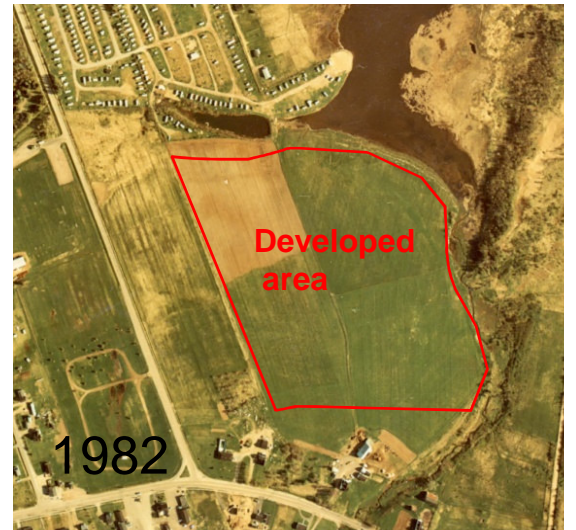
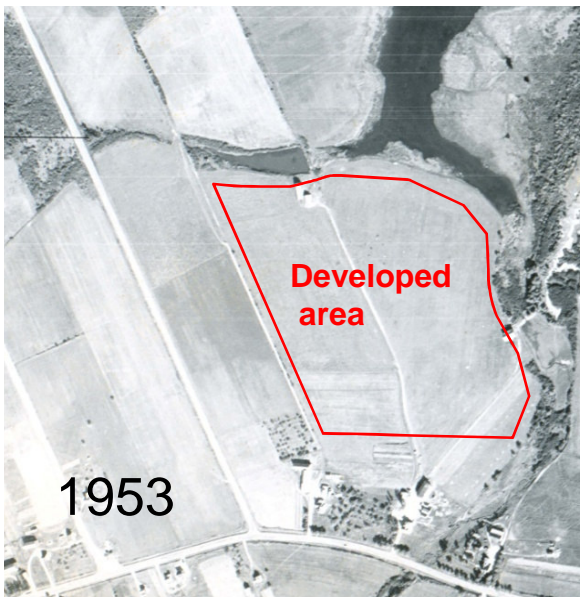
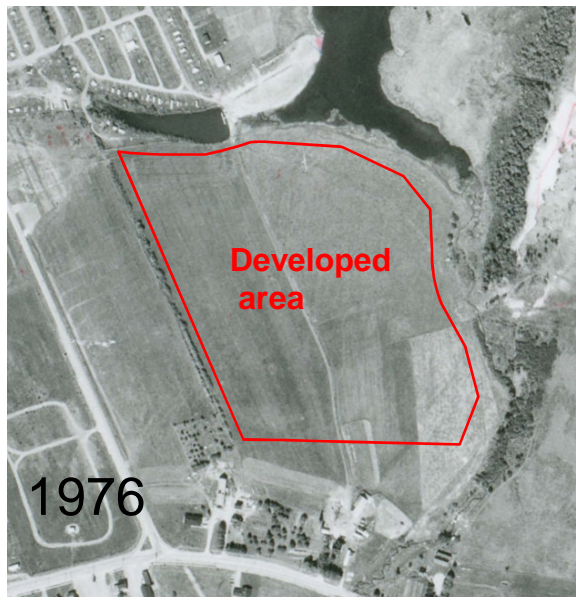
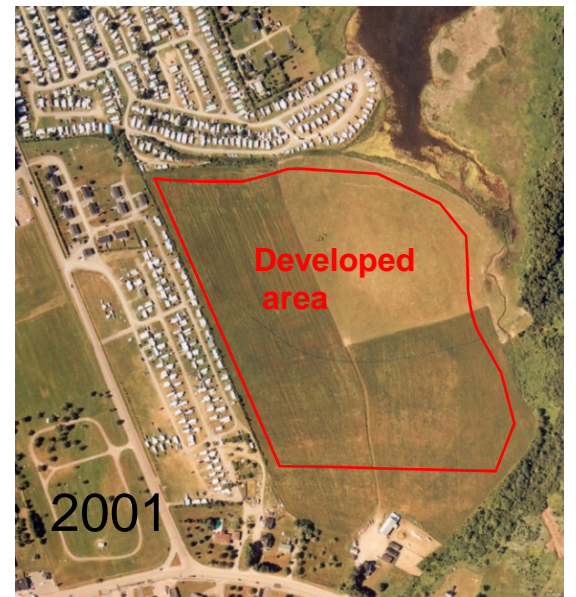
According to available aerial photographs, the property has been used for farming for the last 50 years. Currently, it is used as a pasture for horses. Historical aerial photographs are presented in Figure 3-1.

Ocean Surf Campground
Historical Aerial Photos

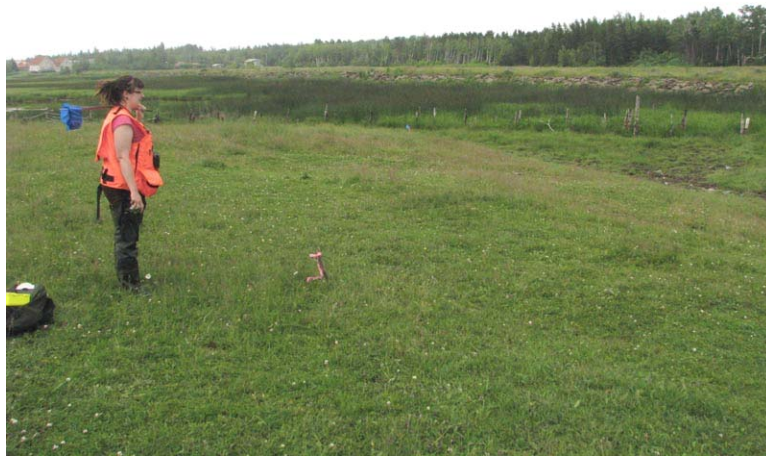
Photo 1 - Looking north from pasture onto the salt marsh

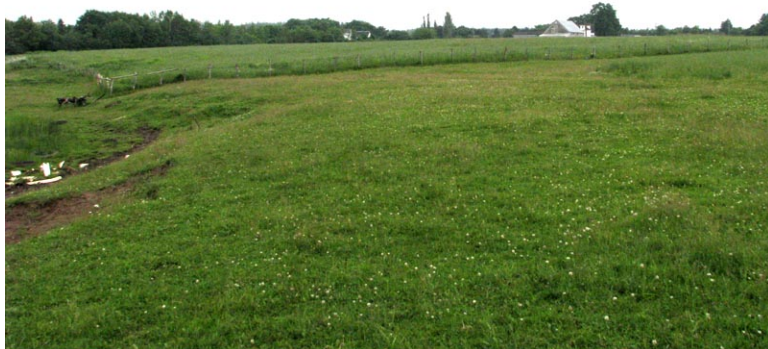
Photo 2 - Looking south from salt marsh across pasture

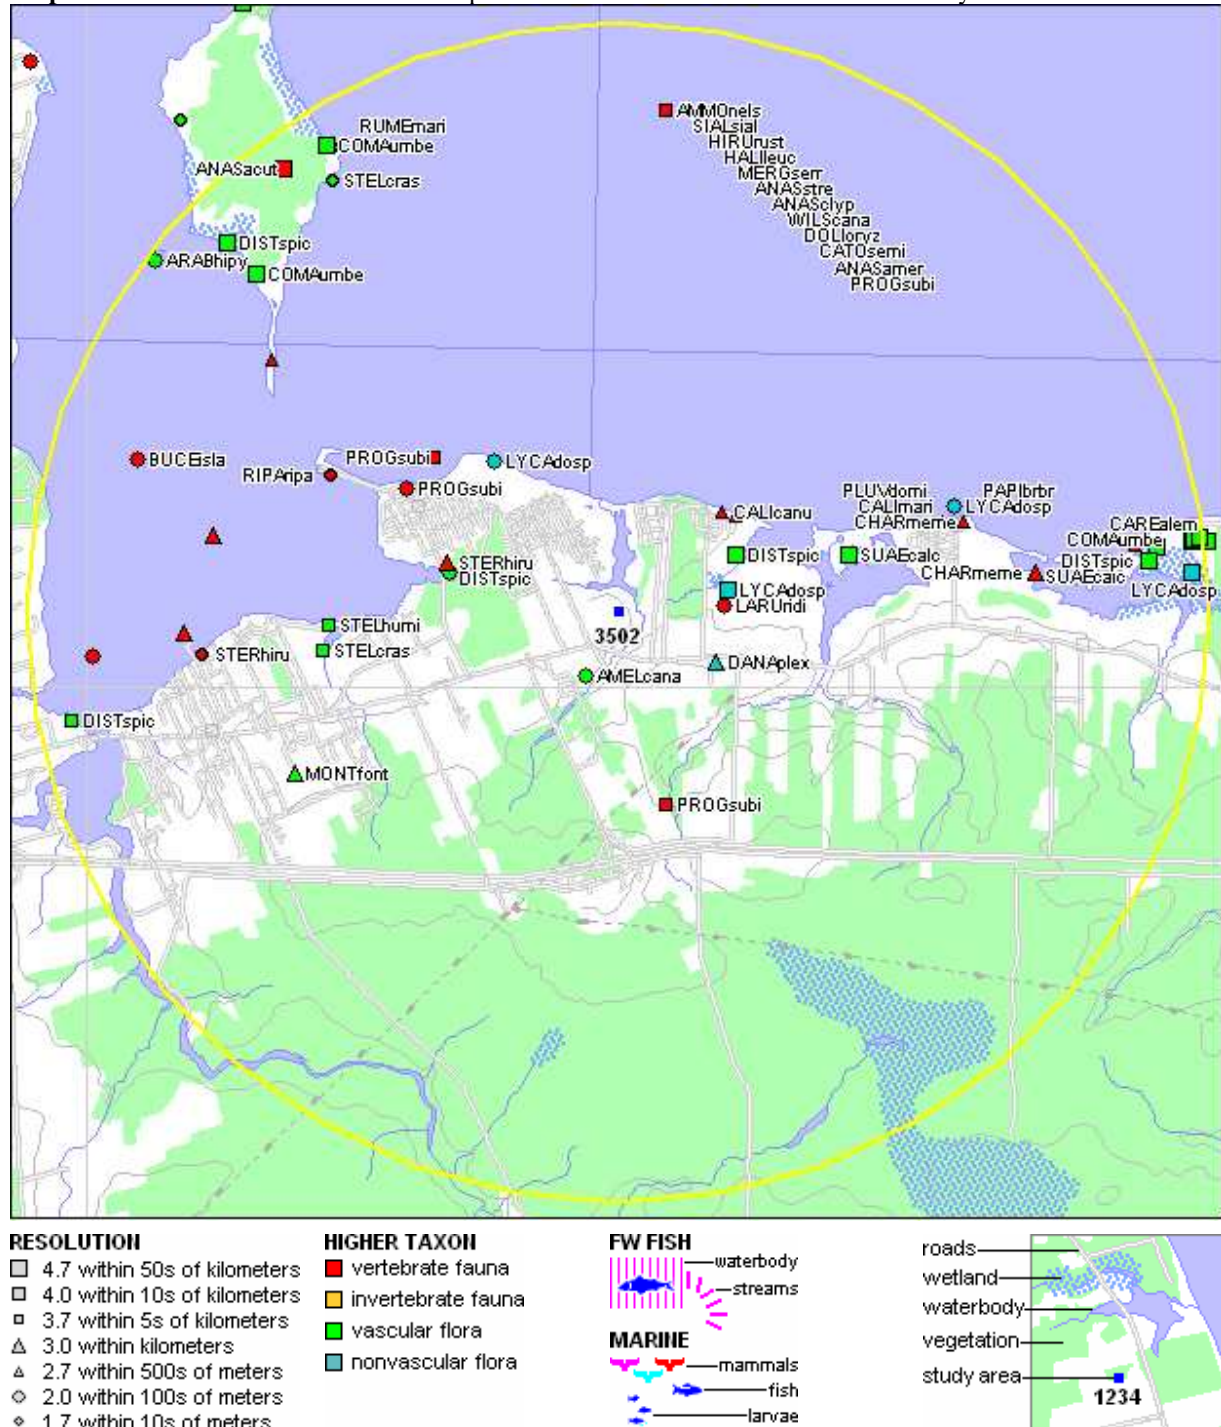
Map 1: Known observations of rare and/or protected flora and fauna within buffered study area.

A 5km buffer around the study area contains 109 records of 21 vertebrate, 9 records of 3 invertebrate fauna (cf attached *eo.dbf). Sensitive data: Wood Turtles are POTENTIALLY present in the study area (cf attached WOTU.rtf).

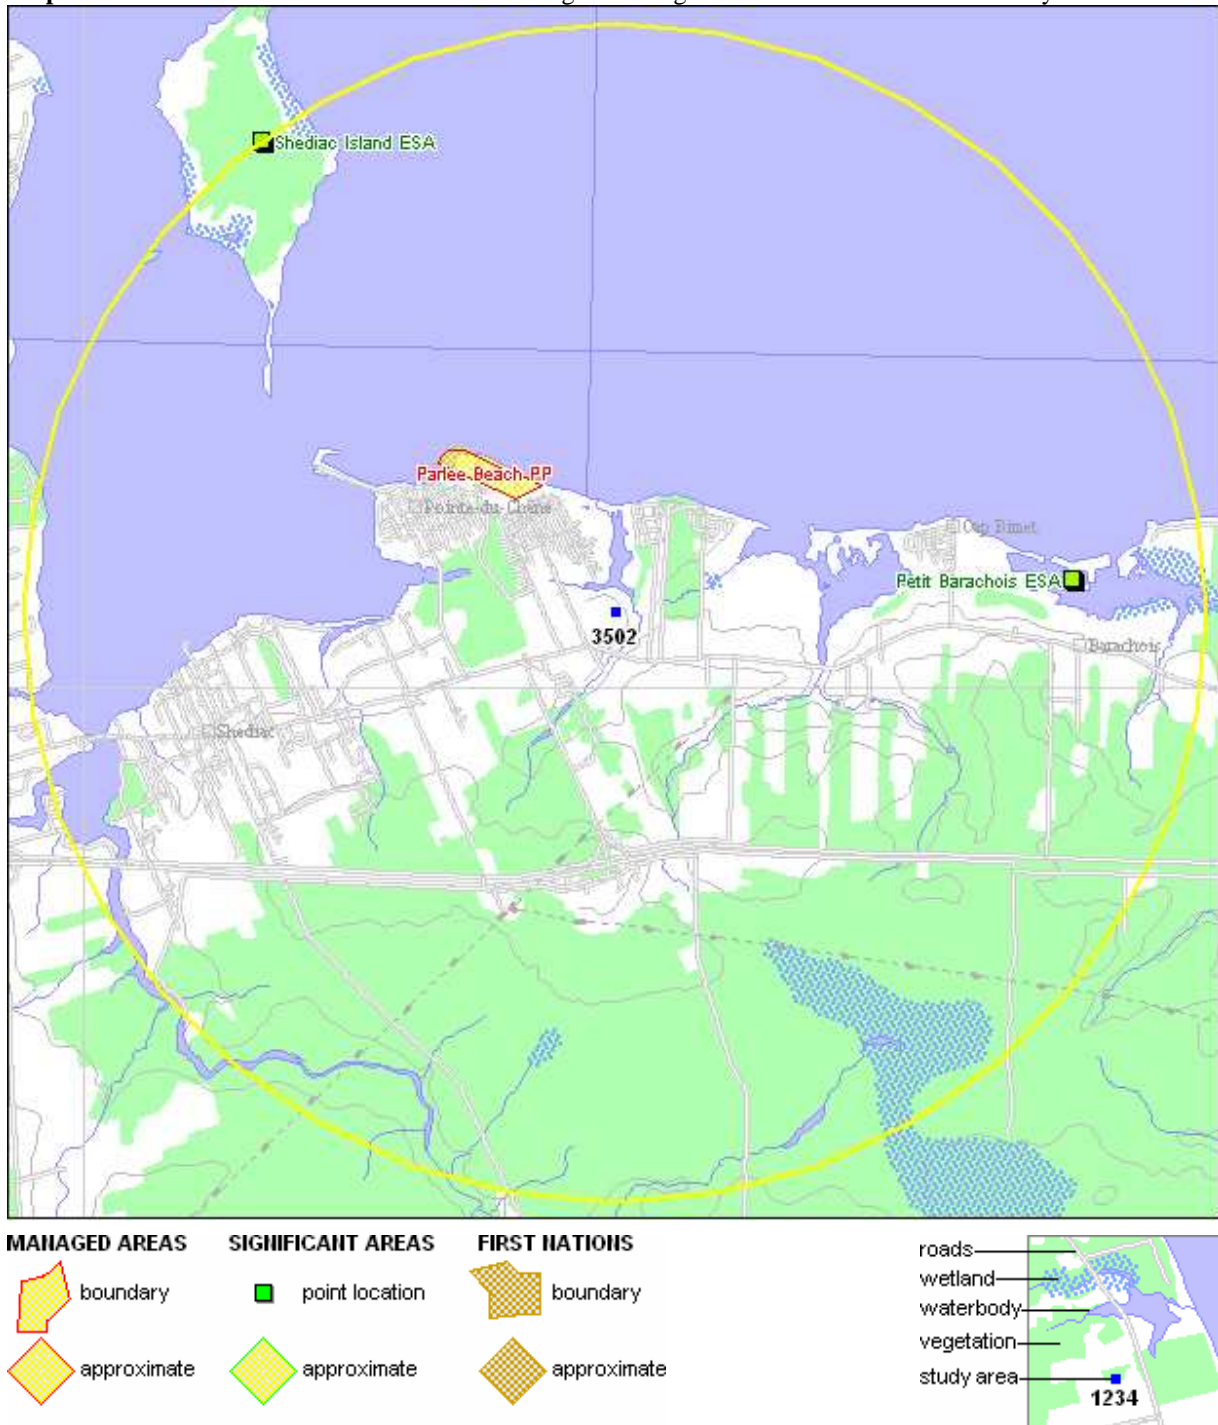
Map 2: Boundaries and/or locations of known Managed and Significant Areas within 5km of study area.

The GIS scan also identified 2 biologically significant areas in the vicinity of the study area; such sites are known for exceptional biotic richness but may or may not have legal status (see attached *sa.dbf).
