EIA Registration Document

Residential Development, Magnetic Hill Estates Subdivision
Moncton, New Brunswick

Project: 21.03.162
December 1, 2021

**Re: EIA Registration Document, Residential Development
Magnetic Hill Estates Subdivision, Moncton, New Brunswick**

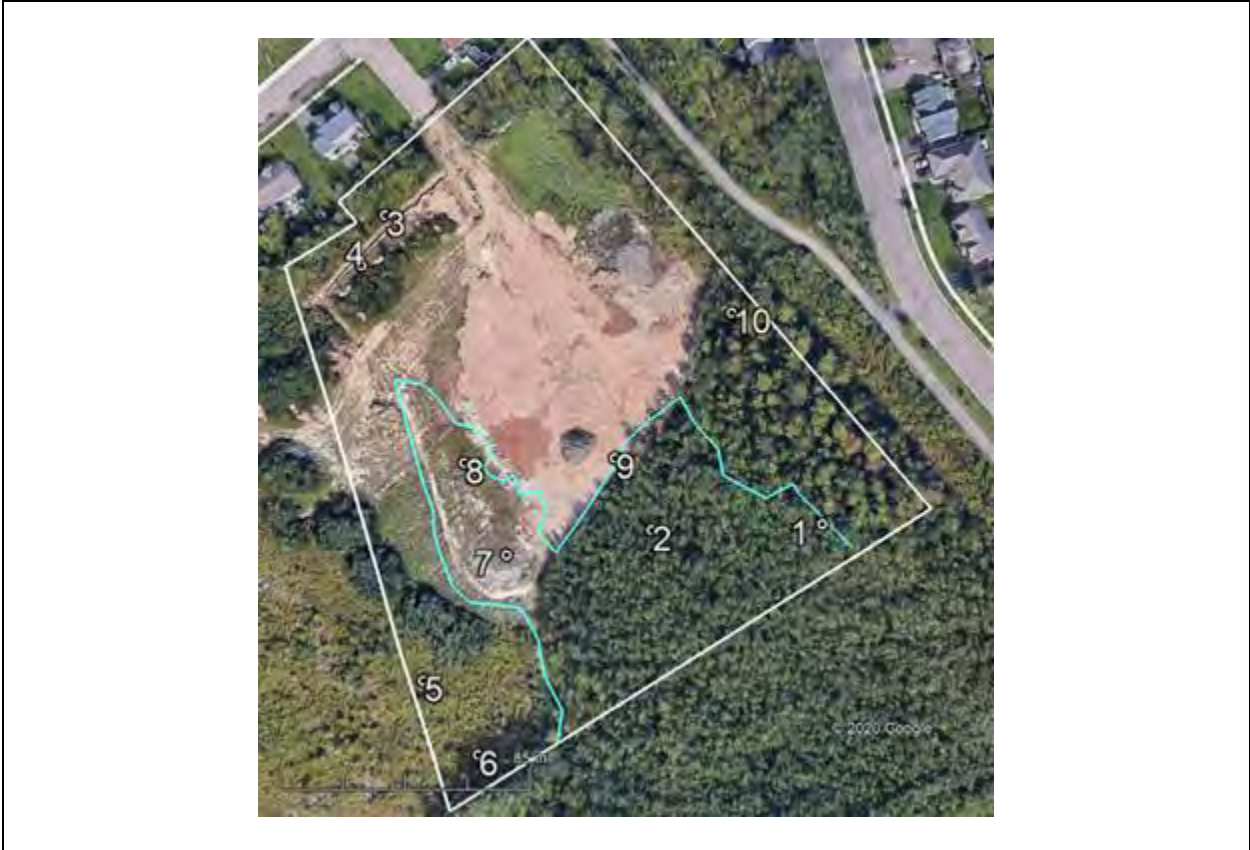
Figure 3. Wetland Delineation Schematic

CVR Home Improvements Inc.	Figure 3	WL polygon and Datapoints	Overdale Environmental Inc.
----------------------------	----------	---------------------------	-----------------------------

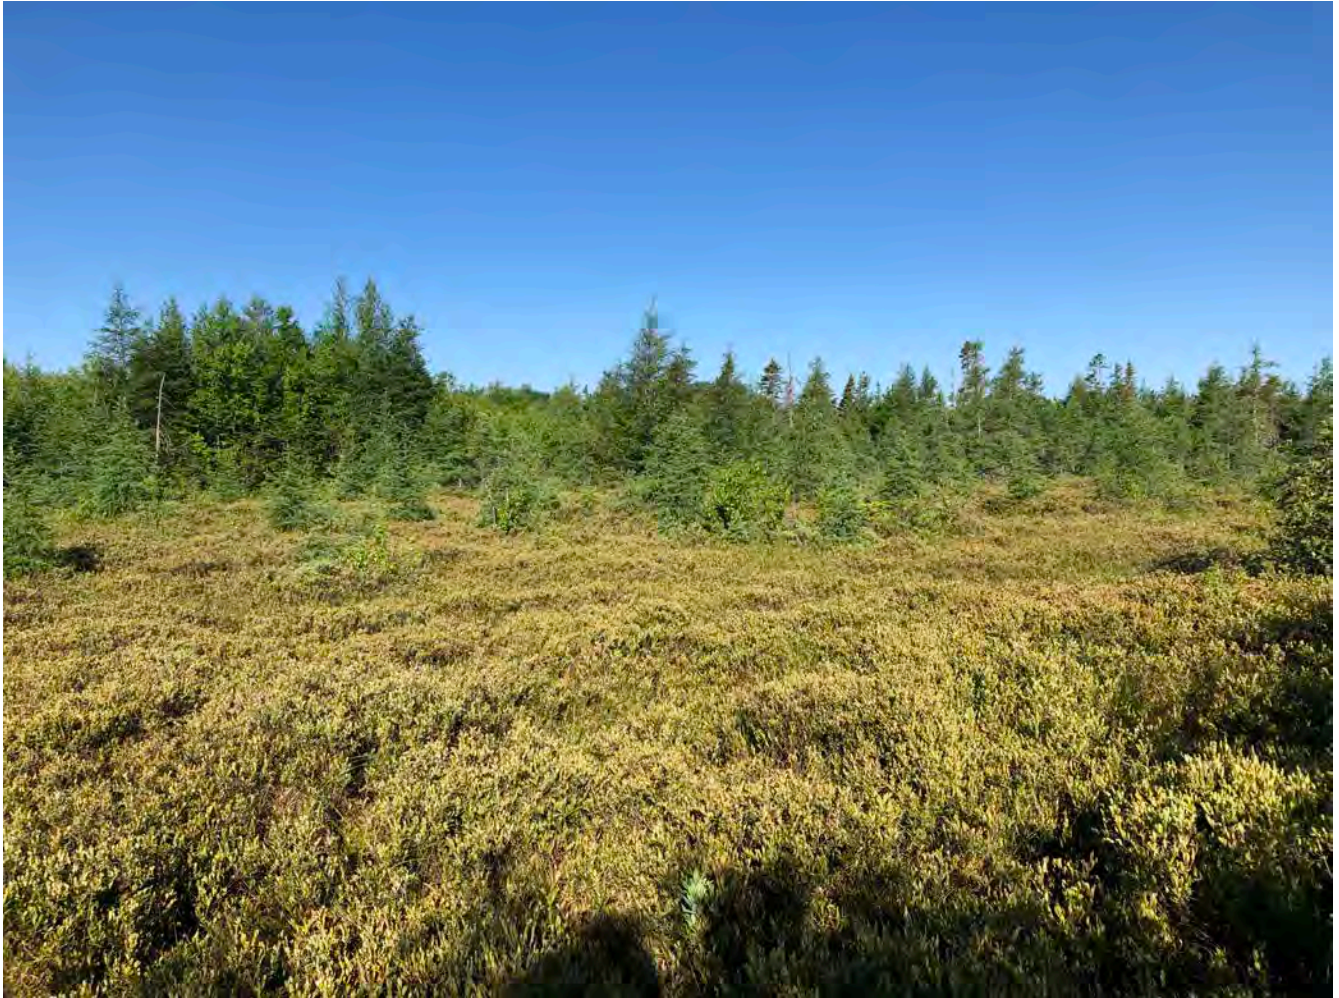
Some of the remaining original bog/wetland habitat can be seen below in the picture with some larger trees in the background. Keeping areas like this provides good habitats for birds.
