Registration Document

Bayside Post-smolt Production Facility-Bayside, NB

May 13, 2022

RE: Project Registration: Bayside Post-smolt Facility-Bayside, NB

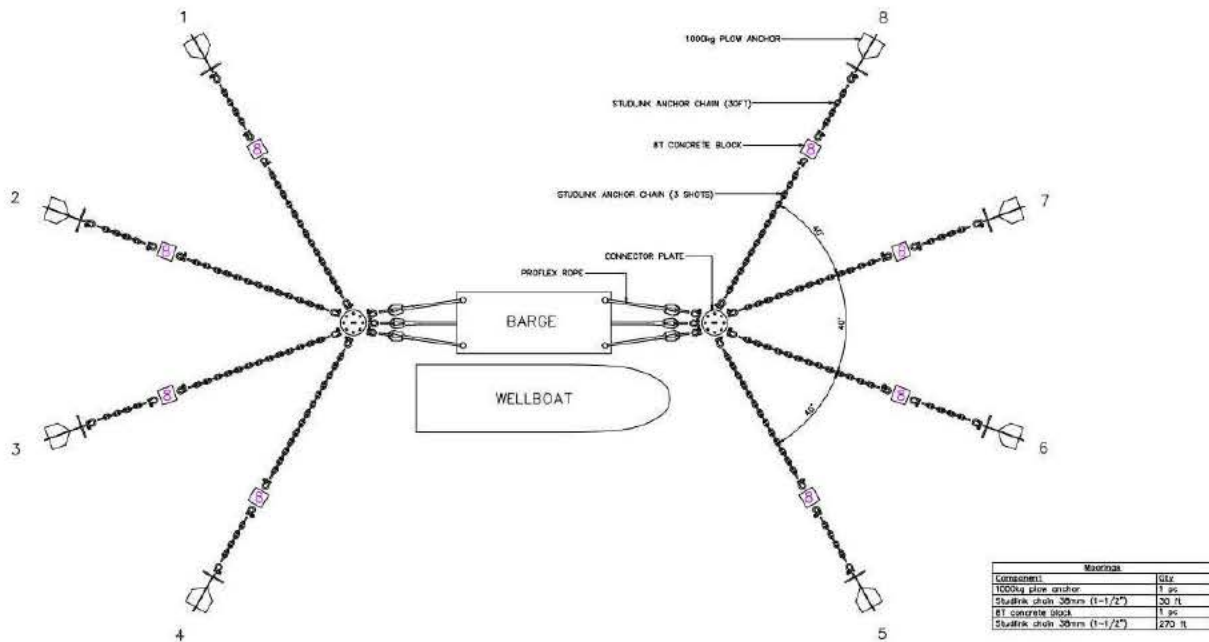
Figure 4 Typical loading barge mooring layout

Moorings will be designed to have a service life of 20 years. All mooring components will be replaced in 20-year intervals.

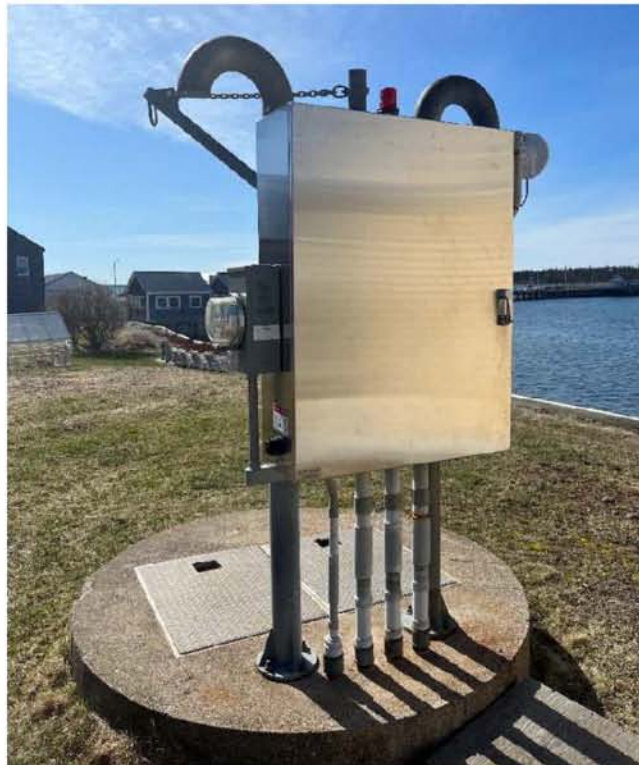
Figure 1 - Typical Control Cabinet

The control panel will have a power meter mounted to the side and will have a side connection for an emergency generator. An emergency generator will be stored on the project site (PID 15166184). In the event of a power outage, the generator would be brought over until power is restored. This will mitigate the risk associated with fuel stored within the protected watershed. The panel will be installed on (2) concrete sonotubes, which will be installed down to bedrock or below frost.

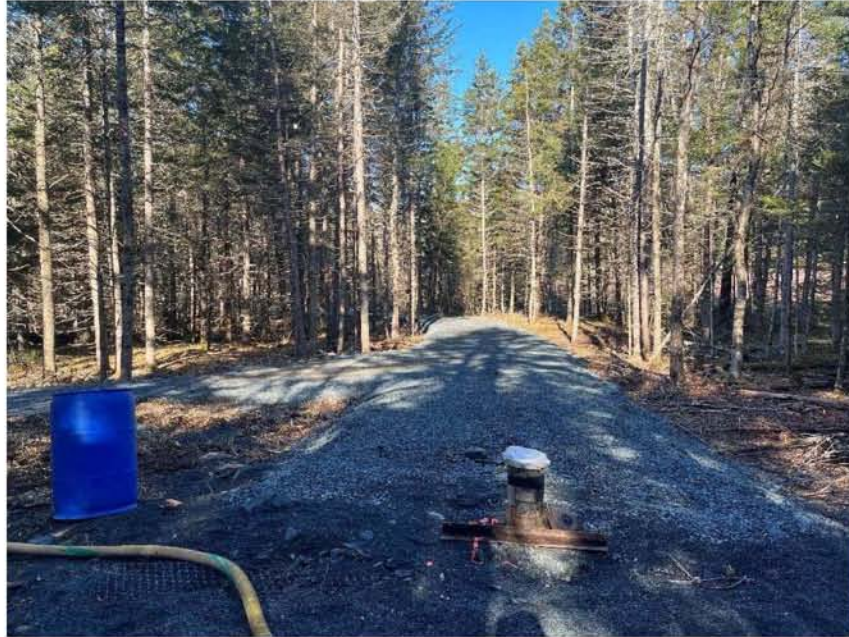
Figure 2 - Well 12, looking towards Well 10

From Well 12, a single pipeline and (2) electrical conduits, for power and monitoring, will be installed to Valve Chamber 1. Monitoring will include level, temperature, and conductivity of the well. On route to Valve Chamber 1, the pipeline will pass through an electromagnetic flow meter before being valved into (2) 100mm HDPE pipes. (2) pipes are being installed to provide redundancy, should a pipeline be damaged at some point in the future. From Valve Chamber 1 to Valve Chamber 2, (2) 100mm HDPE pipes and (2) electrical conduits, will be installed. Figure 2 illustrates Well 12 as it exists looking towards Well 10. The pipelines would be installed on the left-hand side.

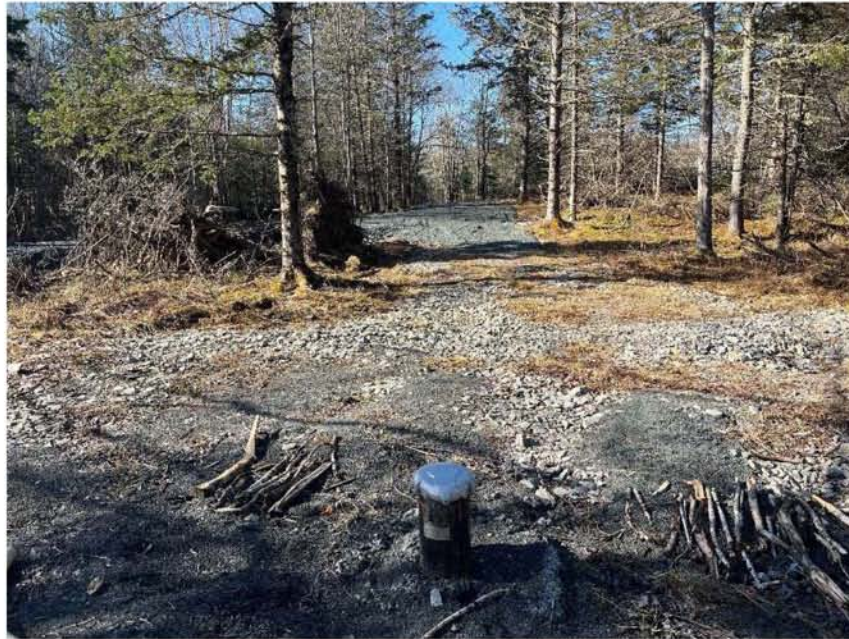
Figure 3 - Well 9, looking towards entrance

From Well 9, a single pipeline and (2) electrical conduits, for power and monitoring, will be installed to the control panel on the existing gravel pad. Monitoring will include level, temperature, and conductivity of the well. On route to Valve Chamber 2, the pipeline will pass through an electromagnetic flow meter before being valved into the (2) 100mm HDPE pipes from Valve Chamber 1. From Valve Chamber 2, (2) 100mm HDPE pipes will be installed to Chamcook No. 3 Road and (2) electrical conduits to the control panel. (1) conduit for the Well 12 power supply and (1) conduit for monitoring at Well 12 and the Well 9 flow meter. Figure 3 illustrates Well 9 as it exists, looking towards the entrance from Chamcook No. 3 Road.

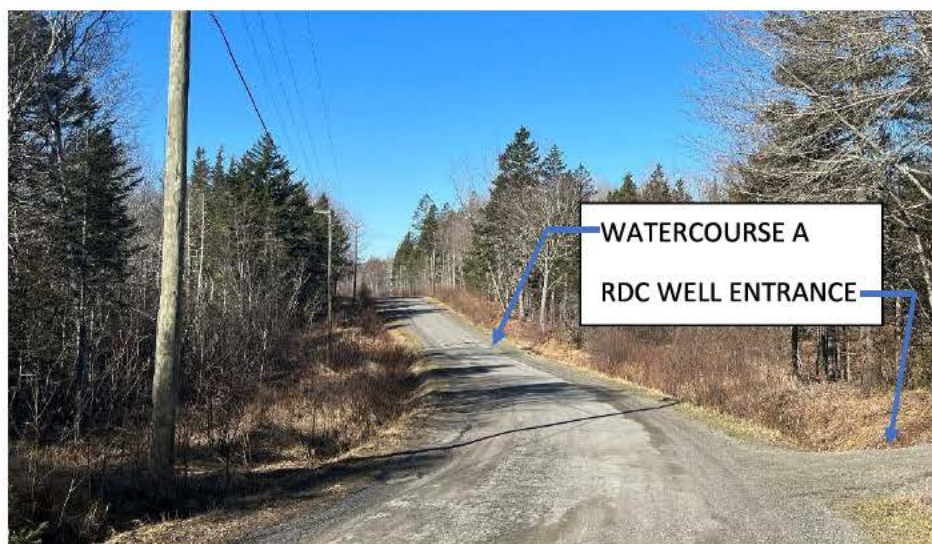
Figure 4 - Chamcook No. 3 Rd at RDC Well Entrance

(2) 110mm HDPE pipelines would be installed from the Chamcook No. 3 Road west under the overhead high voltage power lines, then onward west offset 5m from the powerlines.

Approximately 50m west, the (2) pipelines will pass under the existing Watercourse A. A contractor has estimated the in-stream work will have a duration of no more than 2 days. The watercourse will be dammed with sandbags on the north side of the bridge and the flow will be pumped past the work area. If the work can be completed during a very low flow period, the proponent may seek permission to only dam the watercourse without pumping. The location of Watercourse A is illustrated below in Figure 4 and the watercourse itself in Figure 5 and Figure 6.

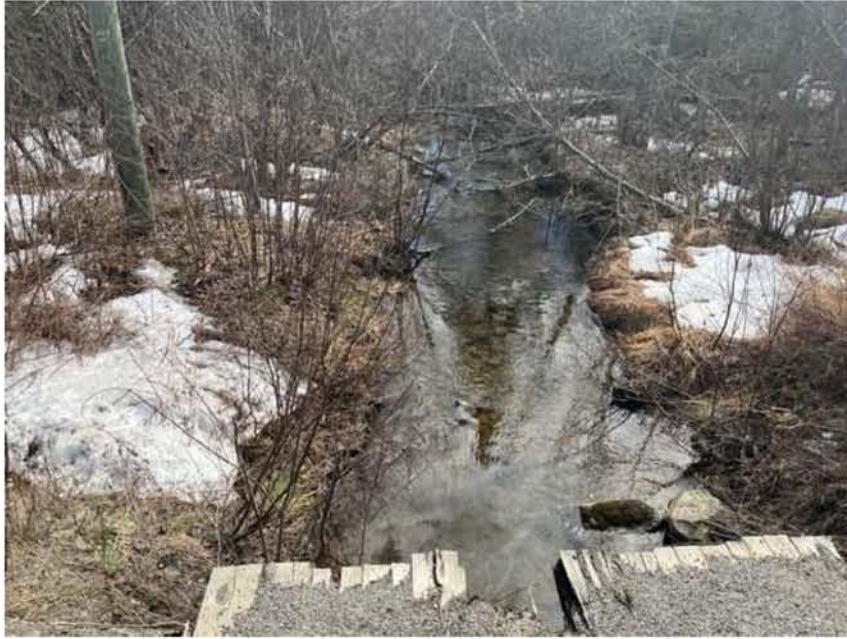
Figure 5 - Watercourse A - Southside of Bridge

After the pipe installation, material from the stream will be used to reconstruct the original conditions. If necessary, cobbles will be imported. The banks of the work area, above the wetted region, will be mulched with straw or hay to minimize erosion.

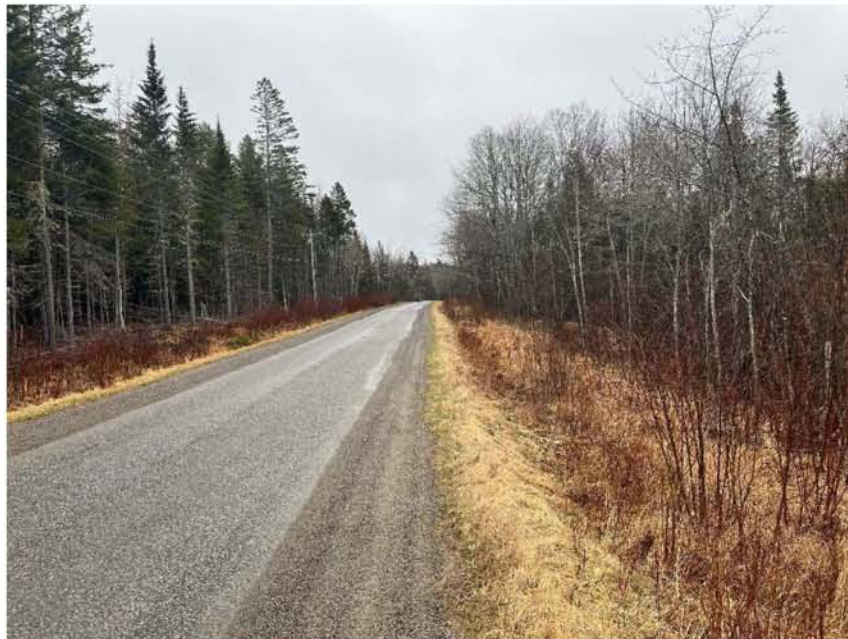
Figure 7 - Looking East from Watercourse B to Watercourse A

Approximately 130m west of crossing Chamcook No. 3 Road, the overhead power crosses the road, which will allow the (2) pipelines to be installed closer to the road. This area is illustrated in Figure 7, which is looking east from Watercourse B towards along Chamcook No. 3 Road.

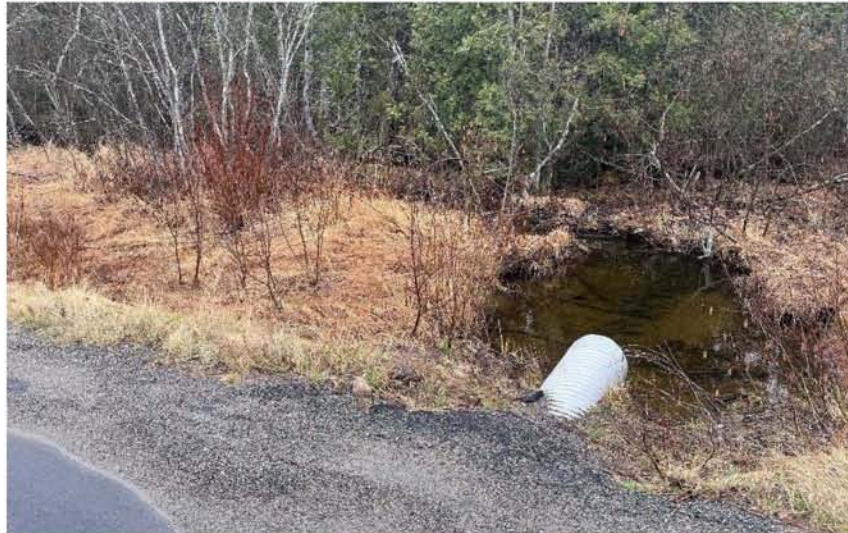
Figure 8 - Watercourse B, south side of Chamcook No. 3 Road

Approximately 310m west of crossing Chamcook No. 3 Road, the pipelines must pass under the existing Watercourse B. A contractor has estimated the in-stream work will have a duration of no more than 2 days. The watercourse will be dammed with sandbags on the north side of the culvert and the flow will be pumped past the work area. If the work can be completed during a very low flow period, the proponent may seek permission to only dam the watercourse without pumping. Watercourse B is illustrated in the following Figure 8.

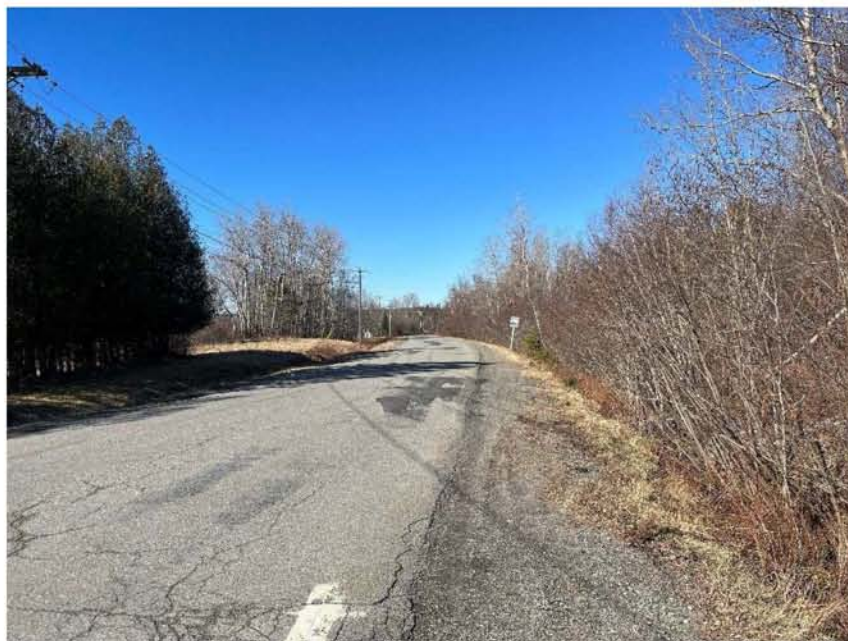
Figure 10 - Entrance to Champlain Drive from Route 127

(2) 110mm HDPE pipelines would be installed from Route 127 west alongside overhead high voltage power lines approximately 280m to PID 15166184. This area is illustrated on the lefthand side of Figure 10.

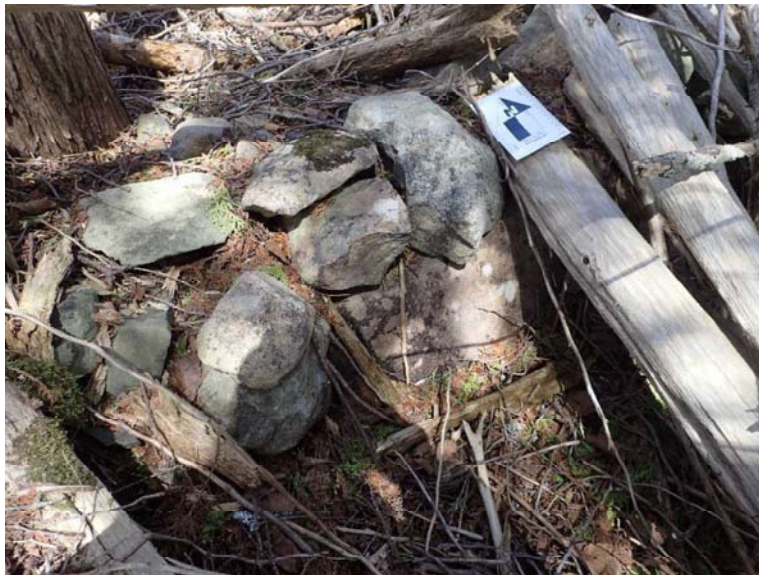
Figure 14: An historic stone foundation ~7m wide by 12m long found in Terrace 3; facing Northeast (C. Colwell-Pasch 2019).

Permit (AFRP) No. 2019NB10. The pedestrian walkover identified 4 Terraces on current or paleo-shorelines with high/medium archaeological potential within the PDA as well as a possible old quarry (Figure 17), a historic foundation (Figure 14), a depression (Figure 15) and an old roadway (Figure 12). Note: if the plans provided by SIM Corp. after the AIA are outside of the assessed areas then the new area will have to be subject to another AIA prior to beginning construction.

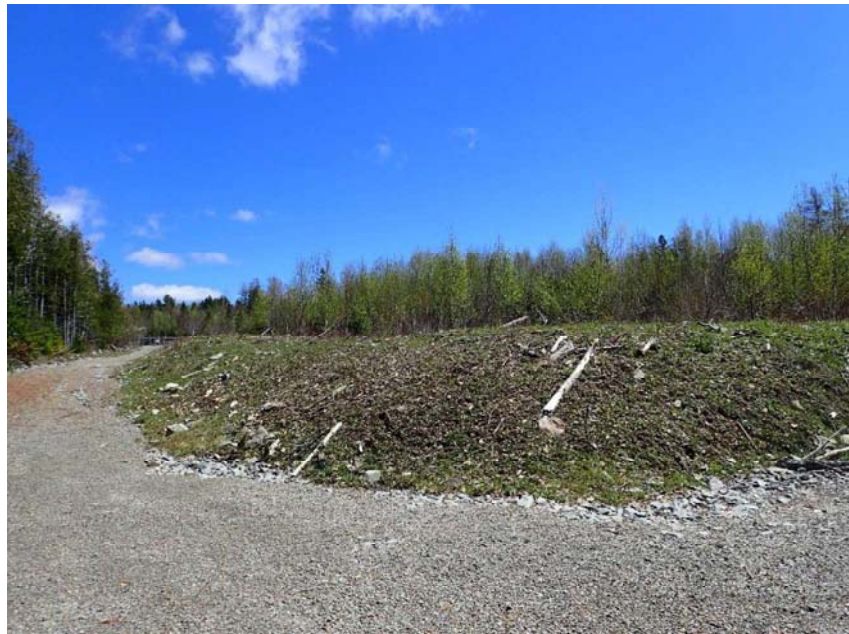
Figure 16: Berms from the creation of a network of roadways through the PID to associated Wells show glacial till as archaeological bottom on Terrace 3; sand is evident in Terrace 4 (C. Colwell-Pasch 2019).

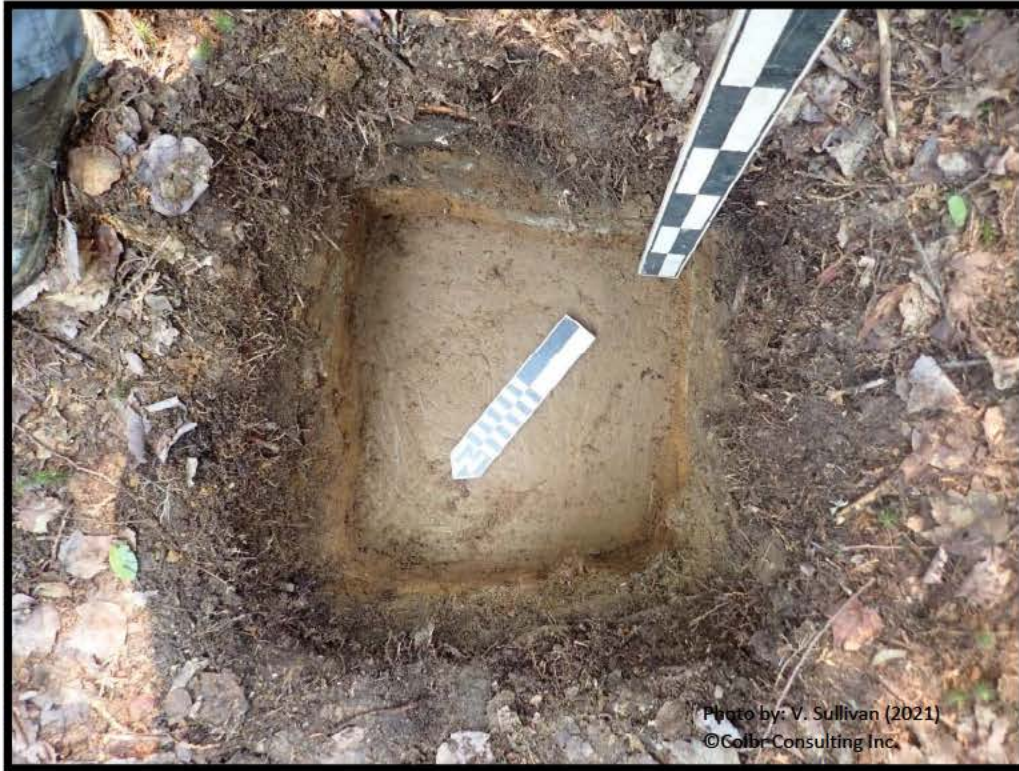
Photo 17: The Test Pit (TP) profile of the Well No. 12 wellhead TP.

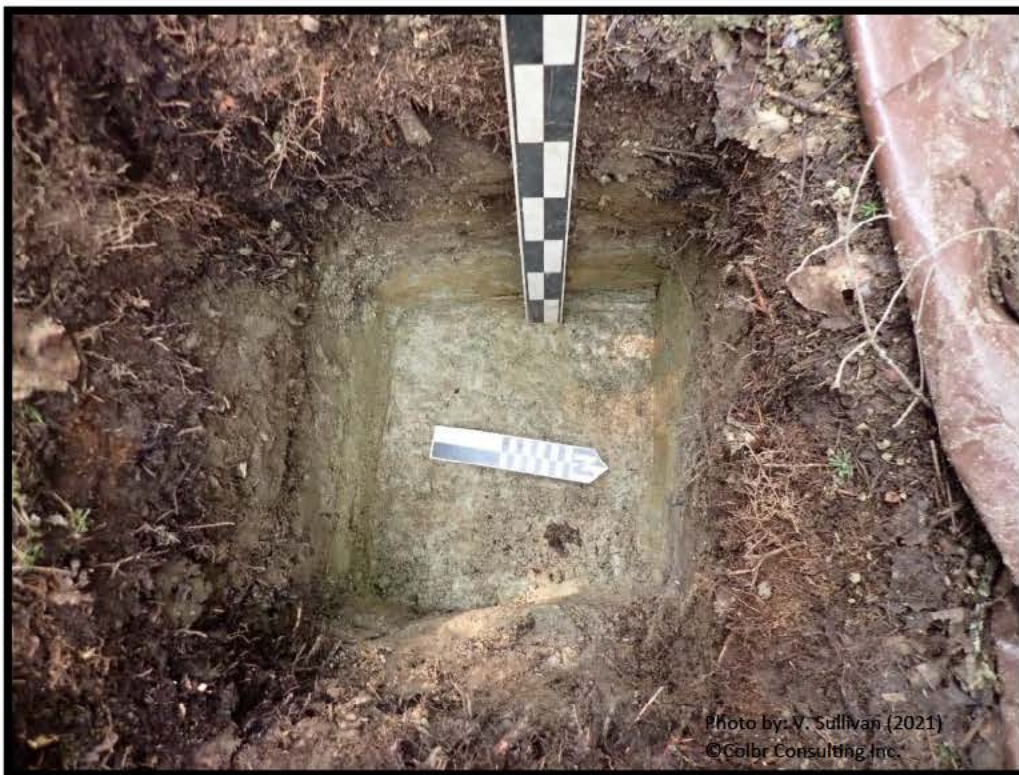
Photo 18: The Project Soil Profile No. 1 from TP #02 at Well No. 12.

Project Soil Profile No. 1 was the predominate stratigraphy observed and recorded during Block 1 testing within PID 1235522. A total of 65 test pits were excavated during Block 1 and 59 were excavated near Well No. 10, No. 11, and No. 12. The additional six were located near Well No. 14 which was a few hundred meters to the southwest of the other wells and at a lower elevation (Appendix A: Project Plans – Part I; Appendix B: Figure 13). After the consistent O Horizon, four B Horizons were observed, an intermittent E horizon (grey silty alluvium) and a marine clay C Horizon. Horizon B1 consisted of a dark brown silty loam which was only observed in two test pits (Appendix C: Photo 18). B2 was a strong brown silt underlying a grey silty loam E horizon as seen in typical podzolized areas. There was only one TP out of the 65 that had a podzolized stratigraphy (TP #1). About 95% of all the test pits around Well No. 10, No. 11, or No. 12 had B3 Horizon under the O Horizon. B3 was a brown silty clay. About 93% had a B4 Horizon under the B3 which consisted of yellow-brown fine silty clay. Finally, all but two test pits had a mottled compacted silty clay bottom called C Horizon. Three test pits hit the water table within a clay matrix. About two of the six test pits at Well No. 14 had these similar, or near similar strata. The maximum depth of this profile was 60-centimeters with an average depth of 39-centimeters.

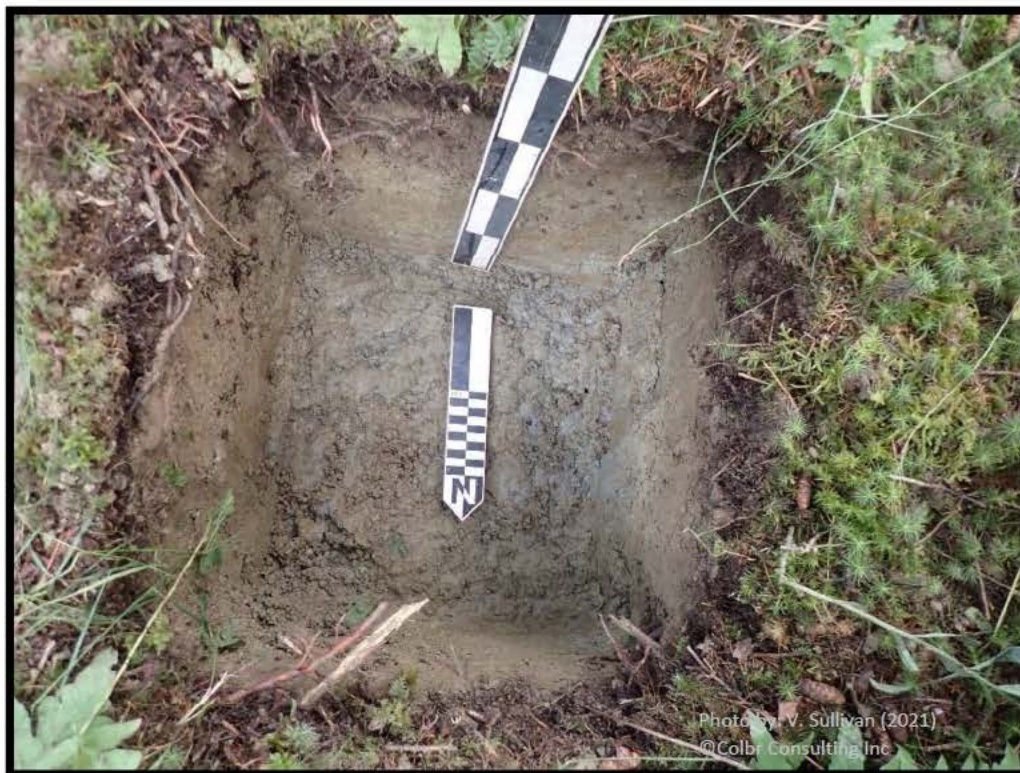
Photo 20: The Project Soil Profile No. 1 from TP #29 at Well No. 10.

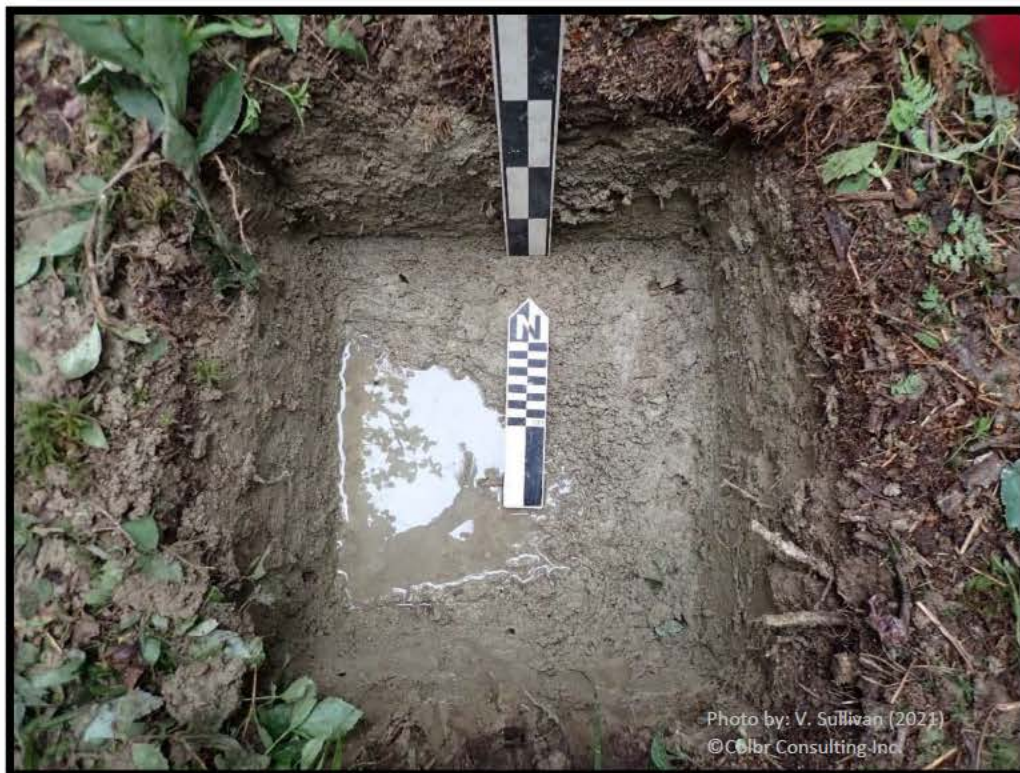
Photo 22: The Project Soil Profile No. 1 from TP #45 at Well No. 11.

A total of 22 test pits were completed along the Well No. 11 PDA (Appendix B: Figure 13). A total of 21 test pits were excavated along the proposed Well No. 11 ROW and one test pit was excavated at the wellhead location itself. All test pits were comprised of a consistent sub-surface (Project Soil Profile No. 1), with a profile of an O horizon, over a brown silt/silty clay, over a yellowish brown fine silty clay, underlain by a mottled and compacted silty clay (Appendix C: Photo 22). The maximum test pit depth was 40-centimeters DBS. All test pits were negative and there was no significant cultural material or features identified.

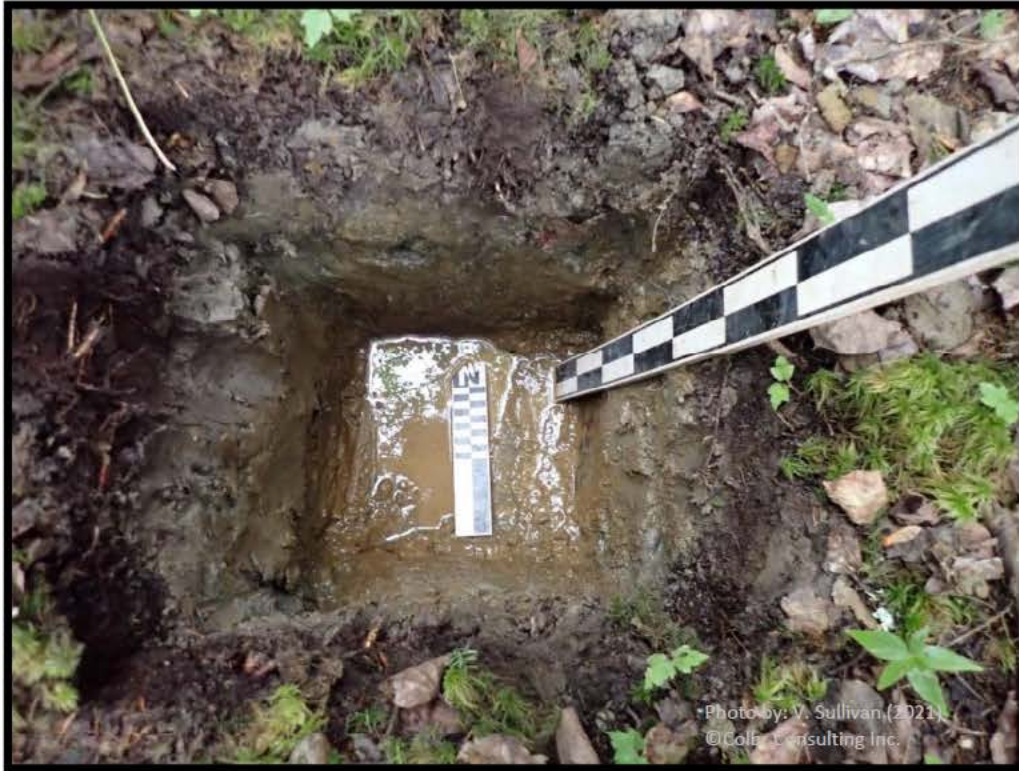
Photo 23: The Project Soil Profile No. 2 from TP #61 at Well No. 14.

water. The stratigraphy was varied (Project Soil Profile No. 2 and No. 3). The primary soil profile, Project Soil Profile No. 2, consisted of an O-Horizon, over a dark grey silt, over a mottled brown, and underlain by a gray silty clay. A test pit at the southern end of the ROW (TP #61) had, below the mottled stratum, a dark yellowish/brown sand, underlain by a dense reddish-brown clay (Appendix C: Photo 23). At the north end of the ROW (TP #64), below the mottled stratum, there was a dark yellowish/brown sand, over a dark yellowish-brown sand, underlain by a mottled sand. TP #64 was much deeper and extended to a depth of 79-centimeters DBS (Appendix C: Photo 24). It is likely that this test pit was within a former channel (Project Soil Profile No. 3). The maximum test pit depth within the Well No. 14 PDA was 79-centimeters DBS. All test pits were negative and there was no significant cultural material or features identified.

Project Soil Profile No. 2 was a unique stratigraphy observed and recorded during Block 1 testing within PID 1235522. Project Soil Profile No. 2 was observed near the Well No. 14 PDA which is separated from most of the other PDAs by a few hundred meters distance and a few meters elevation (Appendix A: Project Plans – Part I; Appendix B: Figure 13). This profile had a lack of the observed B1 from Project Soil Profile No. 1 and instead had a mottled brown stratum over mottled sand and then over a dense mottled clay or C Horizon (Appendix C: Photo 23). These profiles were noticeably deeper as well with a maximum depth of 79-centimeters and average depth of 46-centimeters. About 3 of the test pits out of the six near Well No. 14 had this profile type.

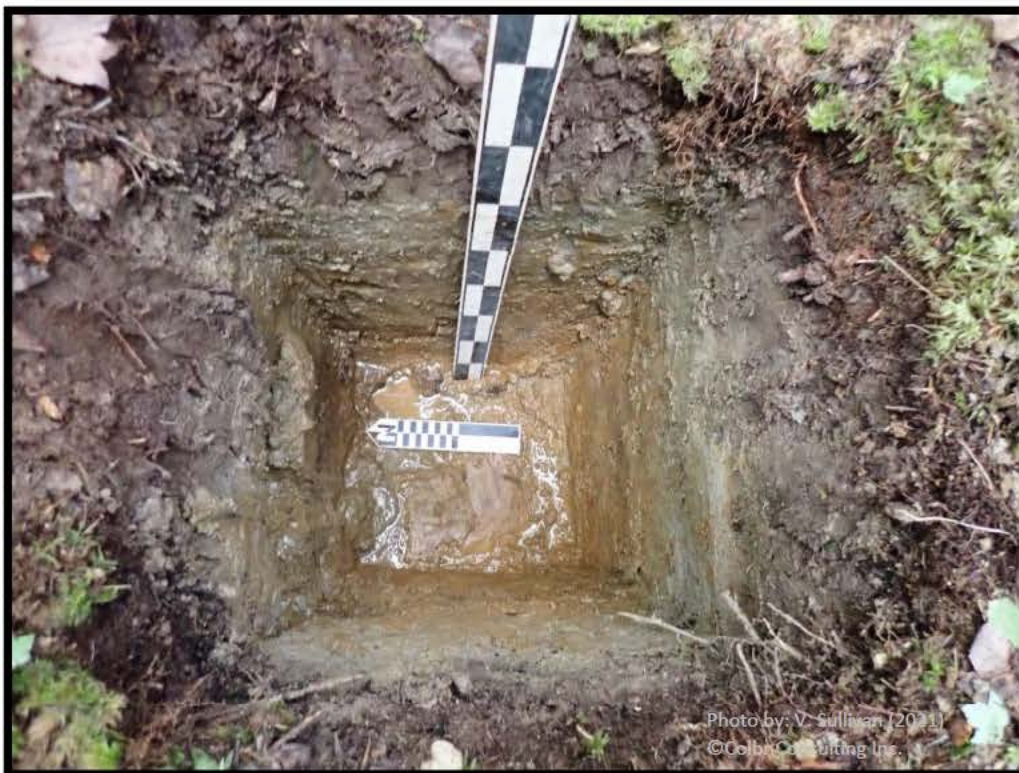
Photo 24: The Project Soil Profile No. 3 from TP #64 at Well No. 14.

Project Soil Profile No. 3 was a single test pit stratigraphy type observed and recorded during Block 1 testing within PID 1235522. Project Soil Profile No. 3 was observed near the Well No. 14 PDA which is separated from most of the other PDAs by a few hundred meters distance and a few meters elevation (Appendix A: Project Plans – Part I; Appendix B: Figure 13). This profile was observed only in TP #64 and had a lack of the observed B1 from Project Soil Profile No. 1 and instead had a mottled brown stratum over variations of sand (mostly mottled) and then over mottled clay or C Horizon (Appendix C: Photo 24). The main difference between Project Soil Profile No. 2 and No. 3 was an additional layer of dark yellow-brown dense sand that was observed much deeper (67- to 75-centimeters DBS) over the clay which was also deeper (75- to 79-centimeters DBS). It was believed that this soil profile was within an old paleochannel as the sediments were finer, mottled and deeper than the surrounding sediments.

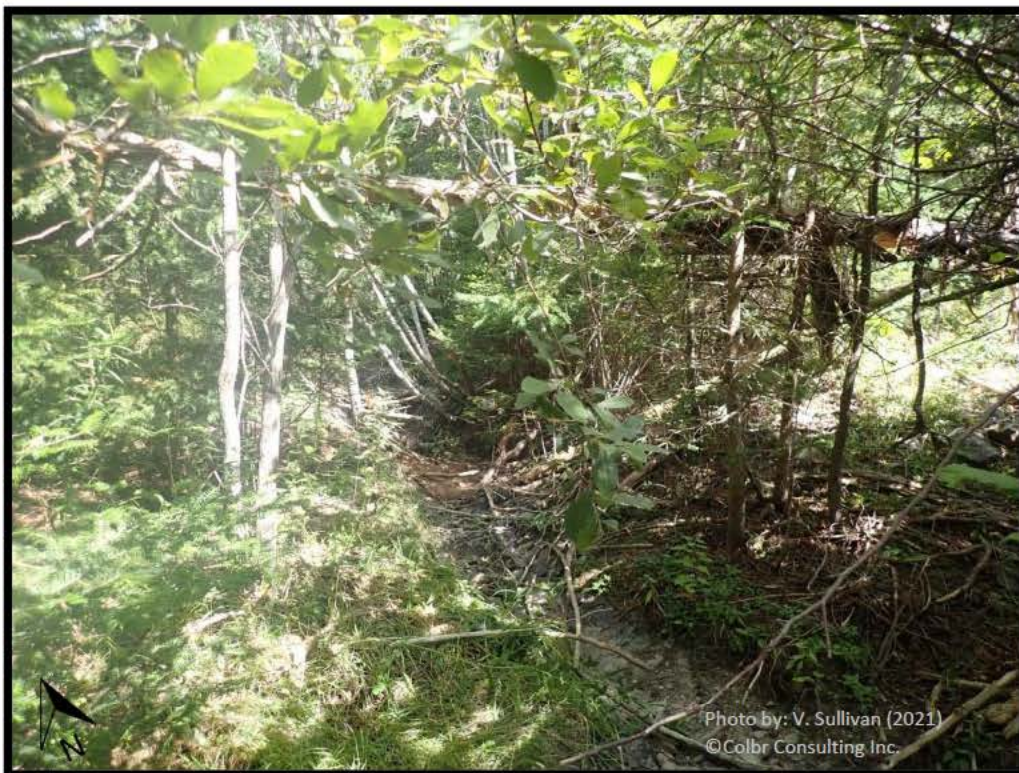
Photo 26: The dry creek bed to the east/southeast of Terrace 2 on PID 15166184.

terrace PDA and a dry creek bed runs along it's southern edge from east to west (Appendix B: Figure 7 and 14; Appendix C: Photo 26).

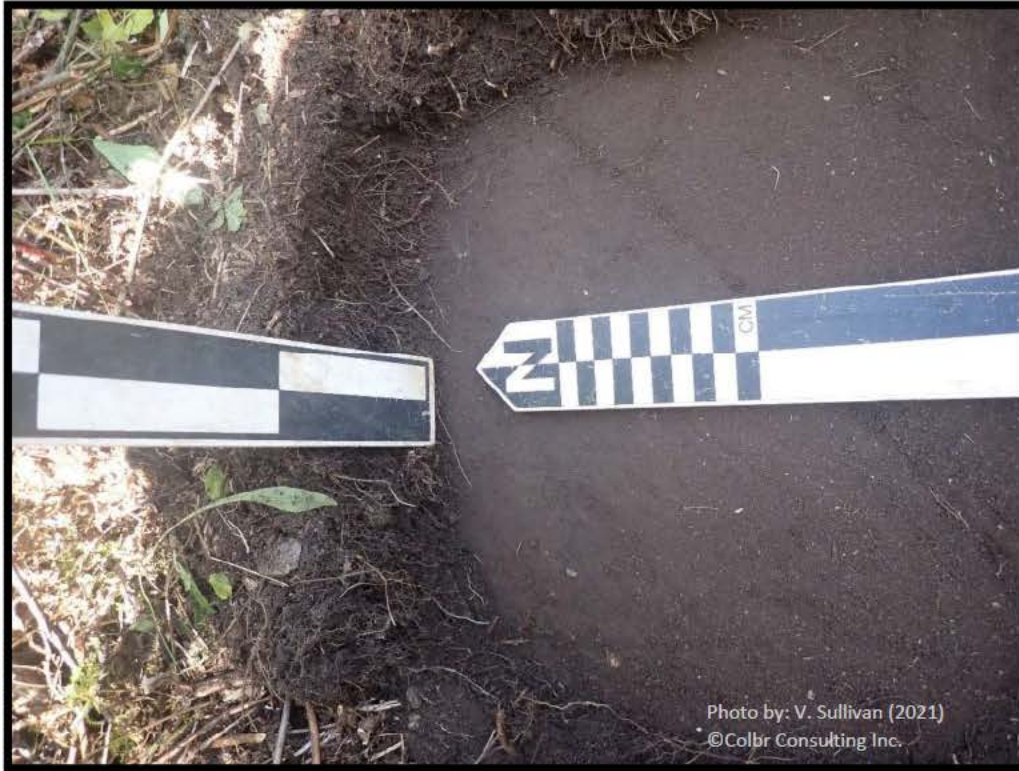
Photo 27: The Project Soil Profile No. 4 from TP # at Terrace 2 during Block 2 on PID 15166184.

Project Soil Profile No. 4 was the predominate stratigraphy observed and recorded during Block 2 and a portion of Block 3 testing within PID 15166184. A total of 29 test pits were excavated during Block 2 and all were within the western portion of Terrace 2. During Block 3, five test pits were excavated in Terrace 2 and 11 test pits were excavated along Terrace 1 (Appendix B: Figure 14). All the test pits in Terrace 2 had a consistent O Horizon, overlaying a grey-brown loamy soil in 57% of all the test pits (B1 Horizon) (Appendix C: Photo 27). Only one test pit (TP #2-12) had an E Horizon. All test pits were terminated at bedrock (R Horizon). Terrace 1 had one of the test pits with this profile.

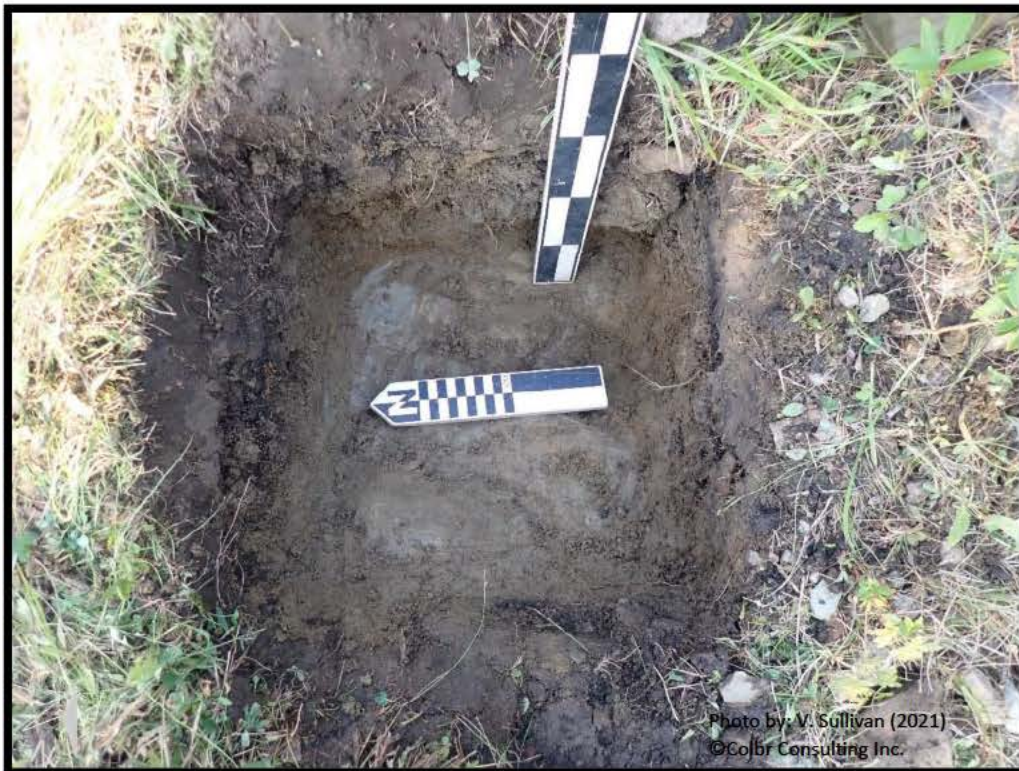
Photo 28: The Project Soil Profile No. 5 from TP # at Terrace 2 during Block 2 of PID 15166184.

Project Soil Profile No. 5 was a unique stratigraphy observed and recorded during Block 2 and Block 3 testing within PID 15166184. A total of 29 test pits were excavated during Block 2 and all were within the western portion of Terrace 2. During Block 3, five test pits were excavated in Terrace 2 and 11 test pits were excavated along Terrace 1 (Appendix B: Figure 14). All the test pits in Terrace 2 had a consistent O Horizon, in 45% of the test pits in Terrace 2 there were varying B Horizons of brown silty sand or sand over the bedrock bottom Appendix C: Photo 28). All test pits were terminated at bedrock (R Horizon). Terrace 1 had 45% of the test pits with this profile.

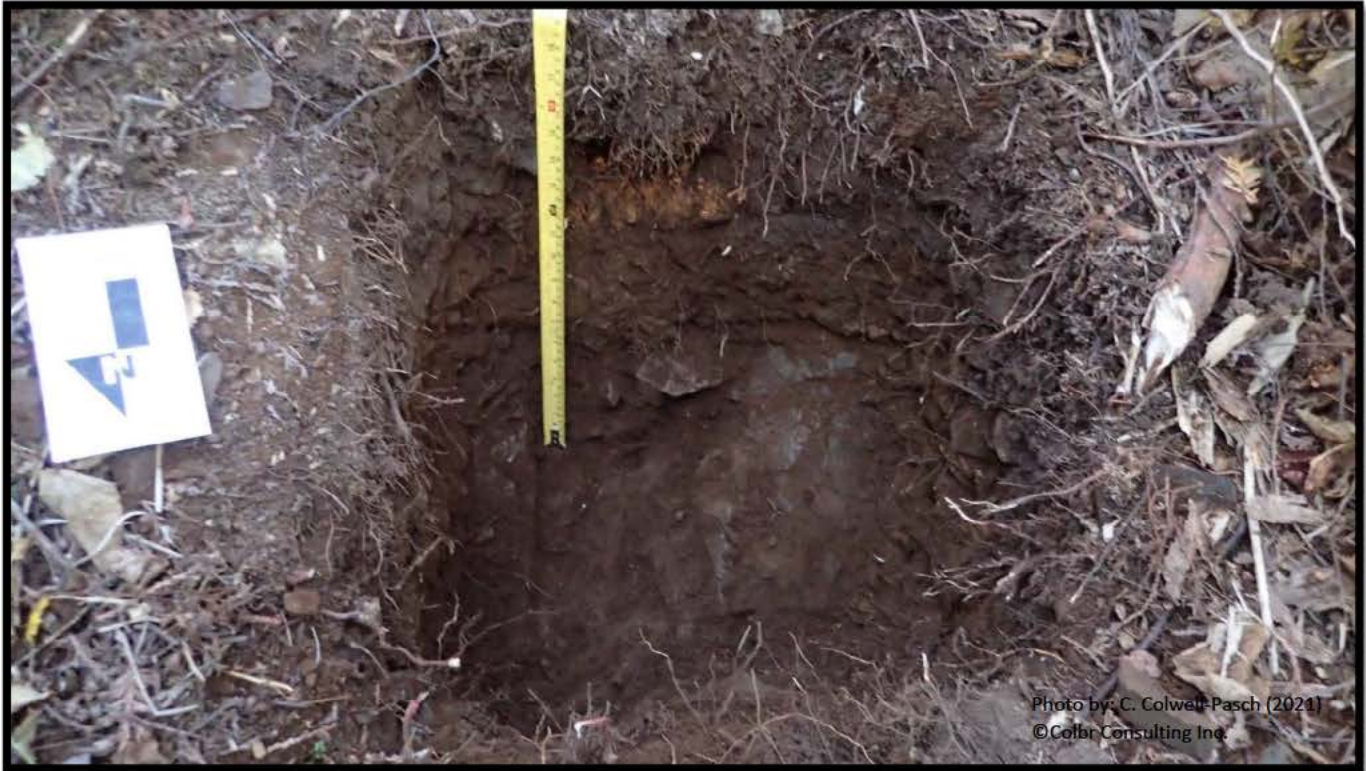
Photo 31: TP #T2-34 profile during Block 3 testing of PID 15166184.

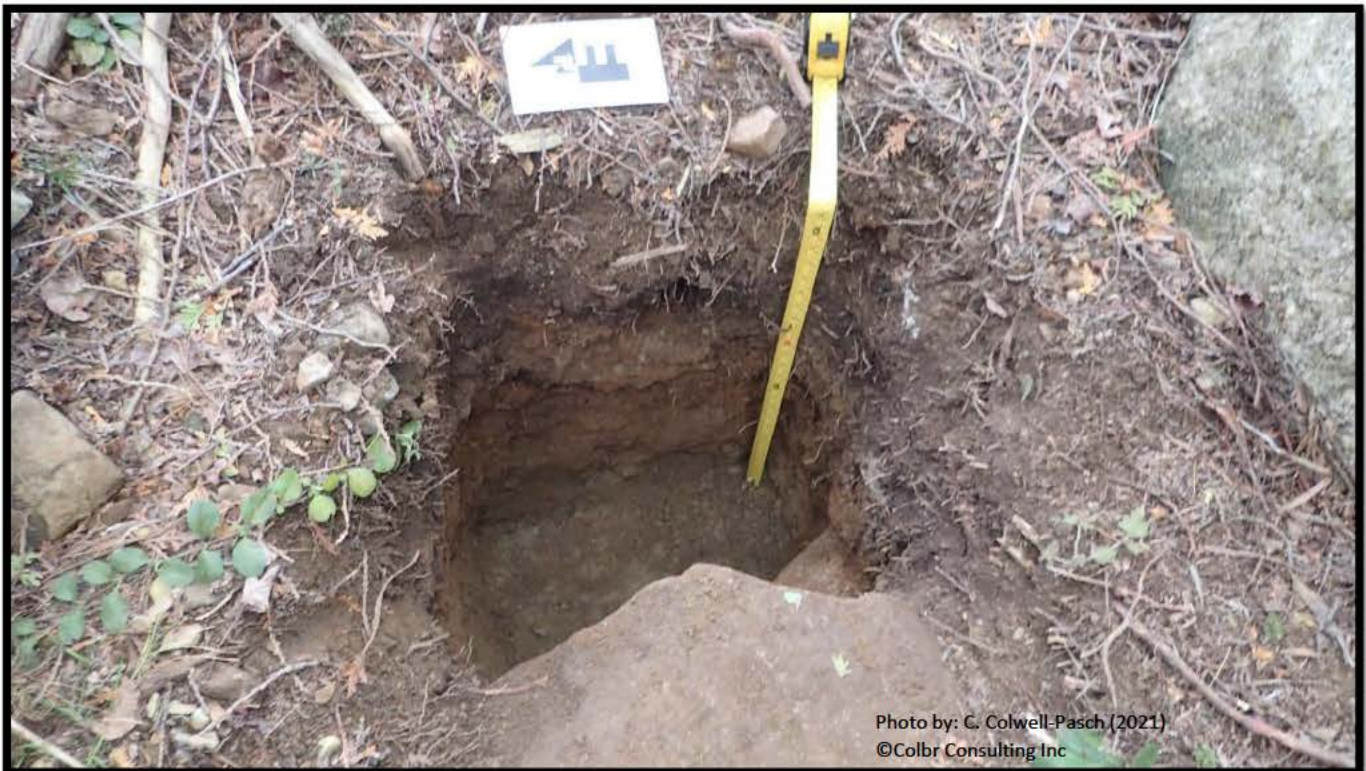
Photo 32: The Project Soil Profile No. 6 from TP #T1-11 at Terrace 1 during Block 3 of PID 15166184.

Project Soil Profile No. 6 was the predominate stratigraphy observed and recorded during Block 3 of Terrace 1 testing within PID 15166184. A total of 11 test pits were excavated during Block 3 in Terrace 1 (Appendix B: Figure 14). This profile had a O Horizon over intermittent layers of either soil with bedrock fragments or just bedrock fragments (R1 Horizon) over bedrock bottom. All test pits were terminated at bedrock (R Horizon) (Appendix C: Photo 32). This makes sense as Terrace 1 is at the bottom on the property on a cliffs edge overlooking the St. Croix River watershed (Appendix C: Photo 33). All loose bedrock material would eventually make its way to the cliff top by way of gravity or water/ice transport.
