**Environmental Impact Assessment
Registration Document
Fundy Regional Service Commission
Crane Mountain Landfill Capacity
Augmentation and Life Extension Project
Saint John, New Brunswick**

GEMTEC Project: 100018.012

June 21, 2023
GEMTEC Project: 100018.012

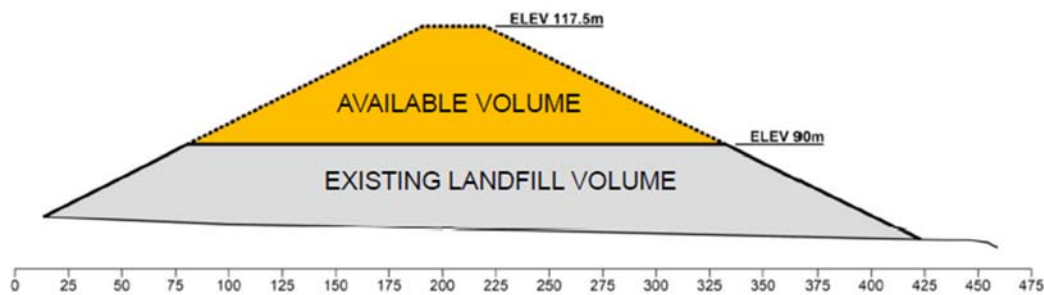
Figure 3 - Example of Geometry of Proposed Landfill Cross Section (East to West)

The increase in height is designed to maintain the current Landfill footprint and exterior slopes. Based on the design geometry, only a small area of the Landfill will reach the new higher elevation as the MSW is placed in a pyramid configuration (Figure 3). This geometry will reduce the relatively flat surface area on the top of the Landfill, improving drainage on the final cover, and thus mitigating against water infiltration and leachate generation.

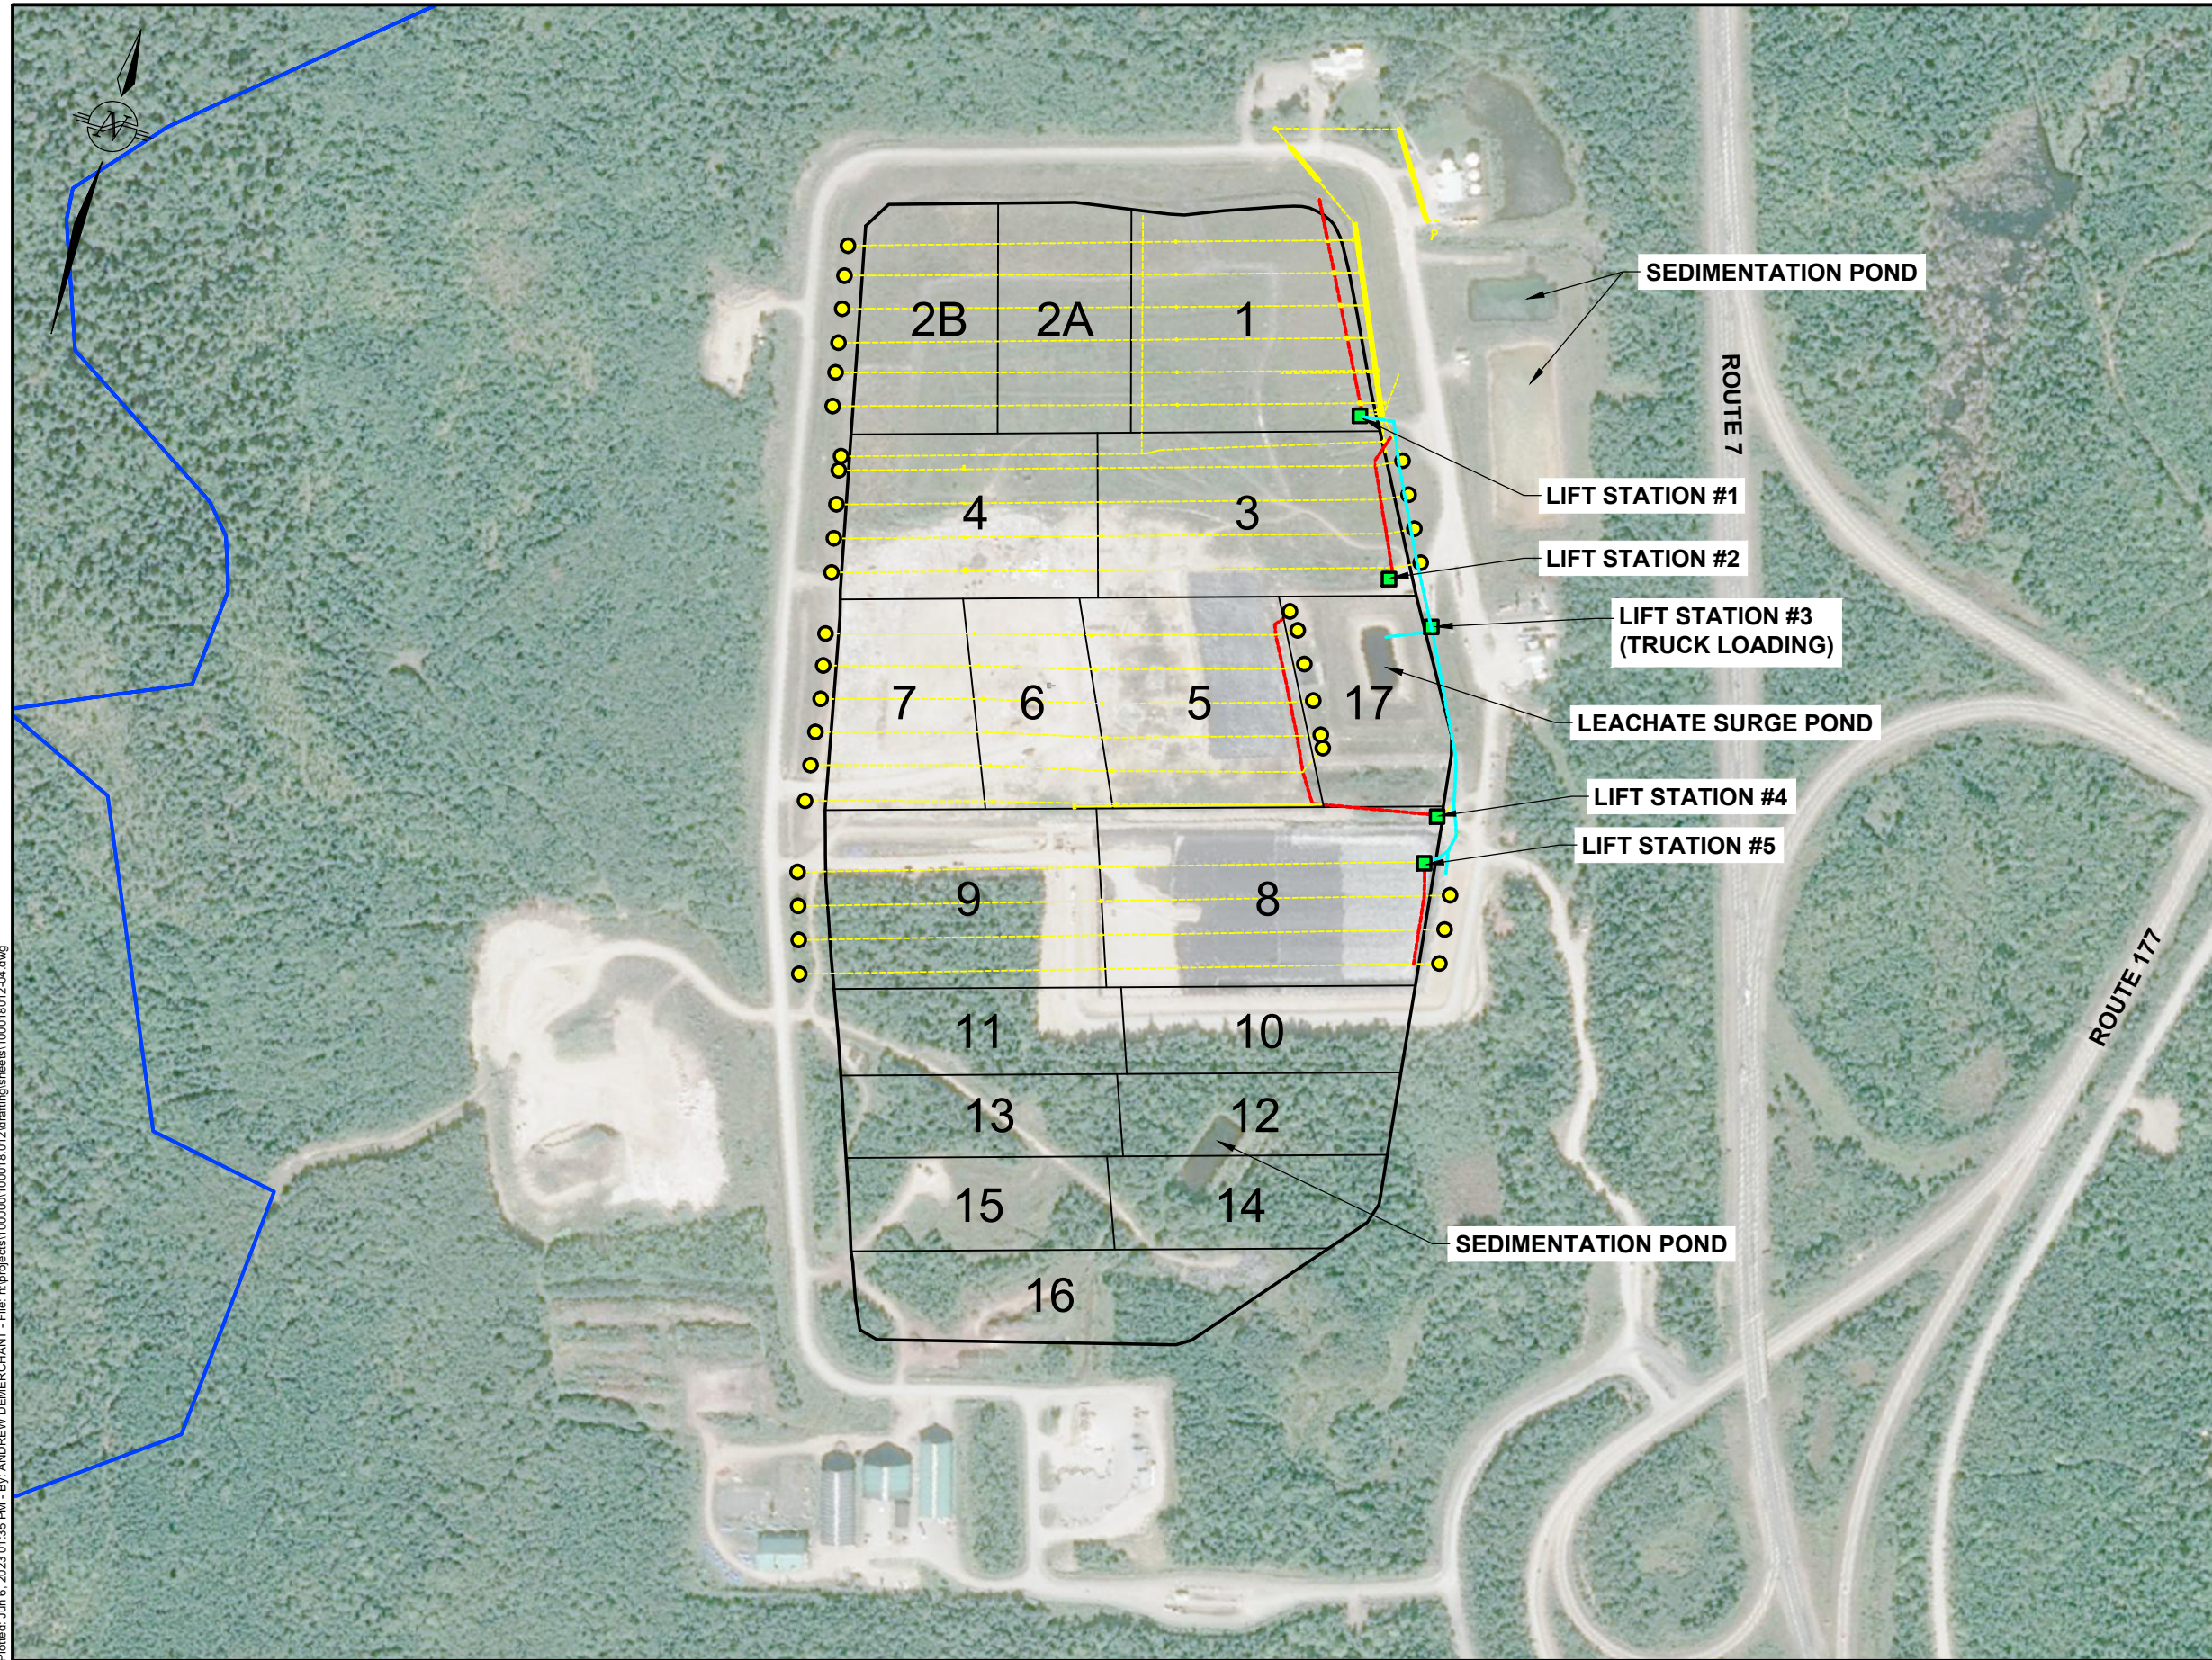
- HYDROGRAPHIC NETWORK (GeoNB)
- LEACHATE COLLECTION PIPE
- LEACHATE HEADER PIPE
- LEACHATE FORCEMAIN
- LEACHATE CLEAN-OUT
- LEACHATE LIFT STATION

The existing leachate collection system will facilitate the requirements of the Project. No additional volume and/or storage within the Leachate Ponds is deemed necessary. The active disposal area footprint, most prone to surface water infiltration (i.e., leachate production), will remain similar to the conditions currently observed on Site.

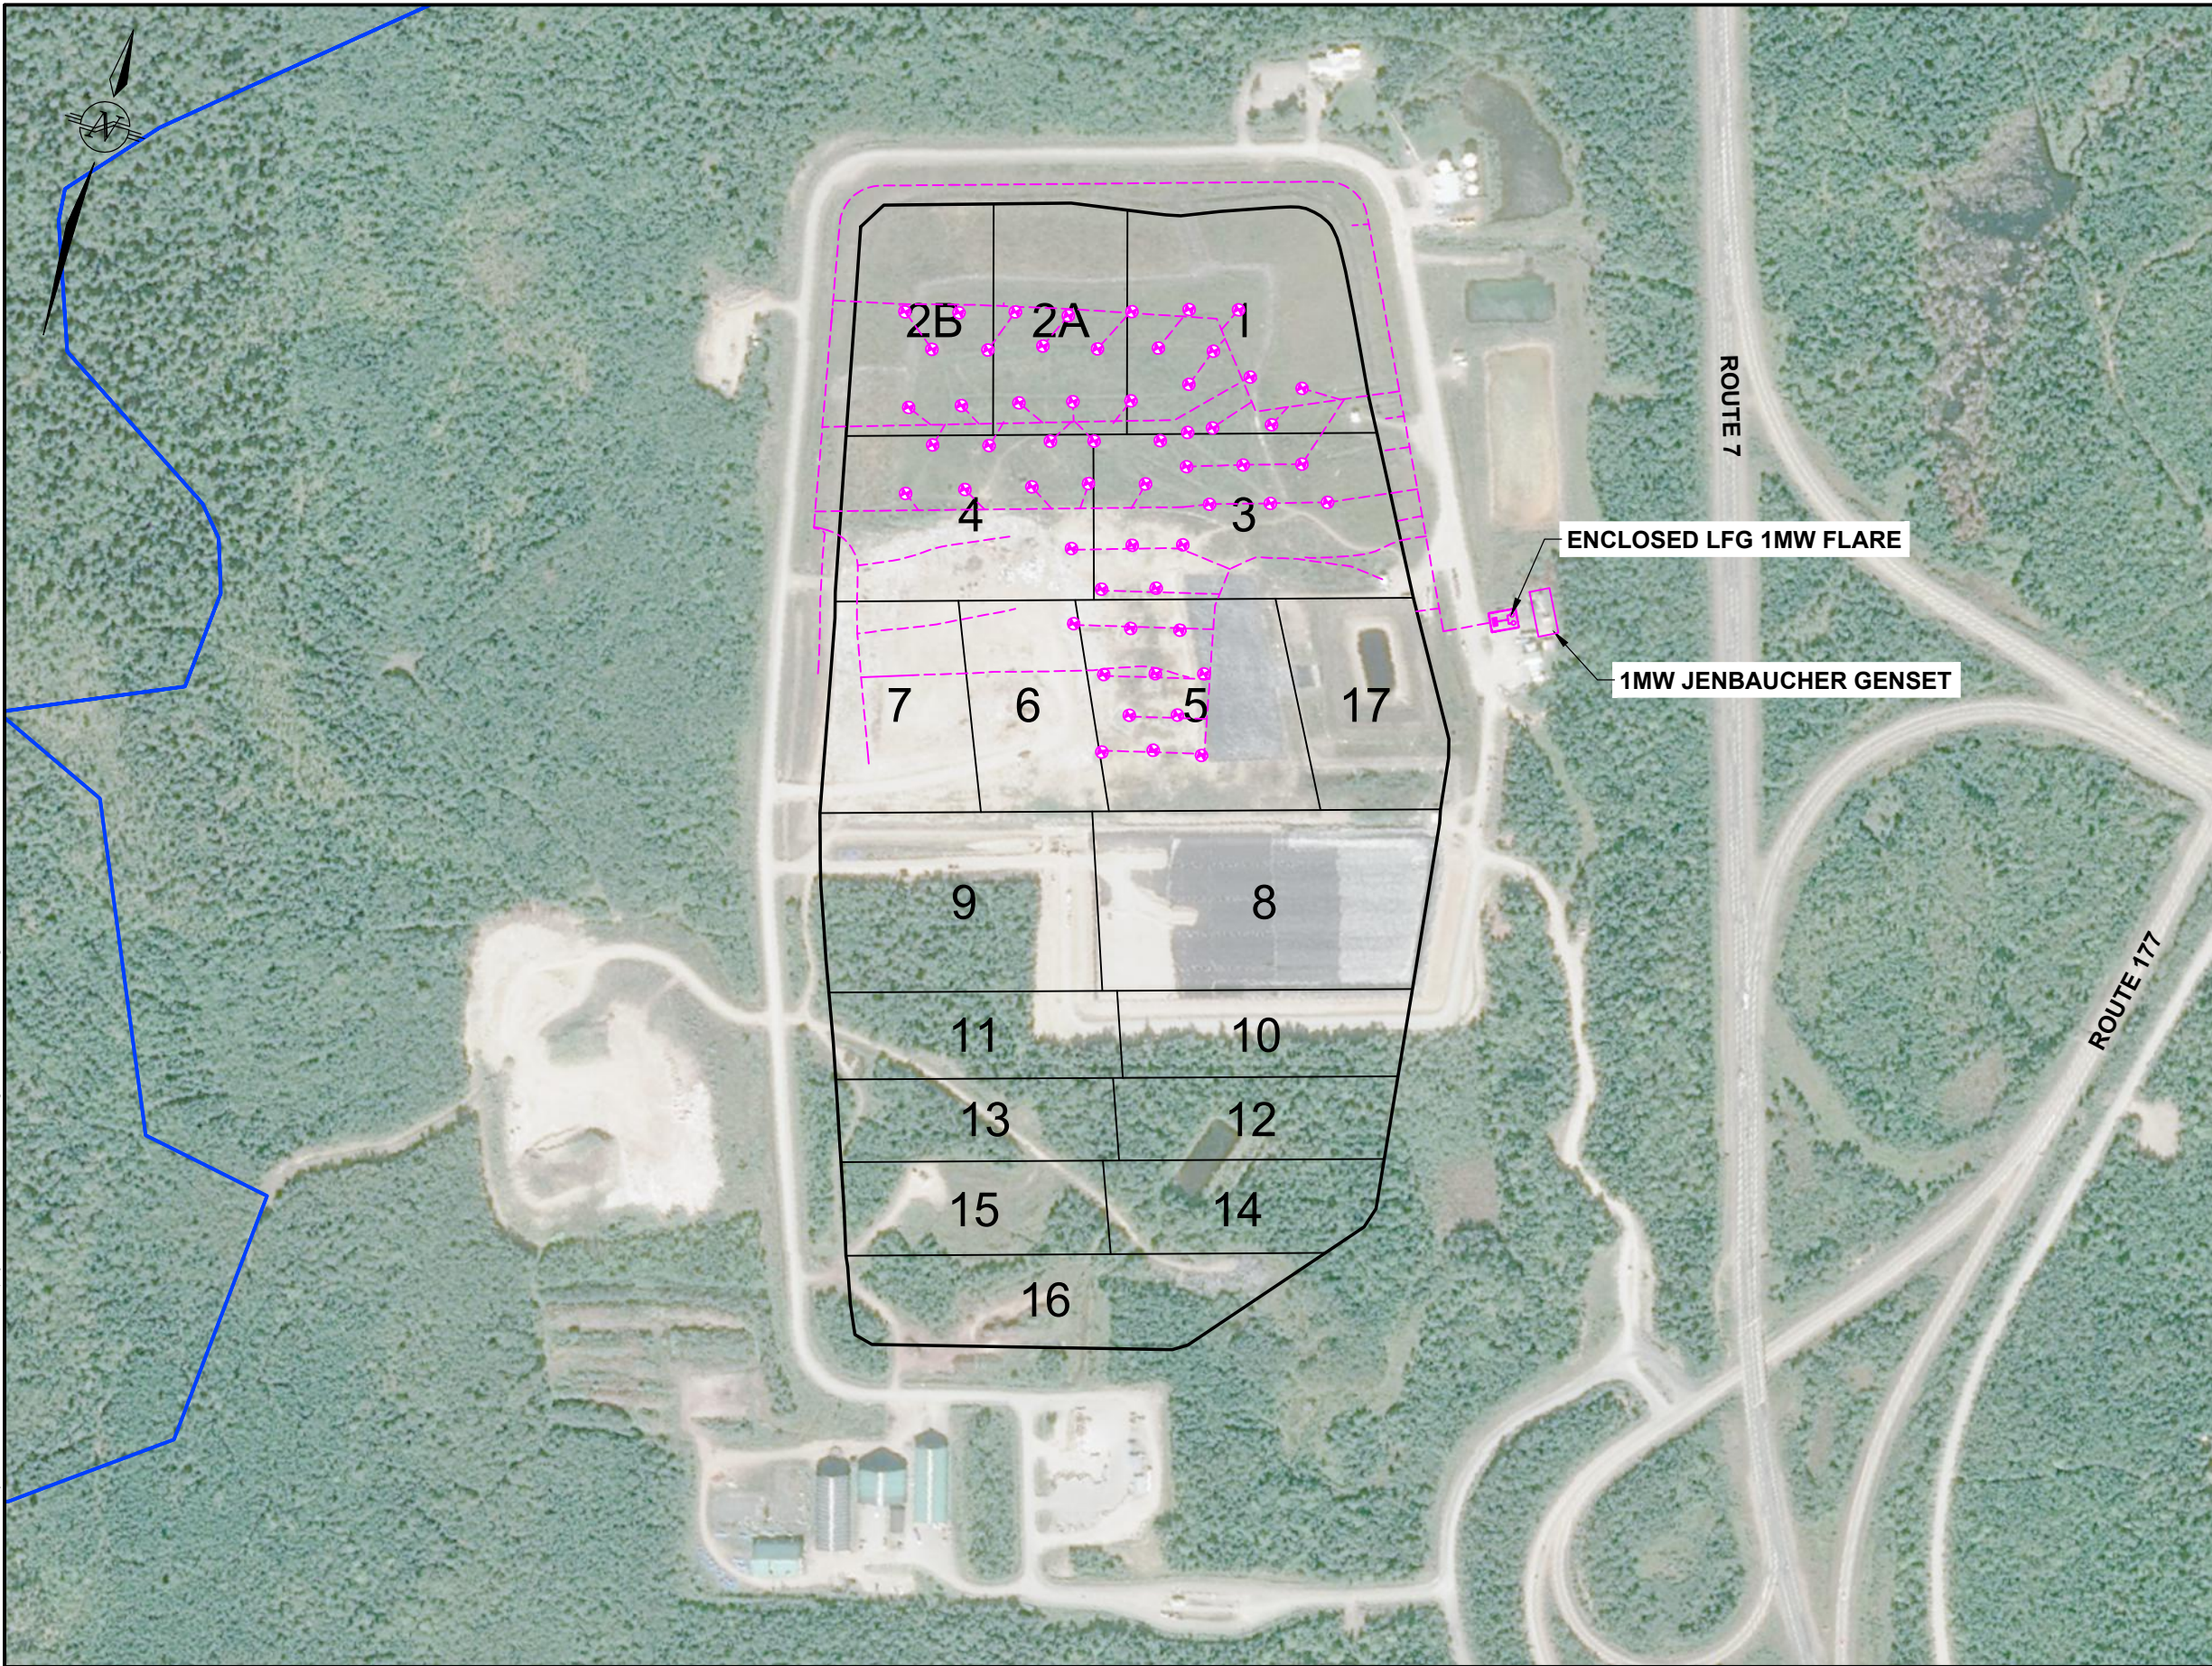
- HYDROGRAPHIC NETWORK (GeoNB)
- - - LFG COLLECTION PIPE
- LFG WELL

FRSC operates the GCCS and LFGUS in accordance with the conditions of their Approval to Operate (Appendix A). The GCCS is expanded on an as needed basis with the installation of new LFG collection wells and piping. Prior to 2023, the Landfill had 35 vertical LFG collectors (wells), and an additional 21 vertical LFG wells were successfully installed in May 2023. These recent developments will significantly bolster the Landfill's LFG collection and management capabilities. LFG is also collected by applying a vacuum to several leachate collection system pipes along the western containment berm. Figure 5 shows the Landfill's LFG related infrastructure and layout prior to the 2023 expansion. Engineered drawings for the 2023 LFG System Expansion are included in Appendix B. .

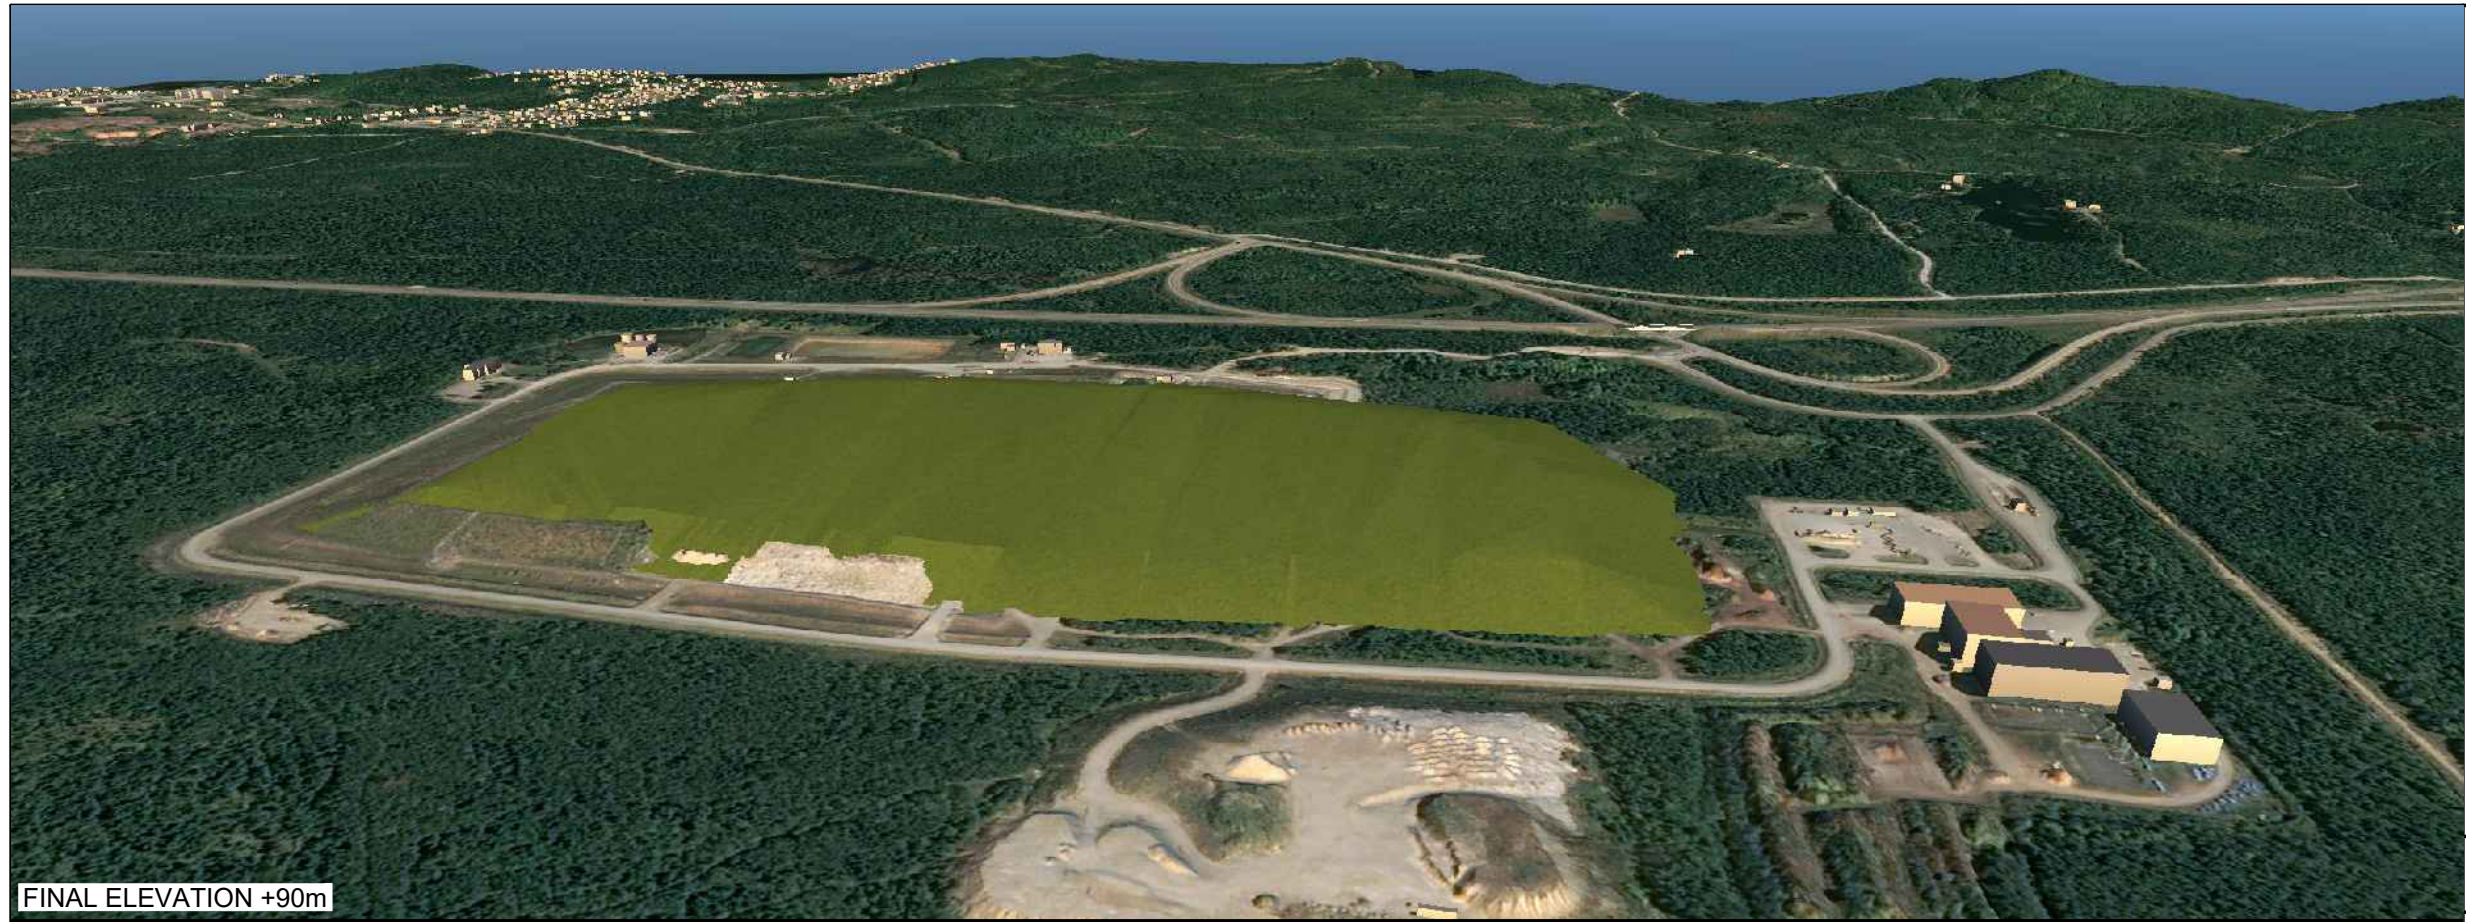
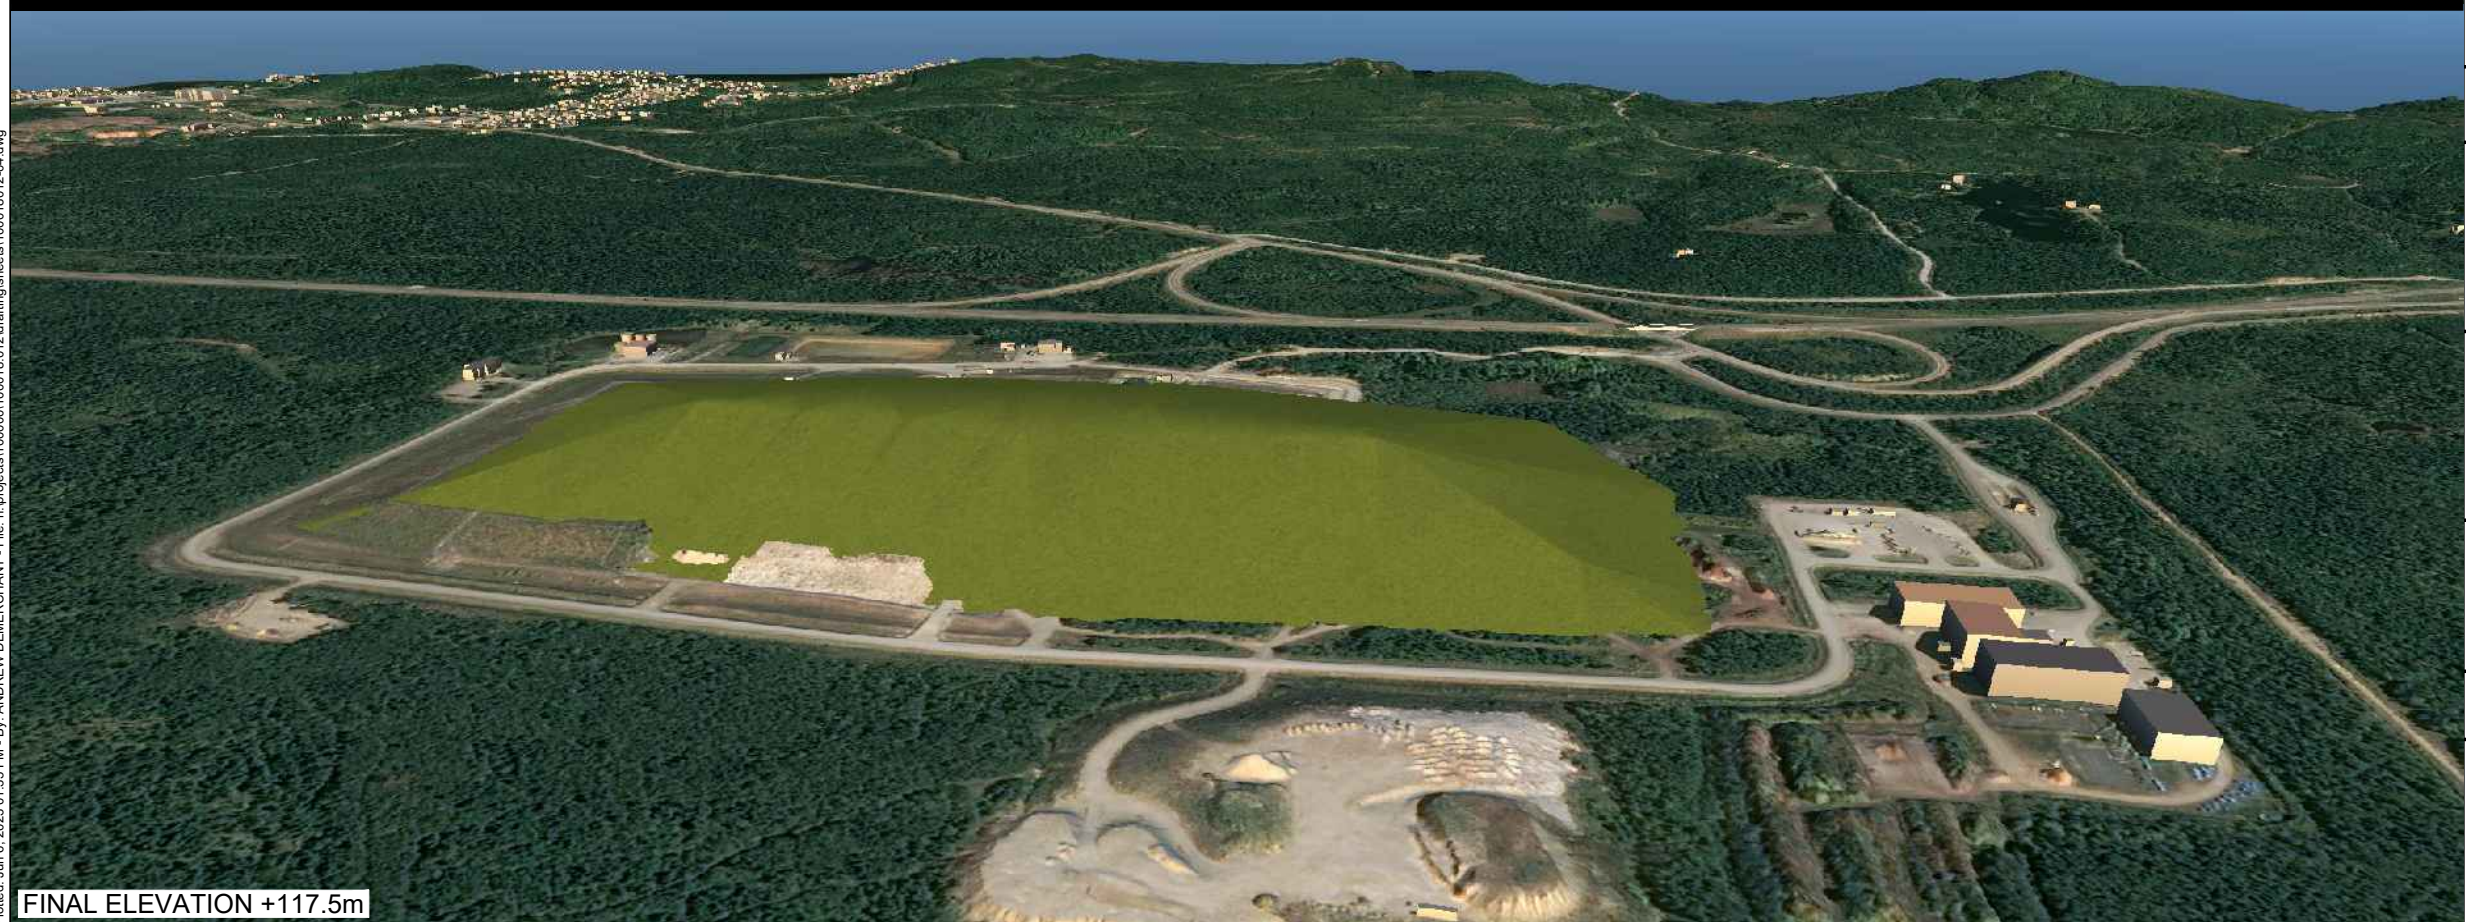
FINAL ELEVATION +90m

FINAL ELEVATION +117.5m

Based on the wind profile power law relationship, the wind speed at an elevation of +117 meters would be about 4% higher than the wind speed at an elevation of +90 meters, assuming all other factors are constant. This small increase is not expected to have a significant effect on the transmission of sound away from the Landfill.

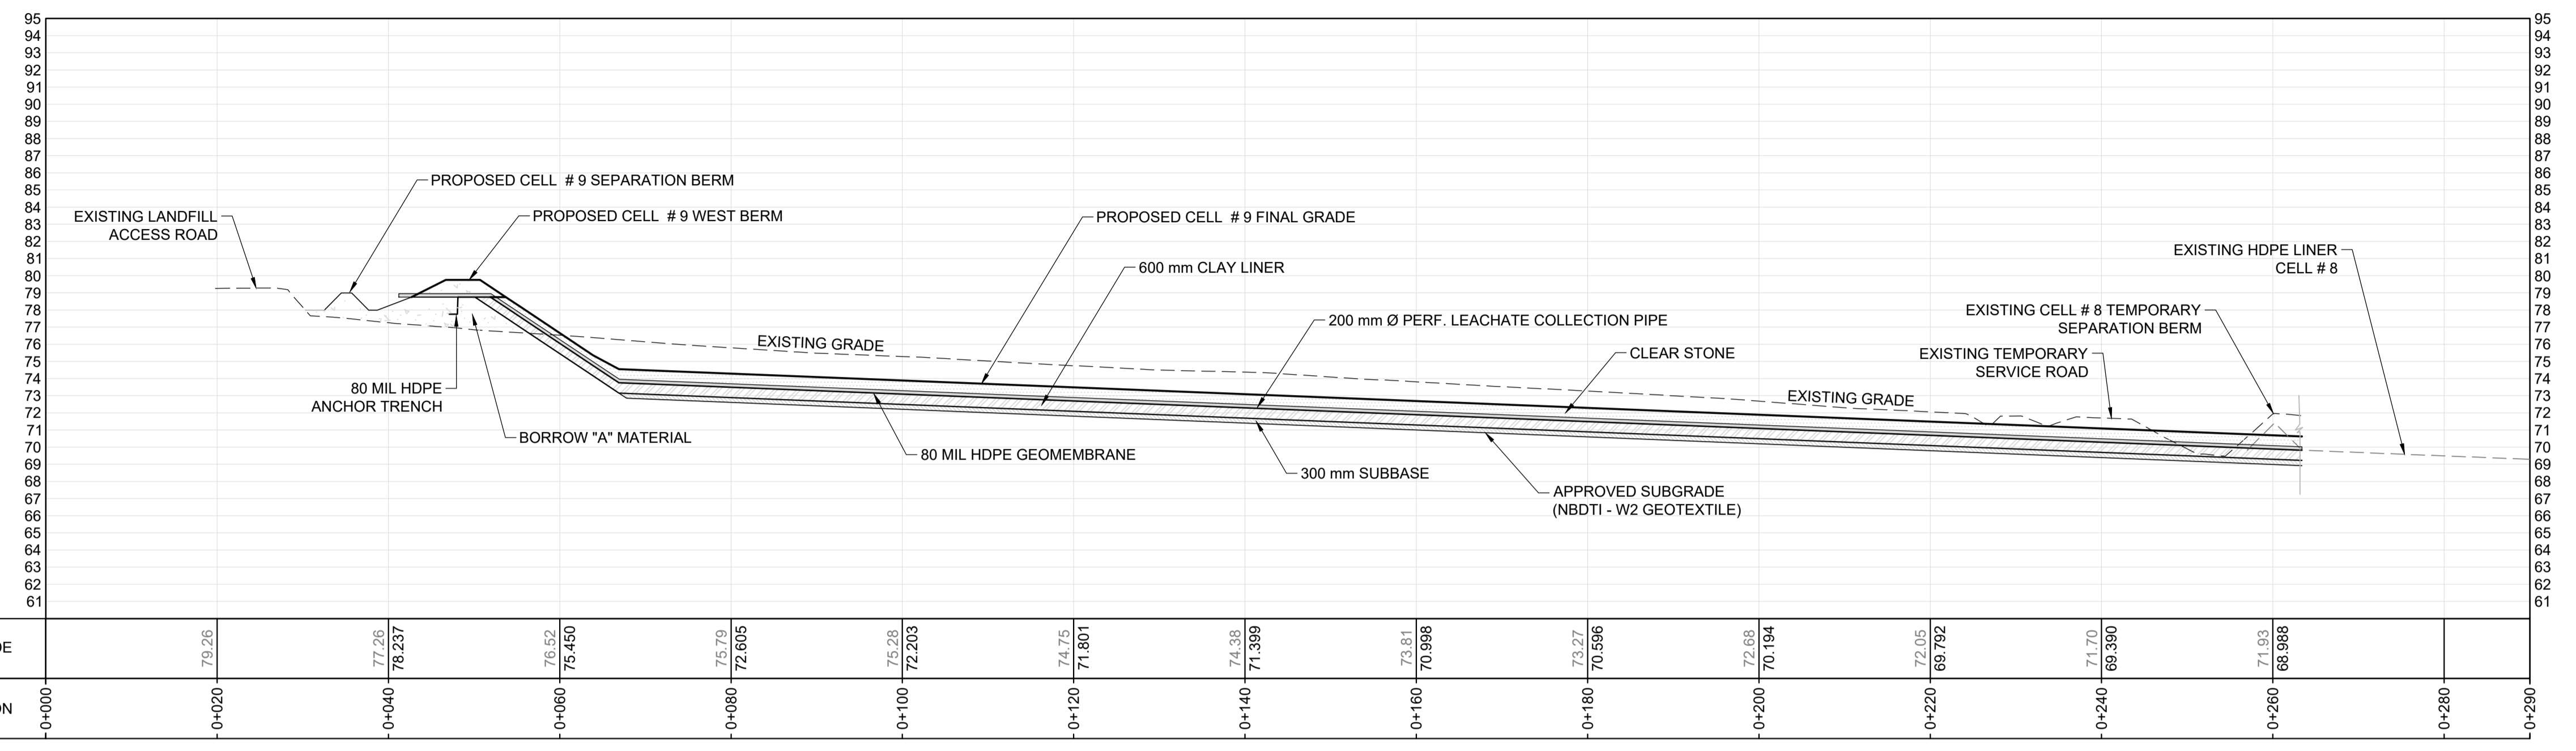
A-A PROFILE

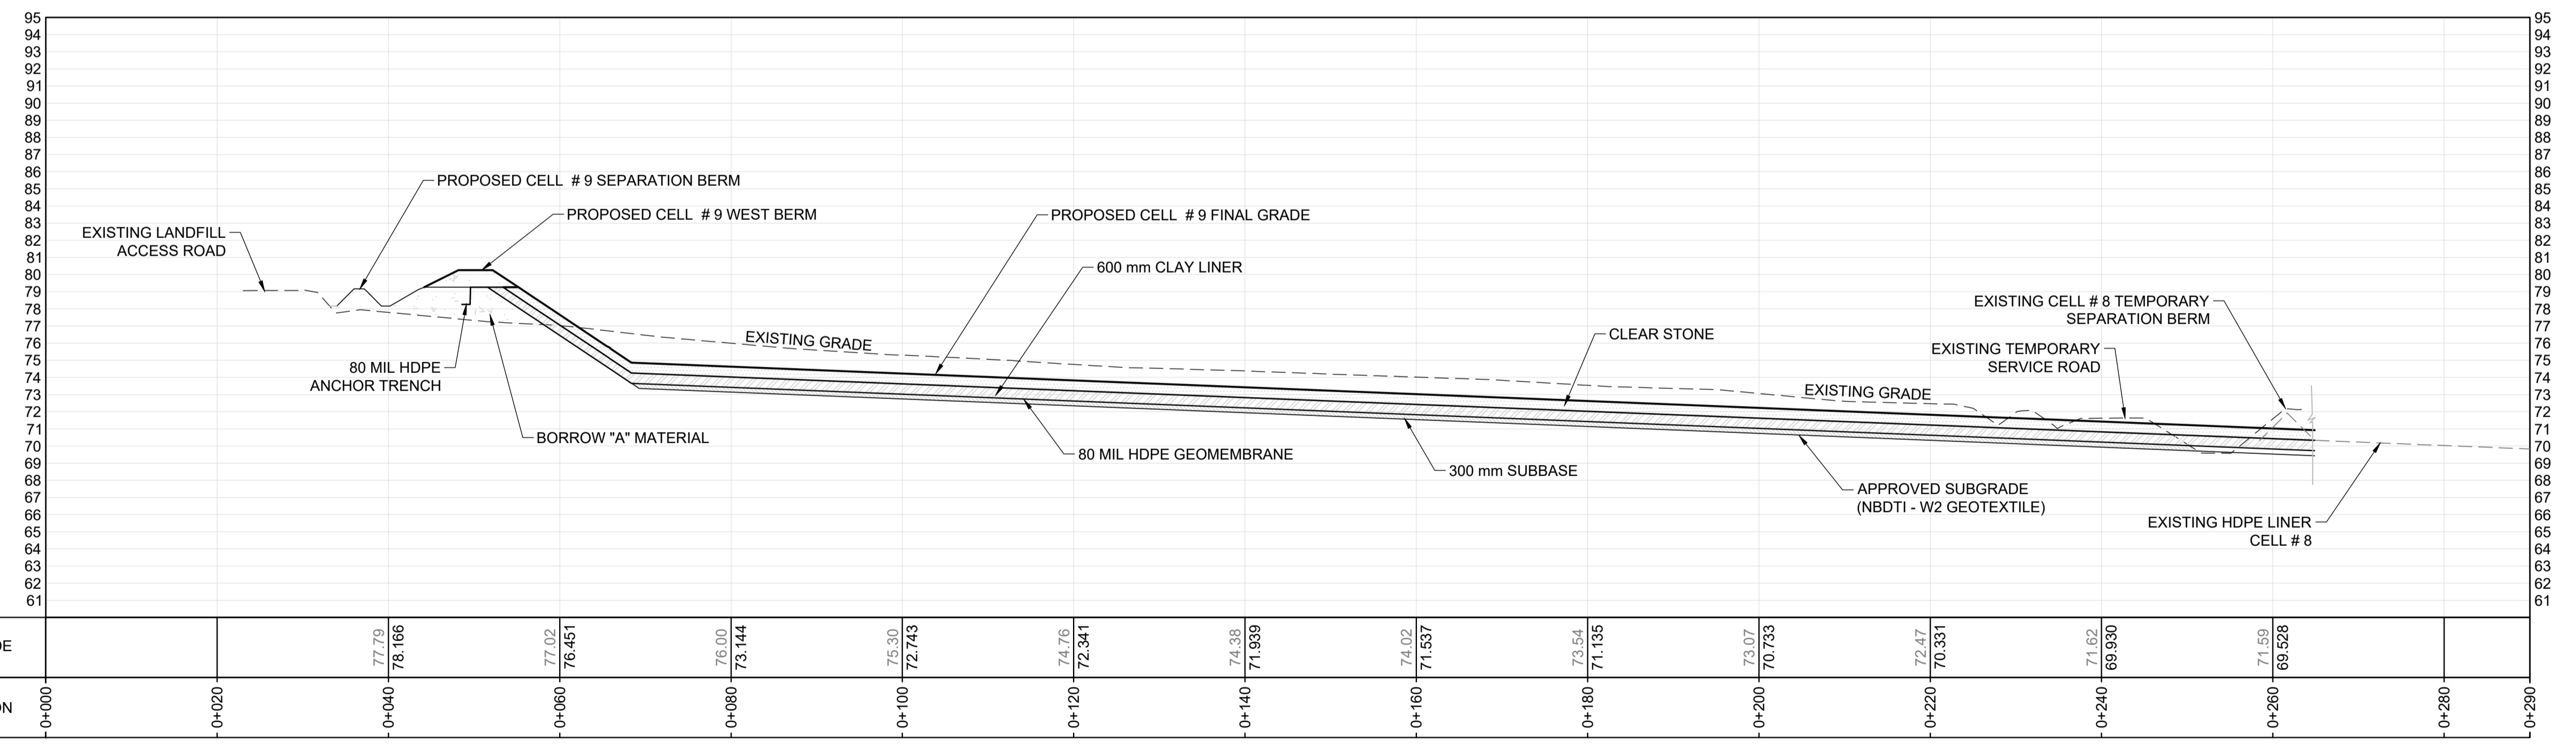
B-B PROFILE

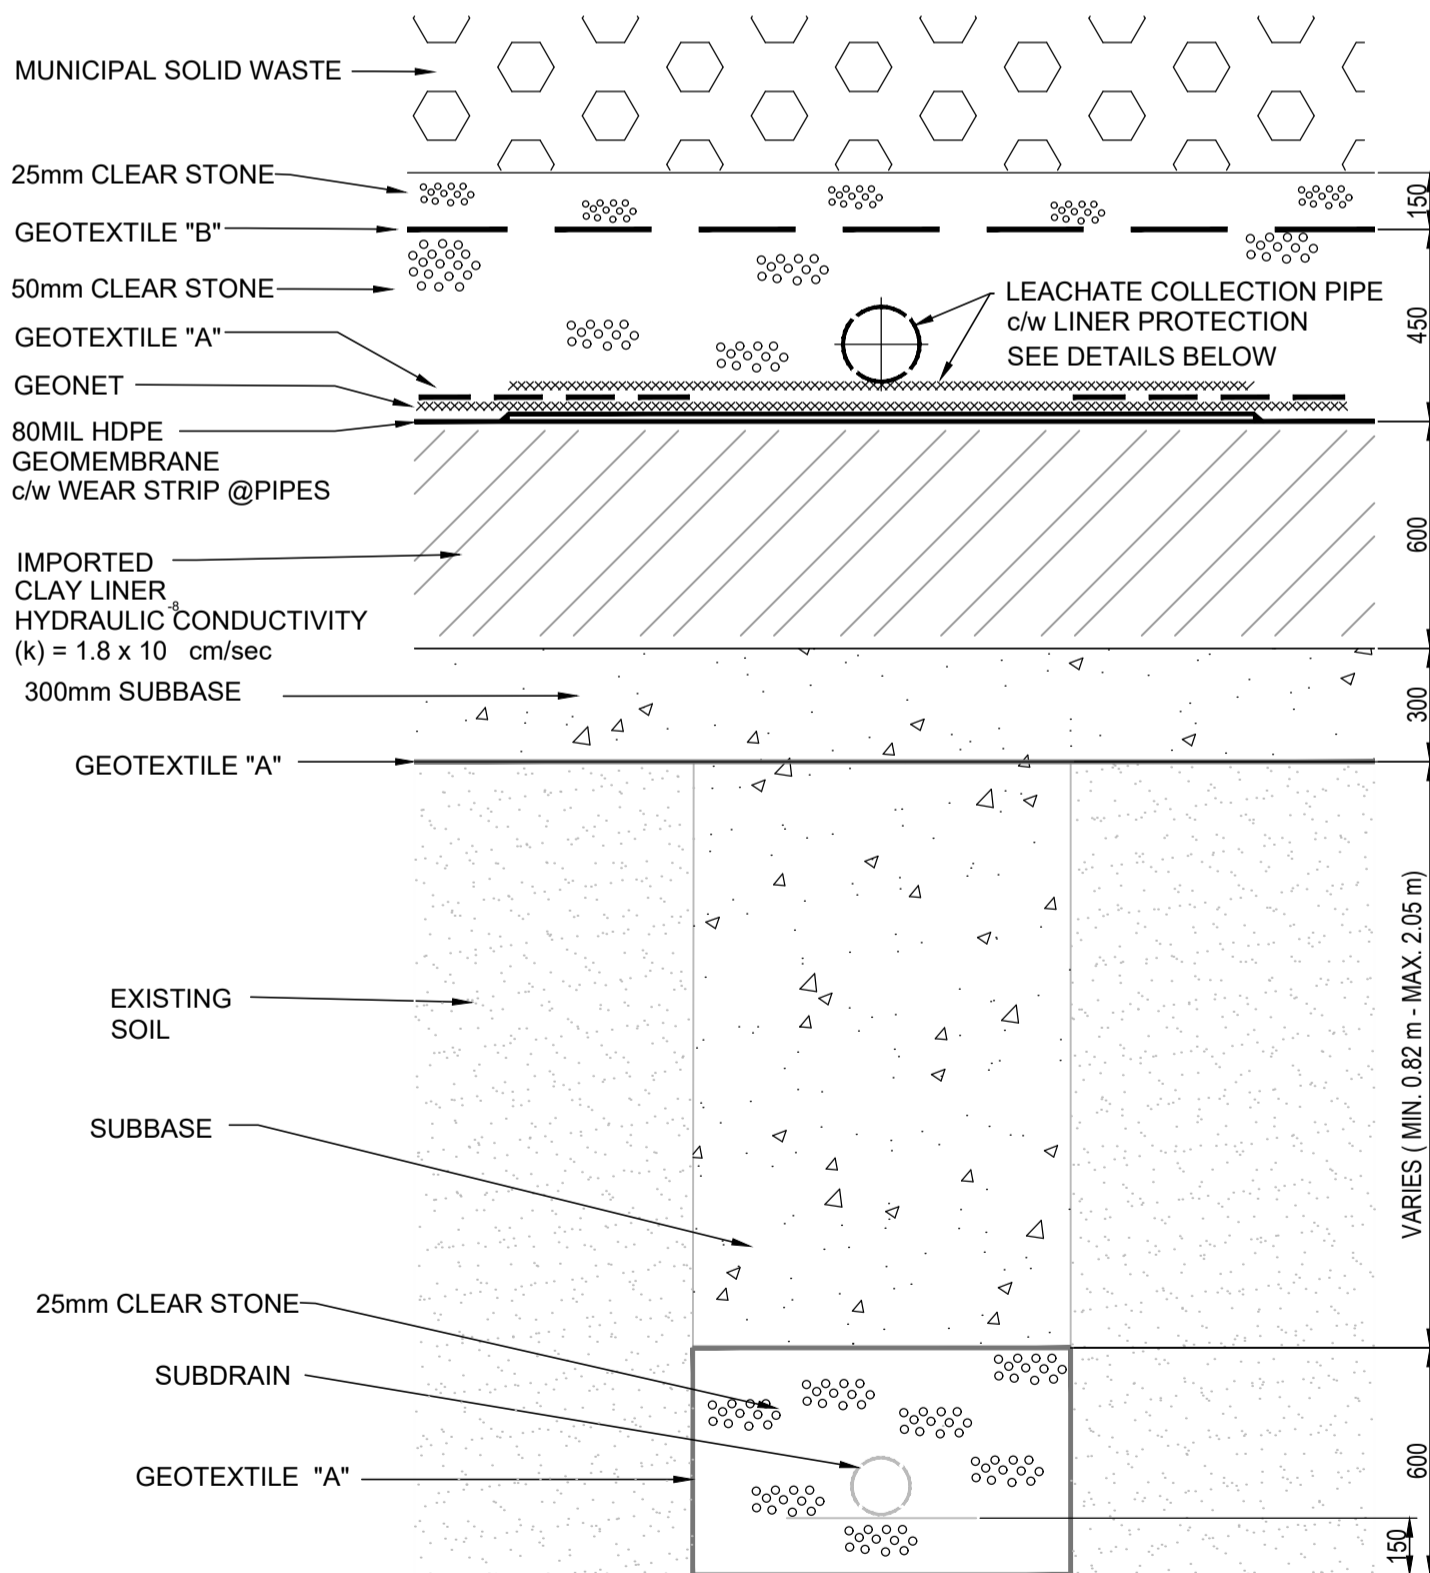
1 PARTIAL TRANSVERSE SECTION THROUGH CELL BOTTOM
SCALE 1:50

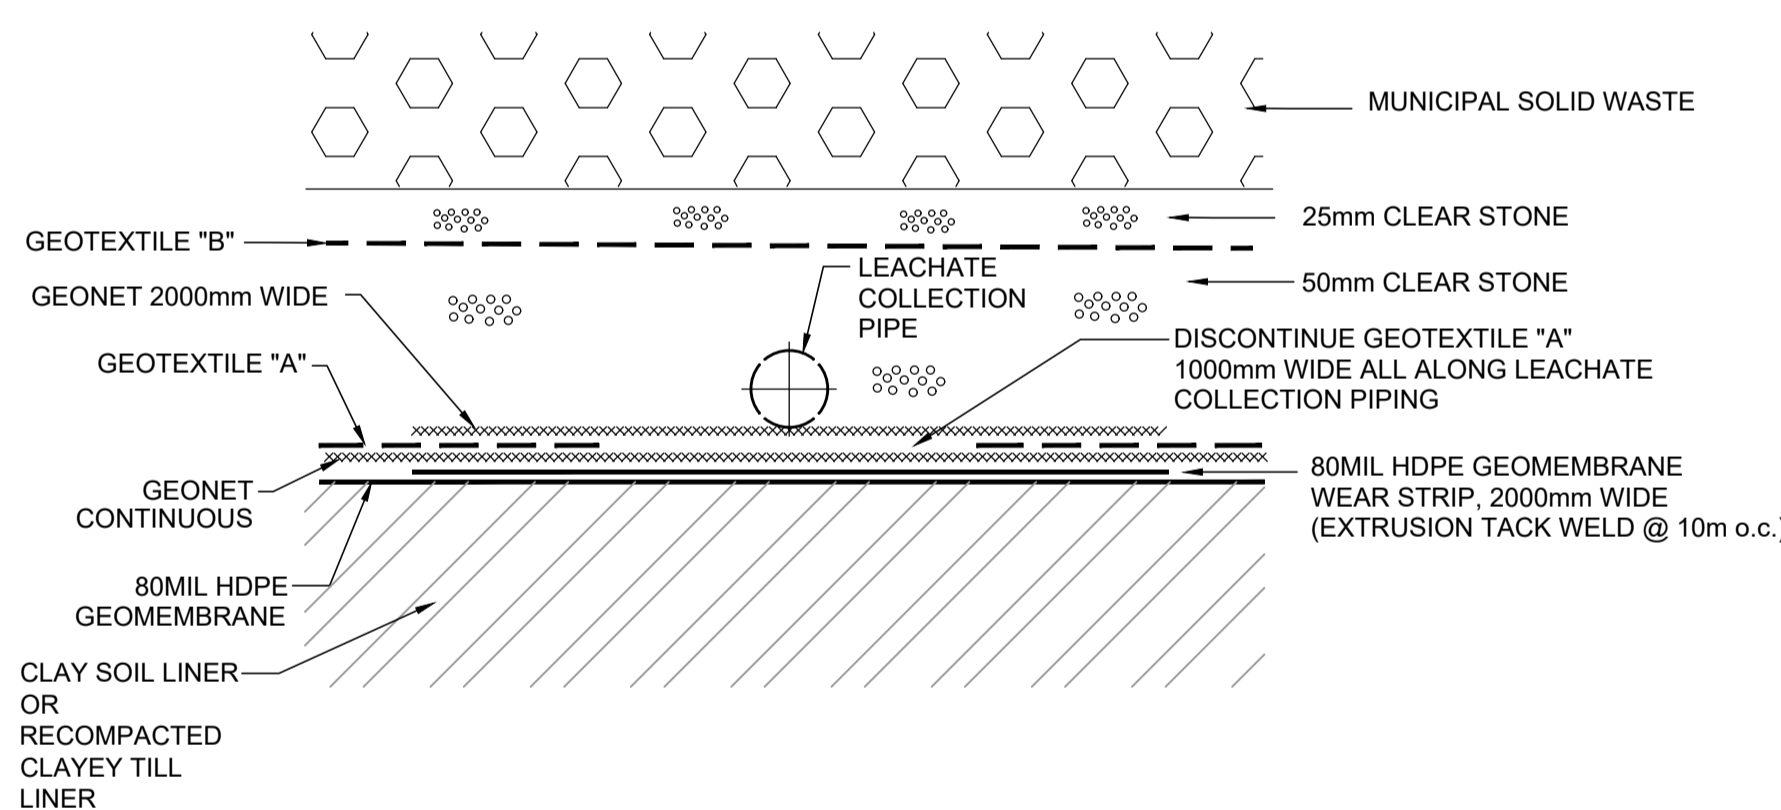
LINER SCHEMATIC
SCALE 1:20

Eventually, a final cover is installed. Historically, the final cover at Crane Mountain Landfill has consisted of a gas venting layer, drainage layers, low permeability material (GCL or clay), frost protection material, and topsoil, and is vegetated with grass and plants as a means of erosion control. See Appendix B for construction drawings for the 2022 capping program.
