**Environmental Impact Assessment
Registration Document
Fundy Regional Service Commission
Crane Mountain Landfill Capacity
Augmentation and Life Extension Project
Saint John, New Brunswick**

GEMTEC Project: 100018.012

June 21, 2023
GEMTEC Project: 100018.012

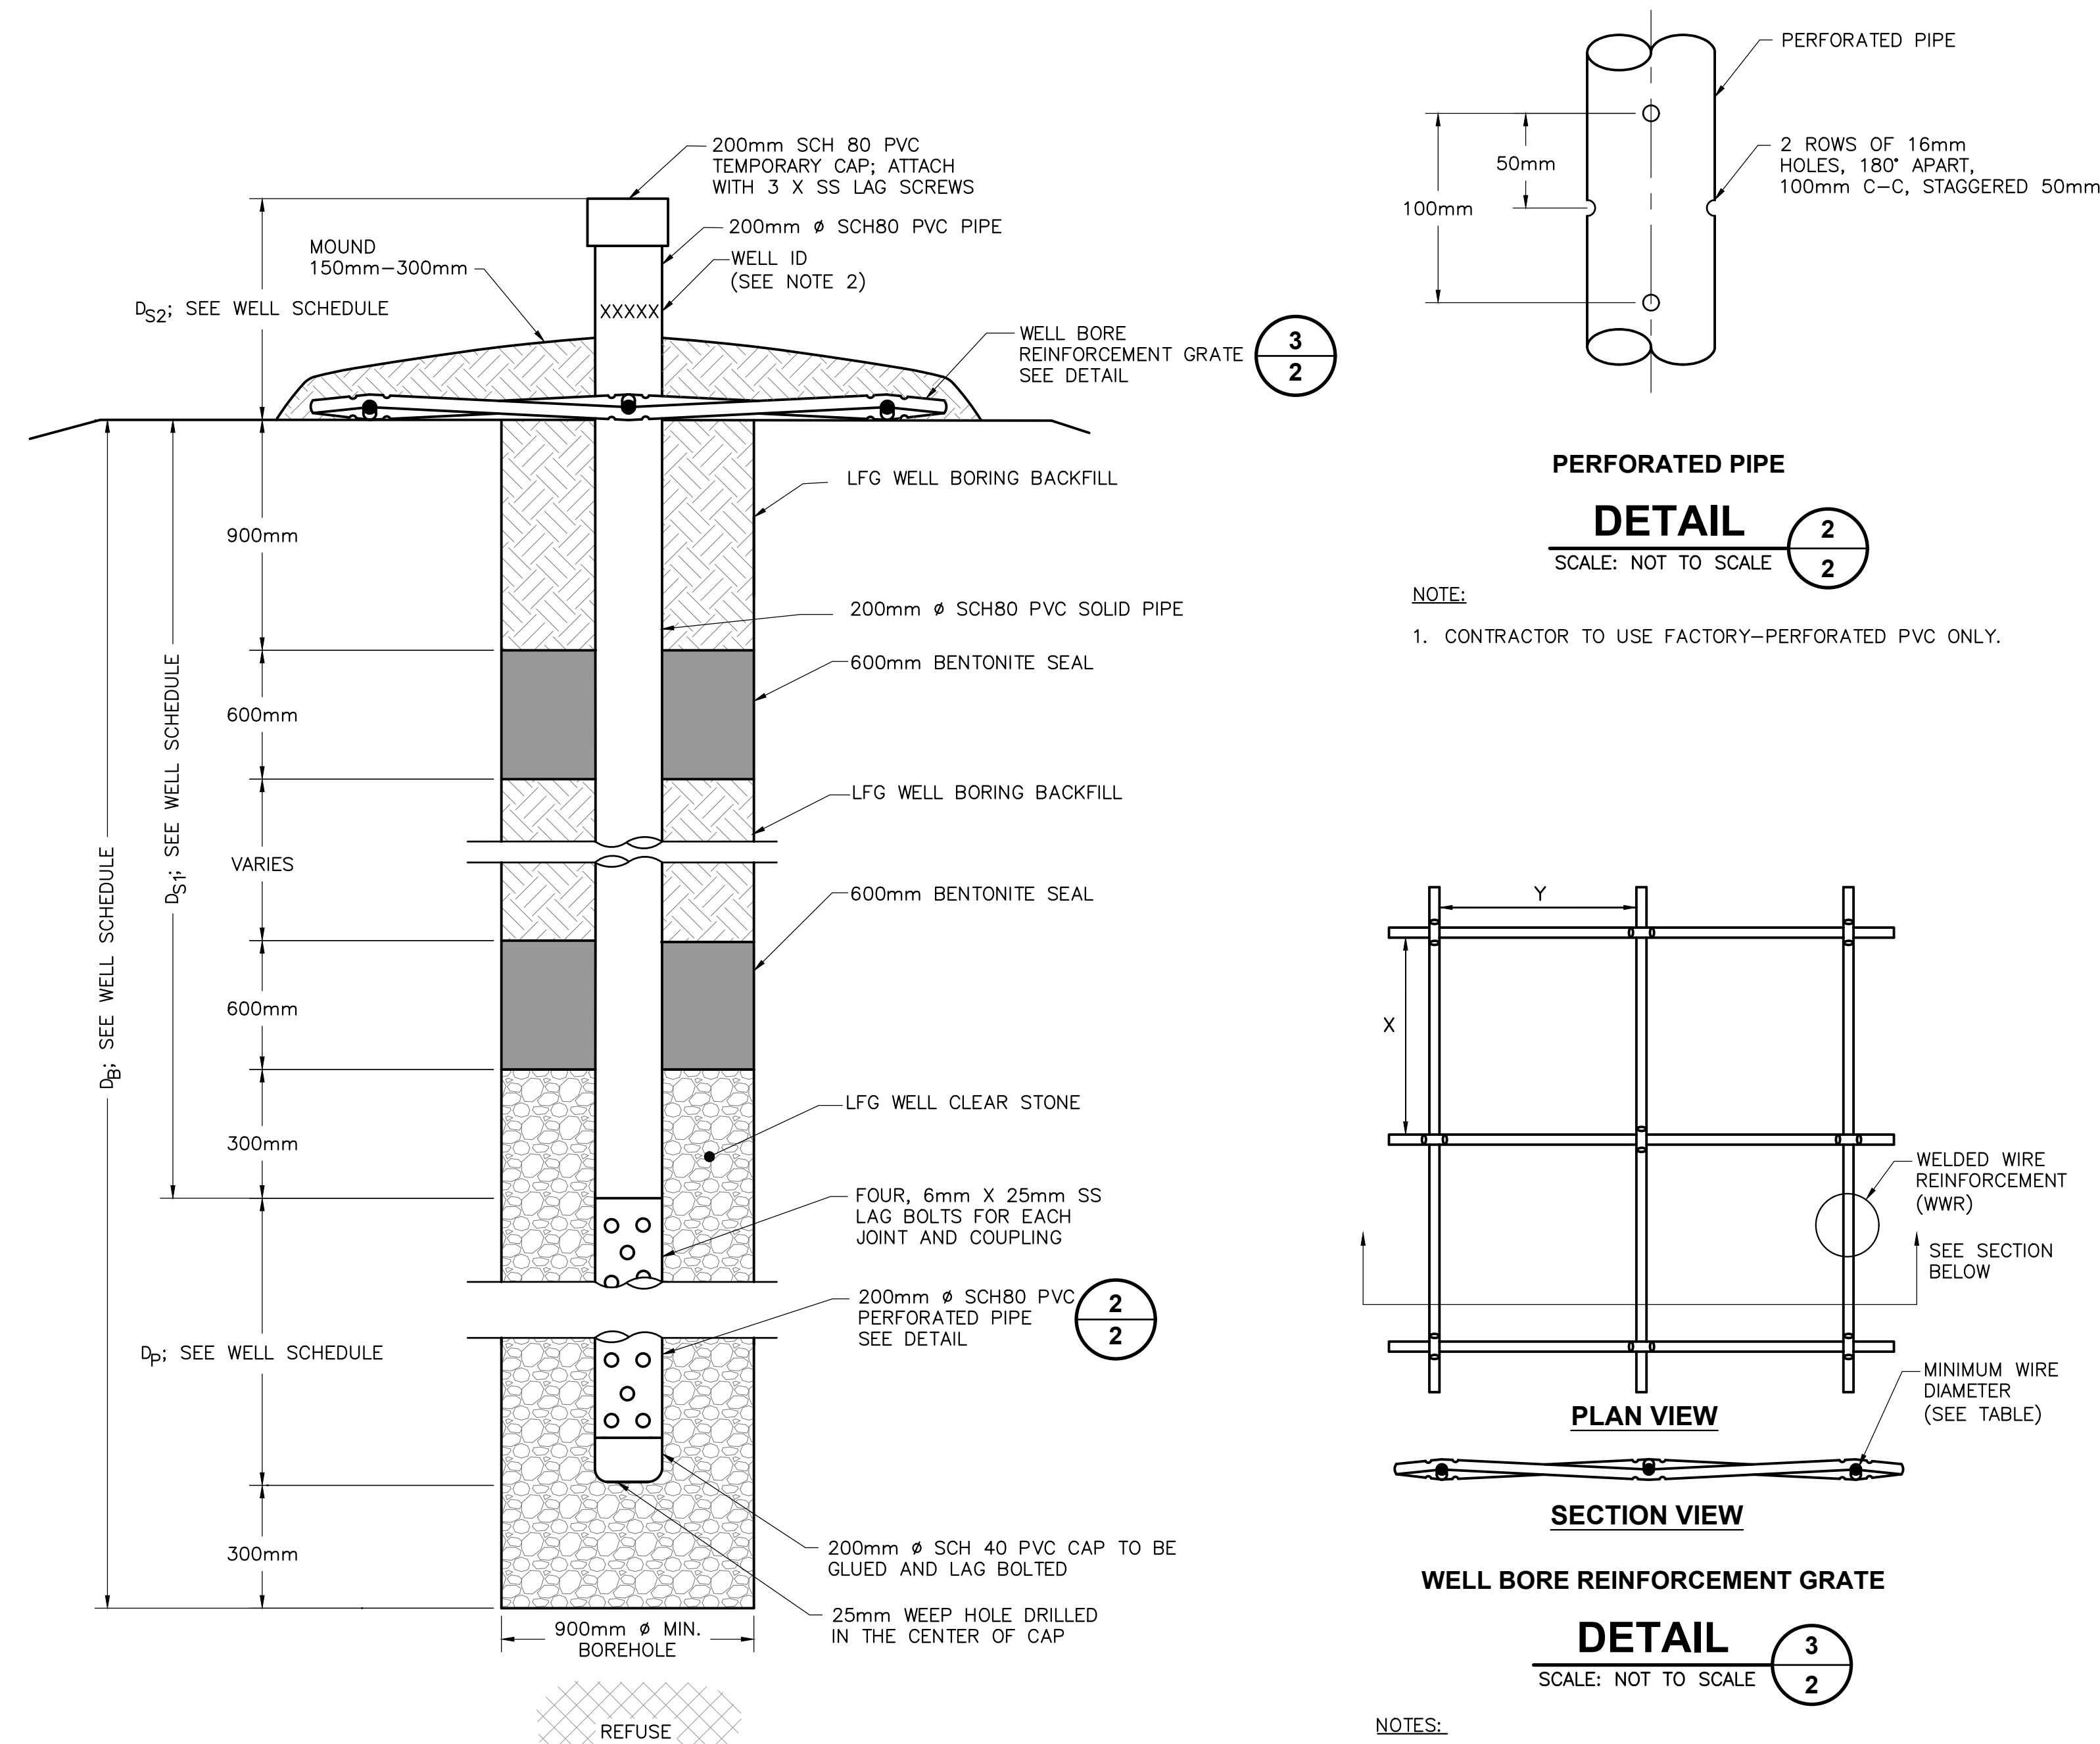
VERTICAL EXTRACTION WELL
DETAIL 1
SCALE: NOT TO SCALE

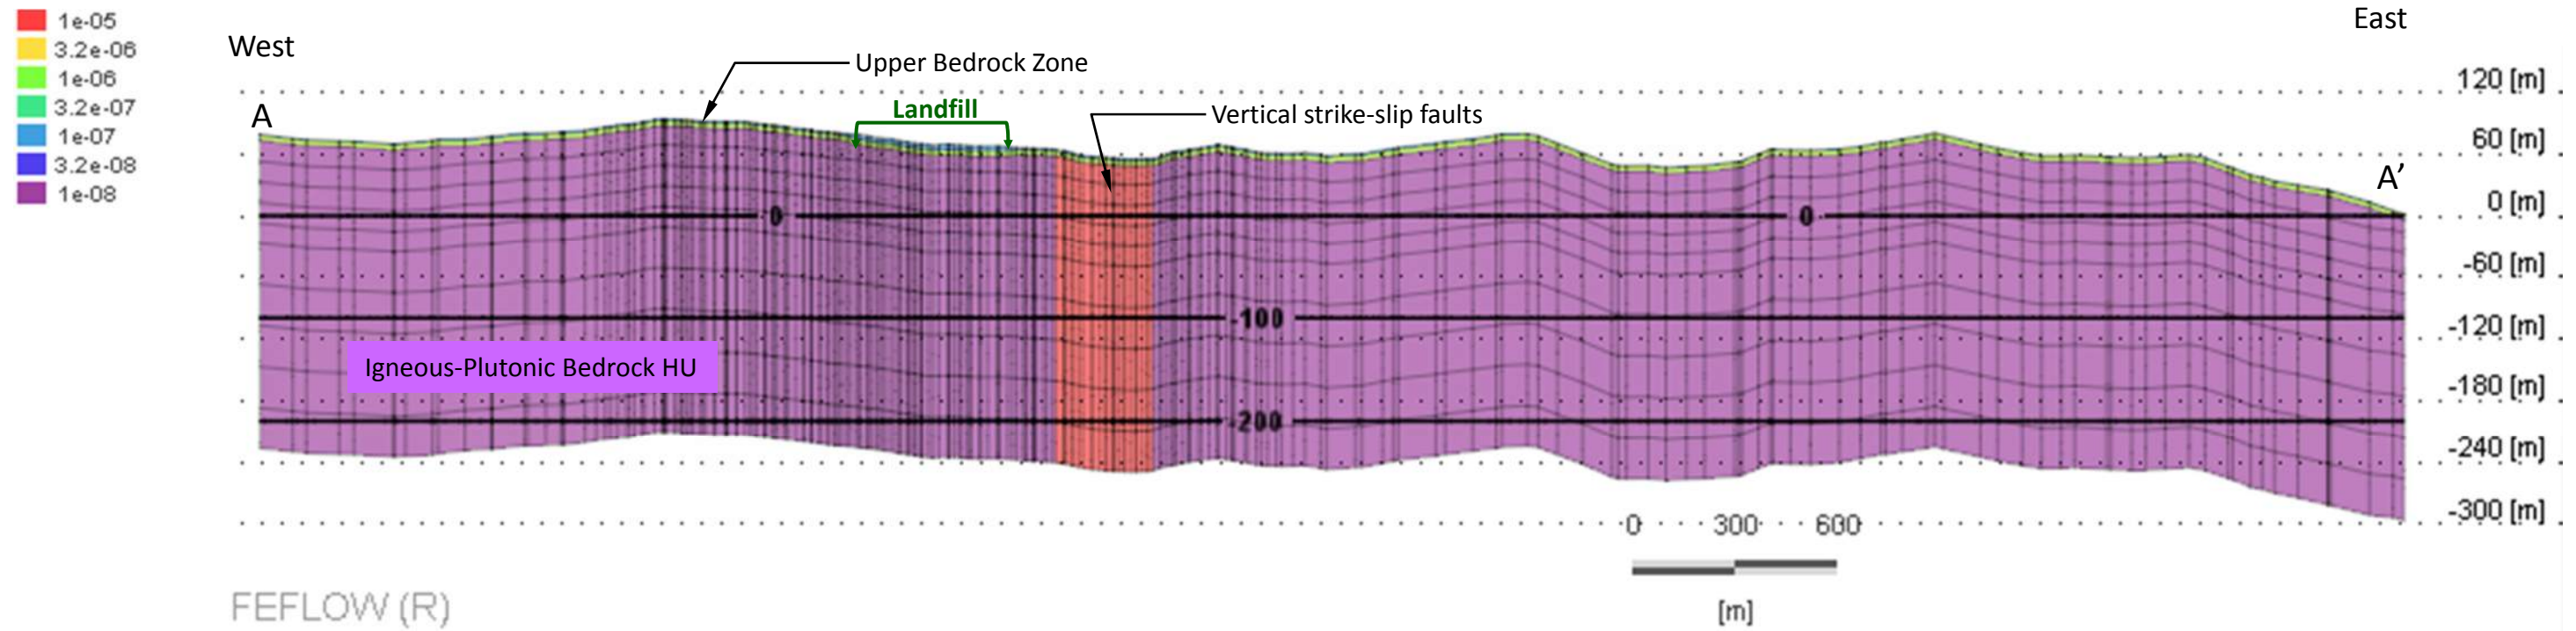
a) Vertical Component of Hydraulic Conductivity Along Cross-Section AA'

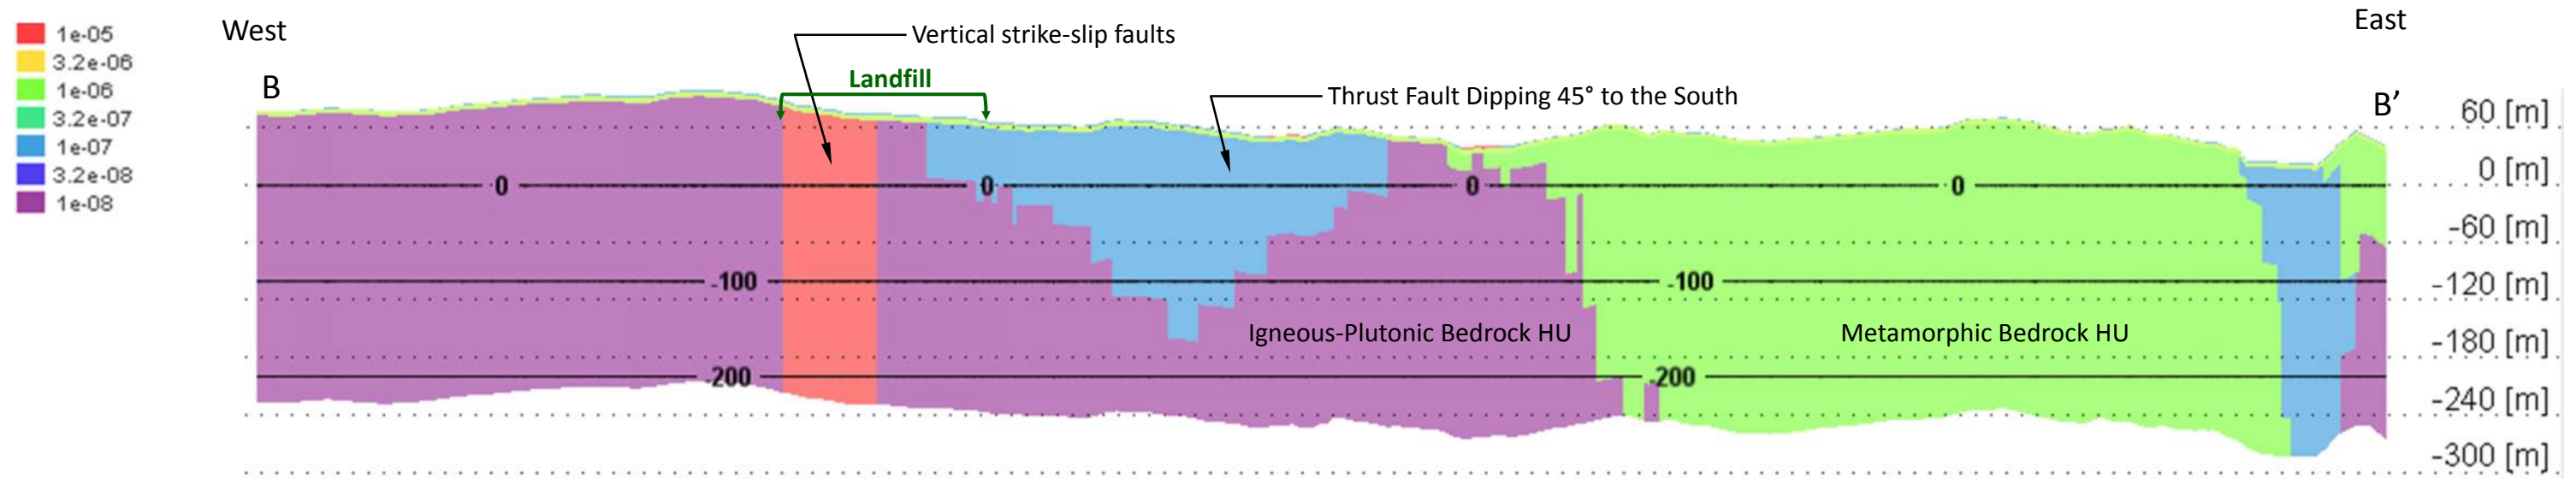
b) Vertical Component of Hydraulic Conductivity Along Cross-Section BB'

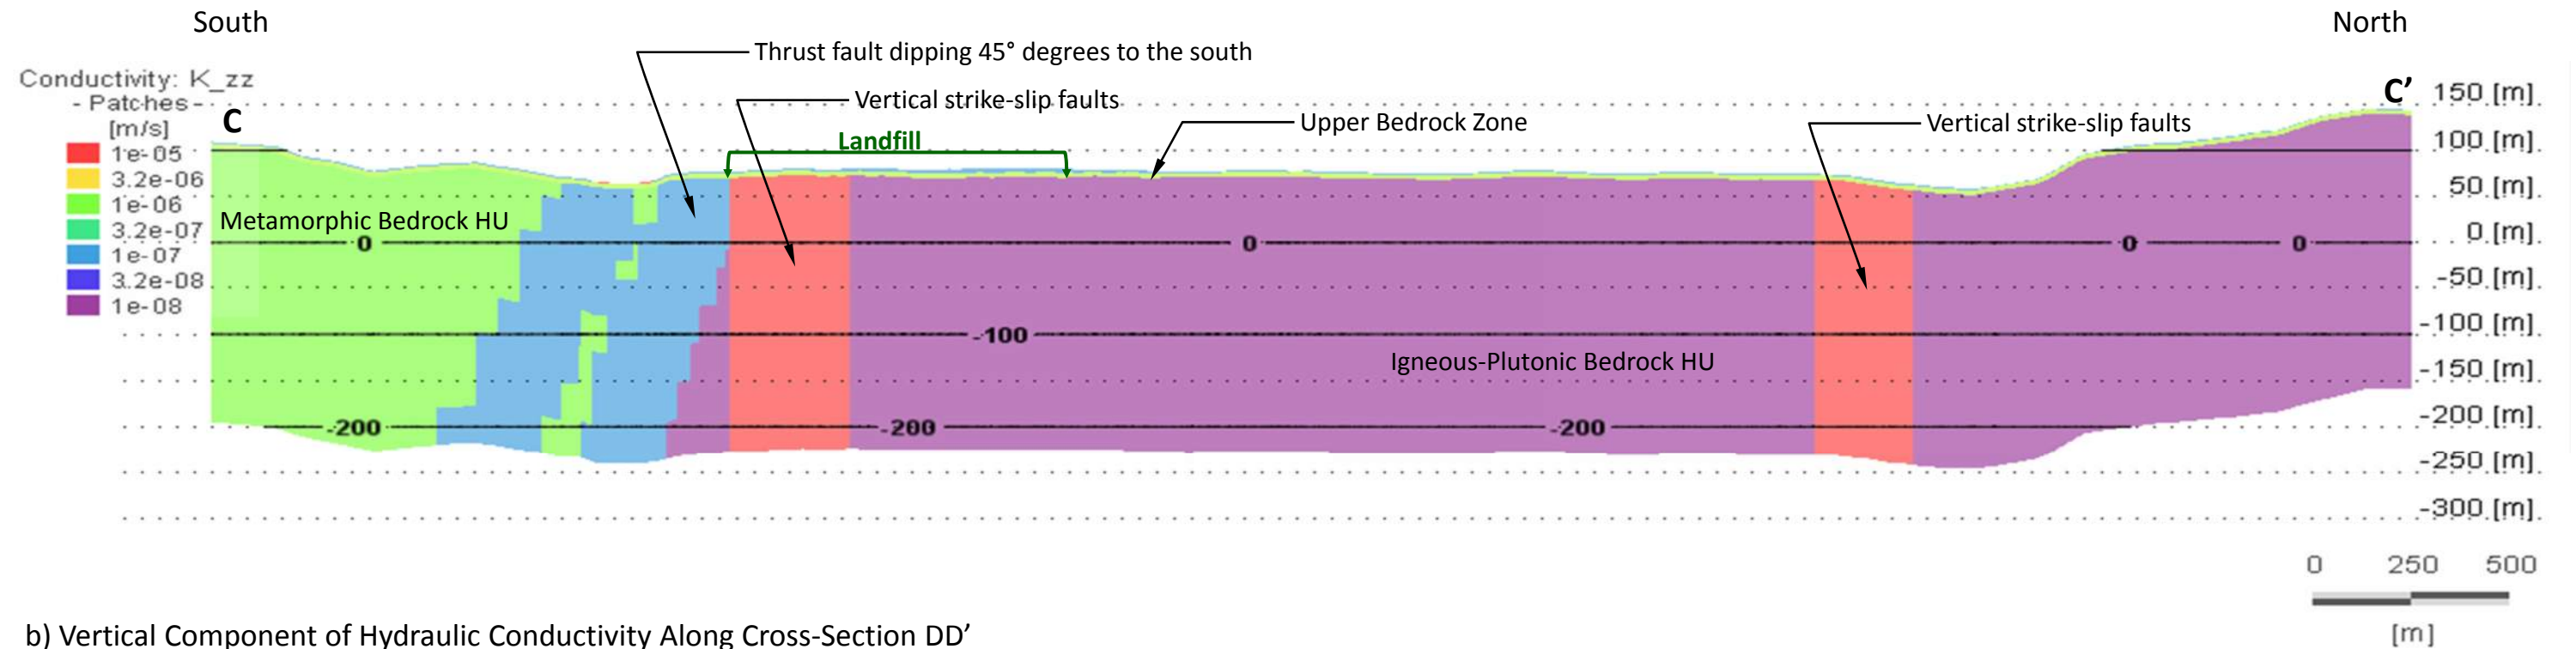
a) Vertical Component of Hydraulic Conductivity Along Cross-Section CC'

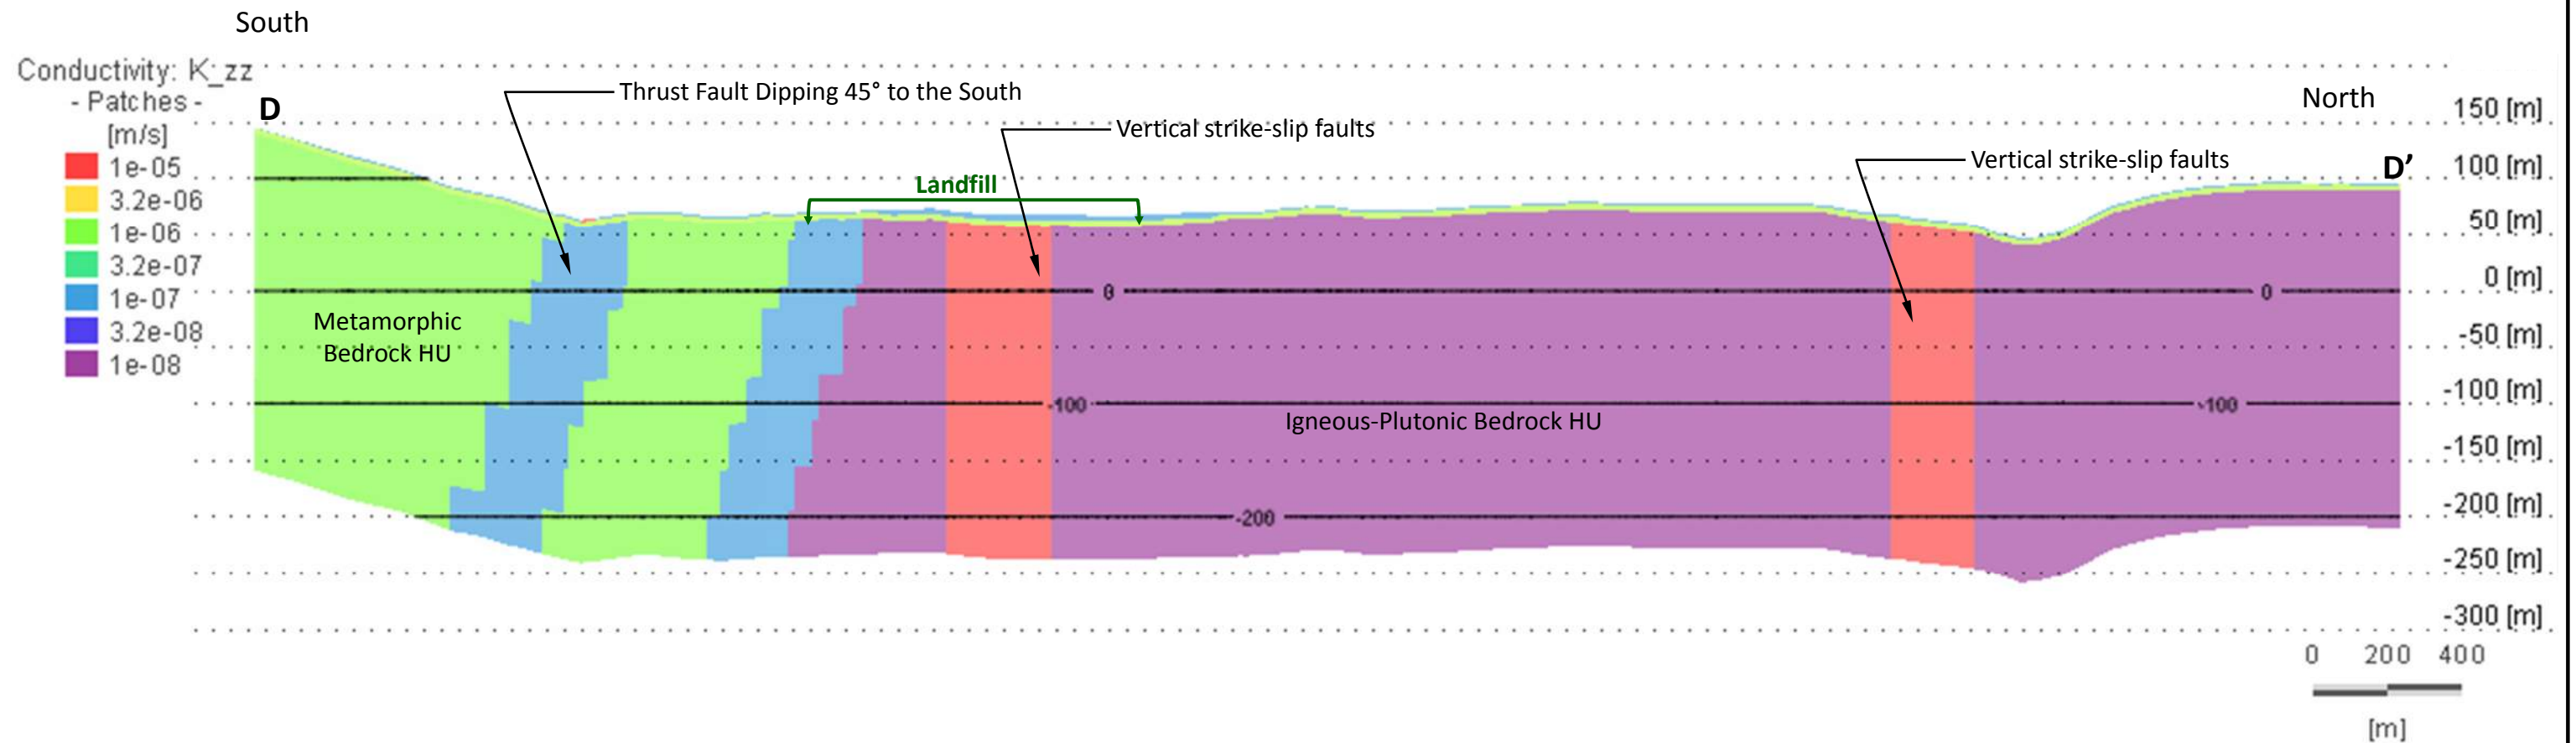
b) Vertical Component of Hydraulic Conductivity Along Cross-Section DD'

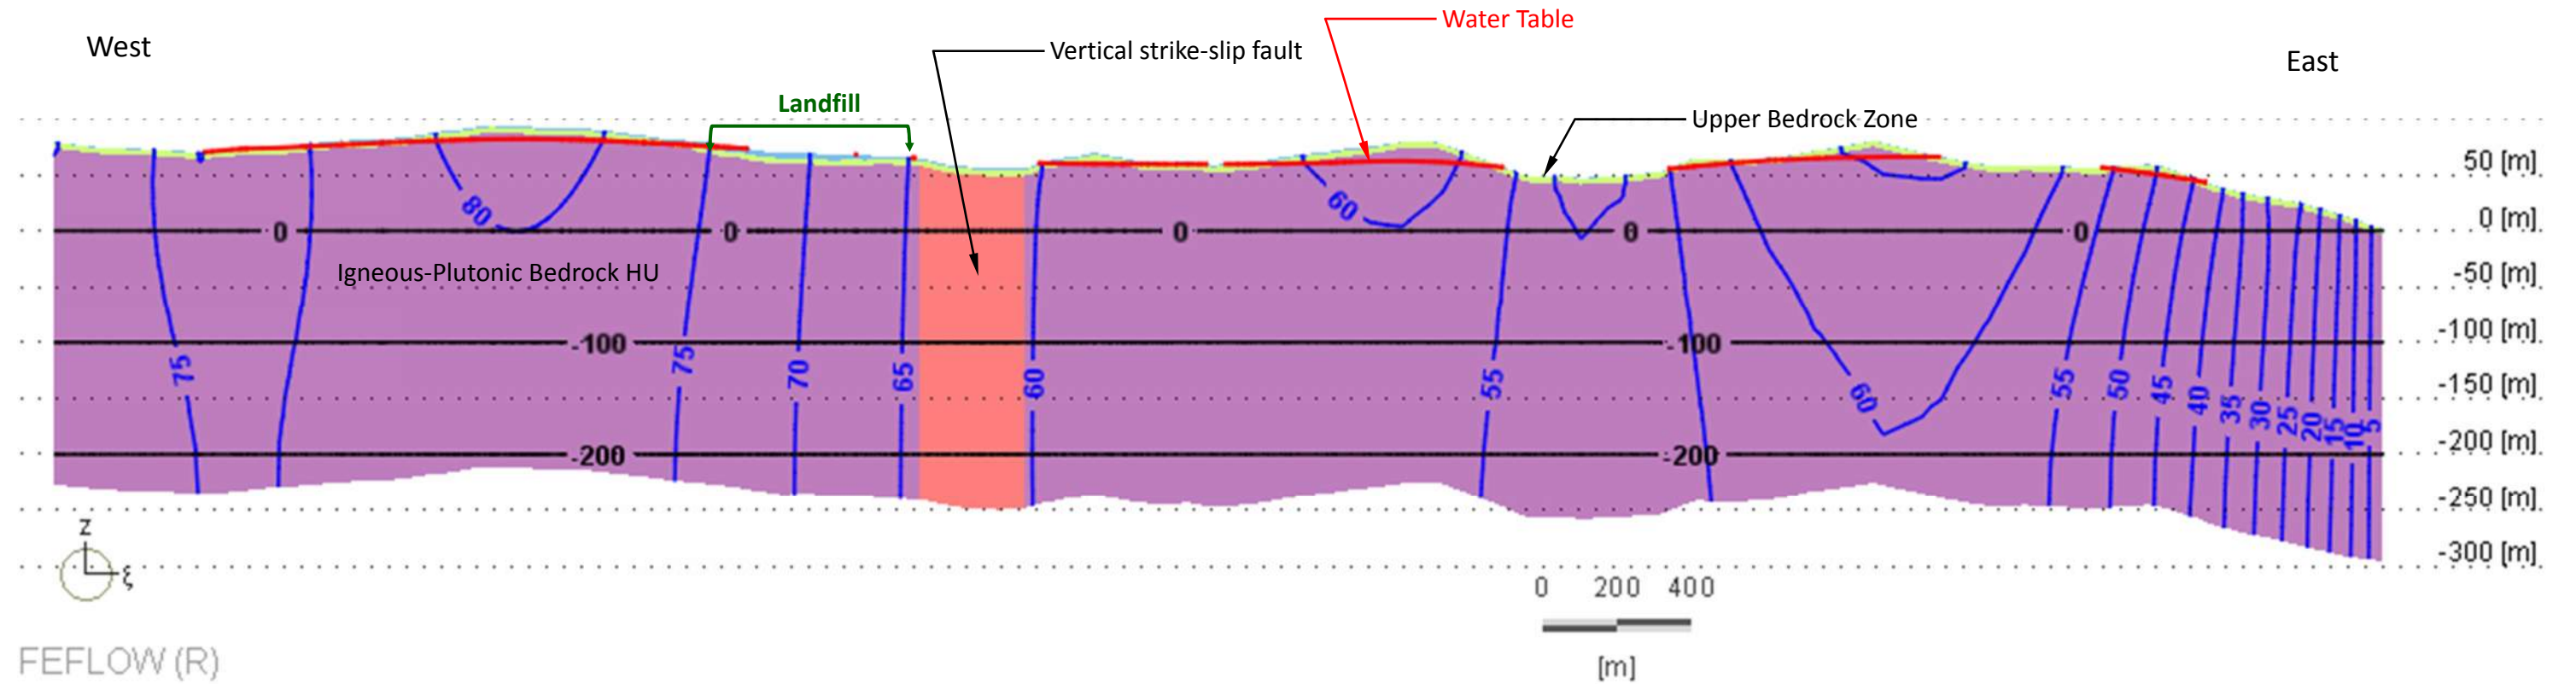
a) Hydraulic Head Distribution Along Cross-Section AA'

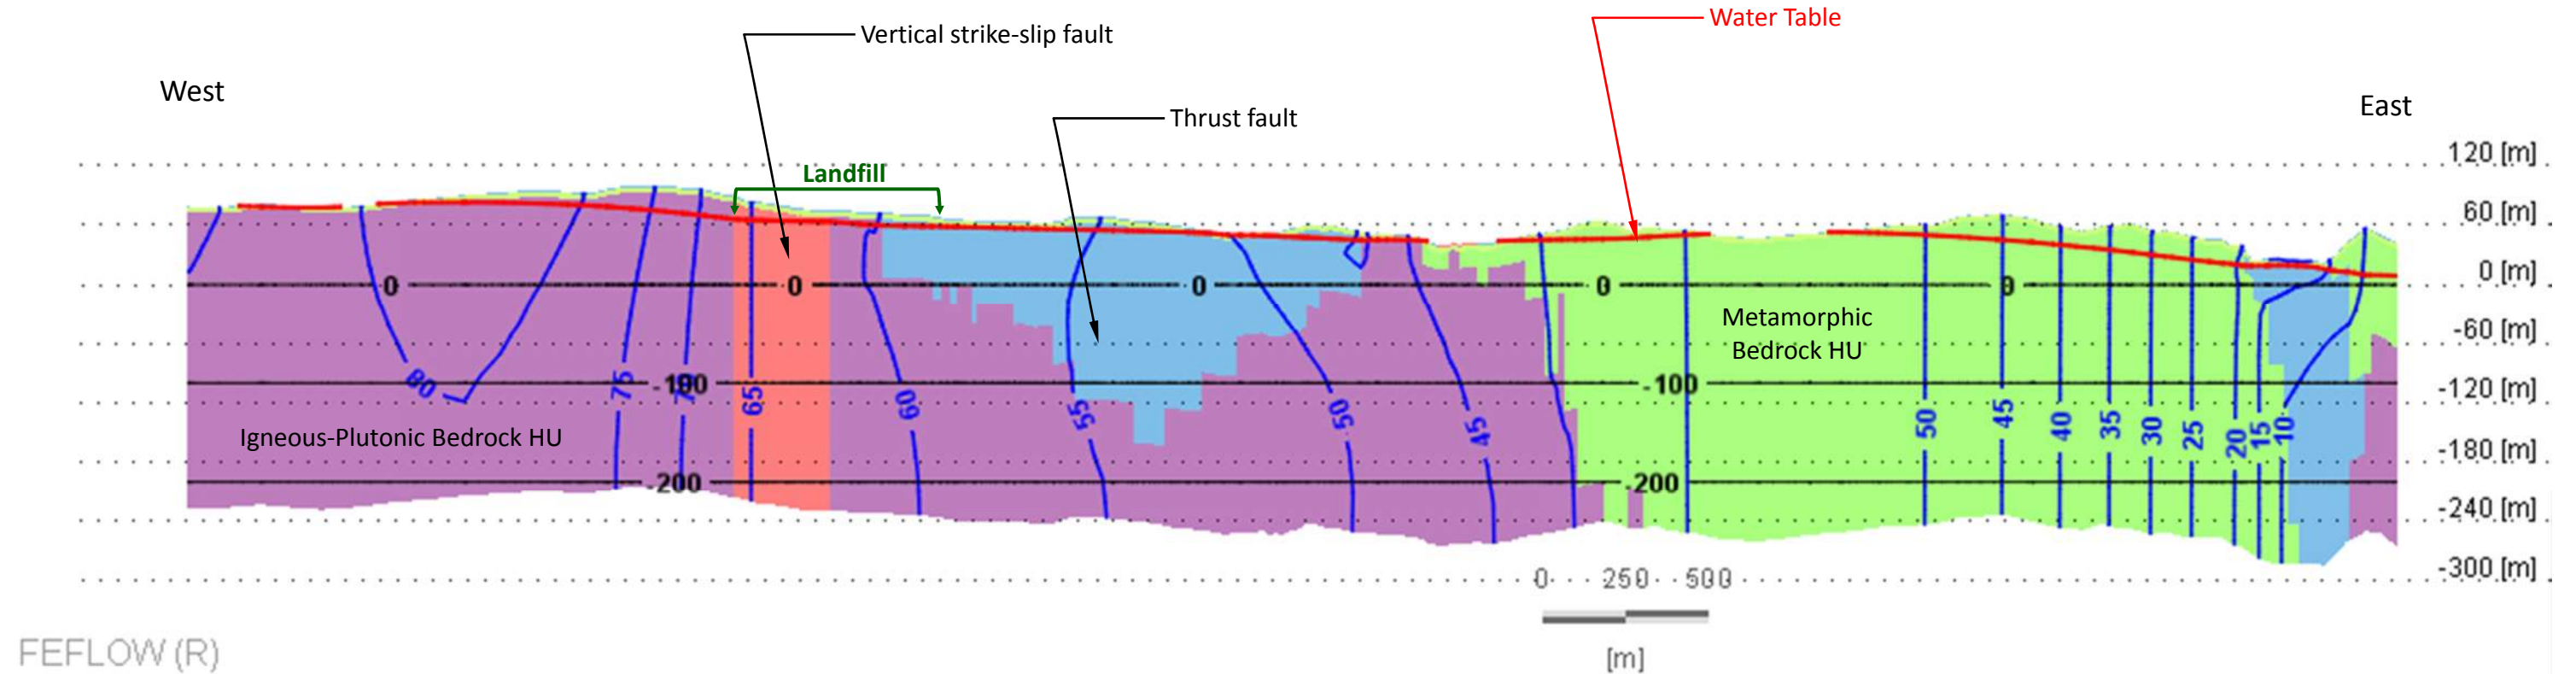
b) Hydraulic Head Distribution Along Cross-Section BB'

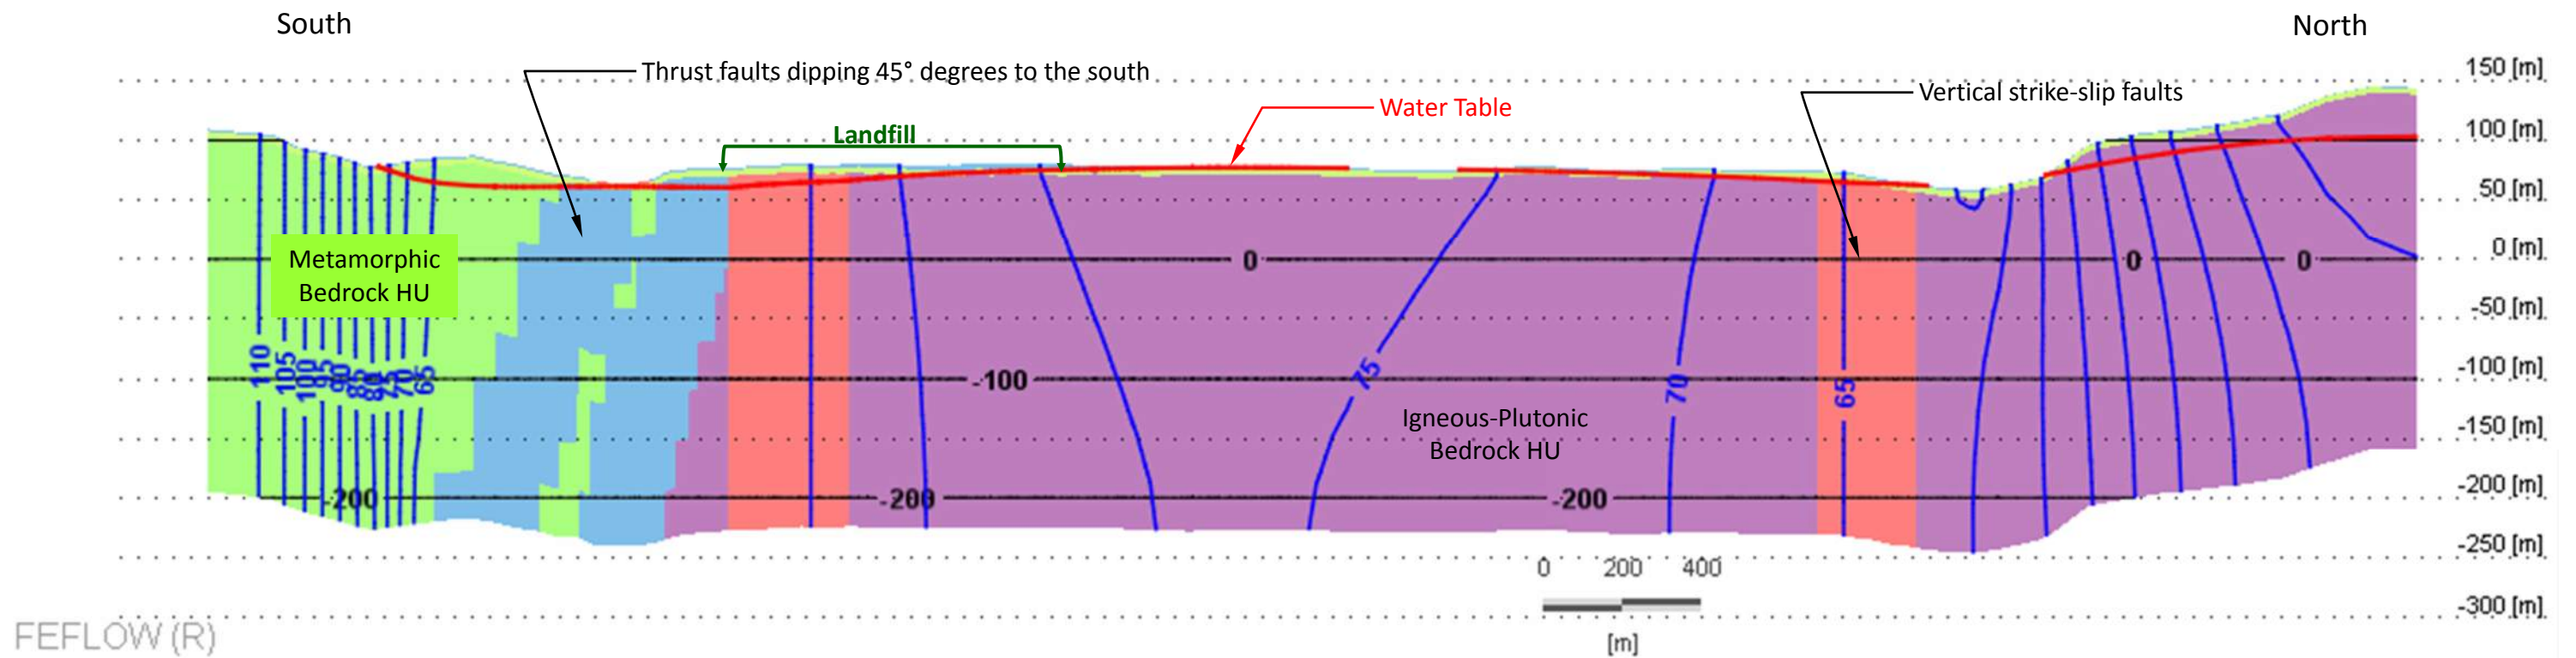
a) Hydraulic Head Distribution Along Cross-Section CC'

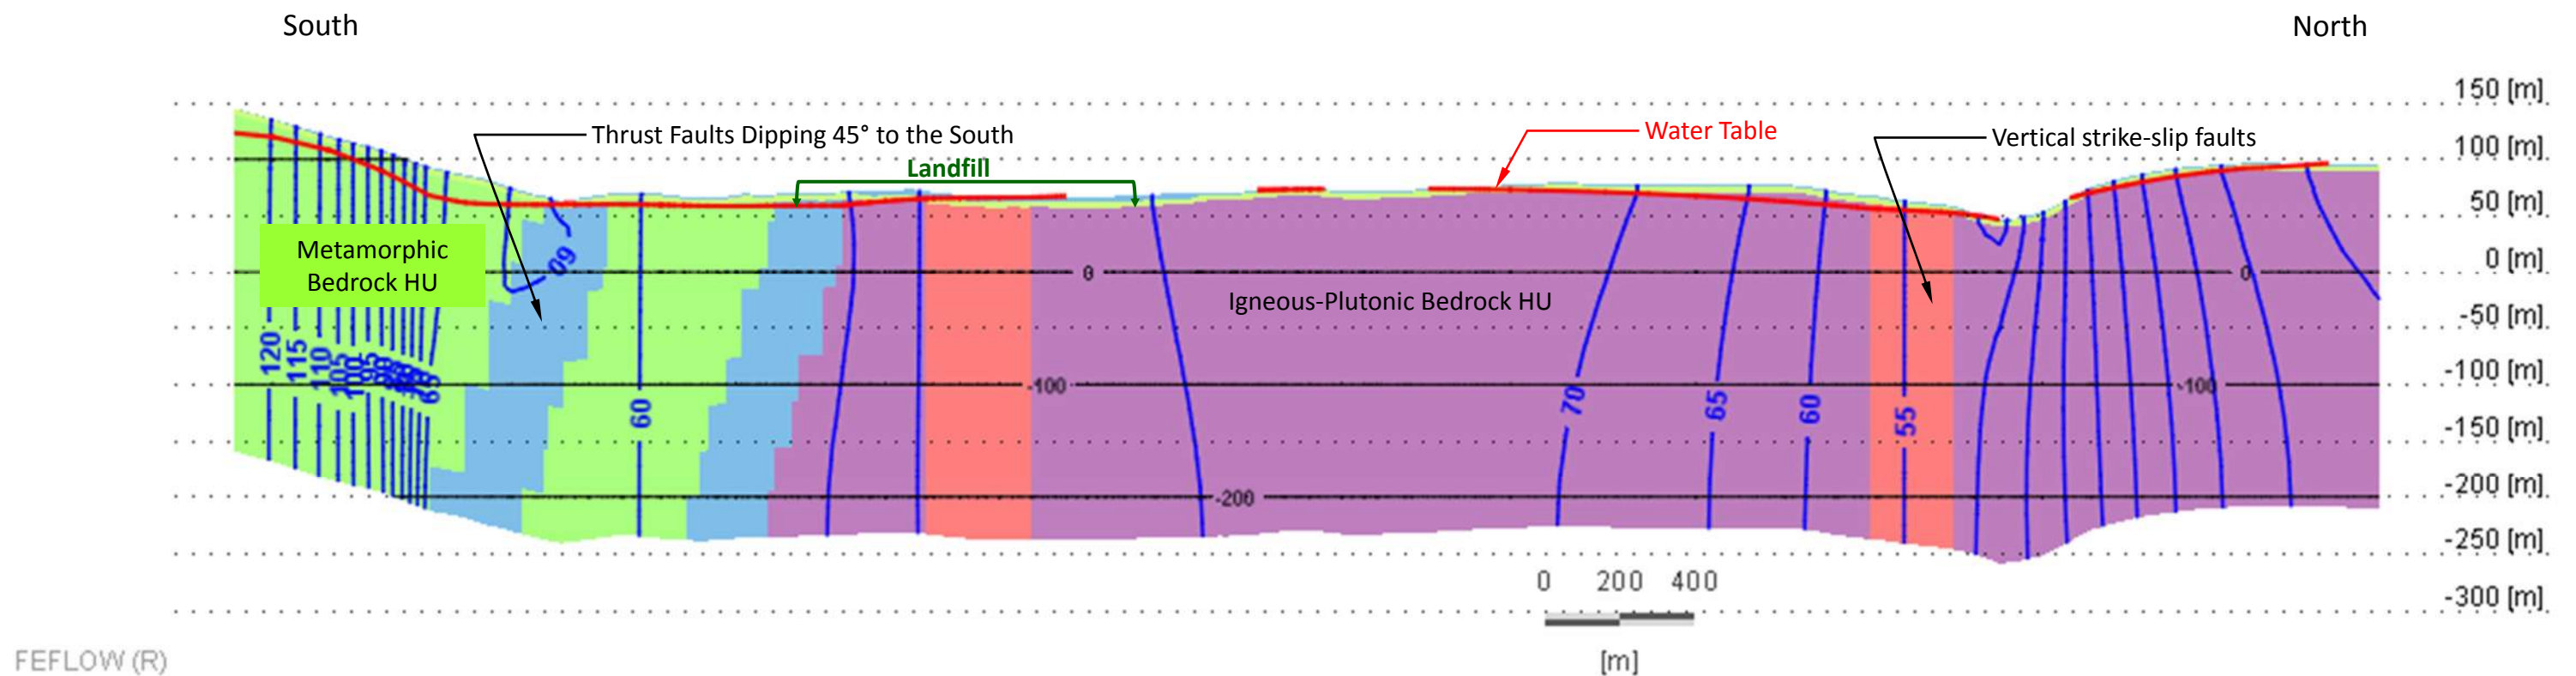
b) Hydraulic Head Distribution Along Cross-Section DD'

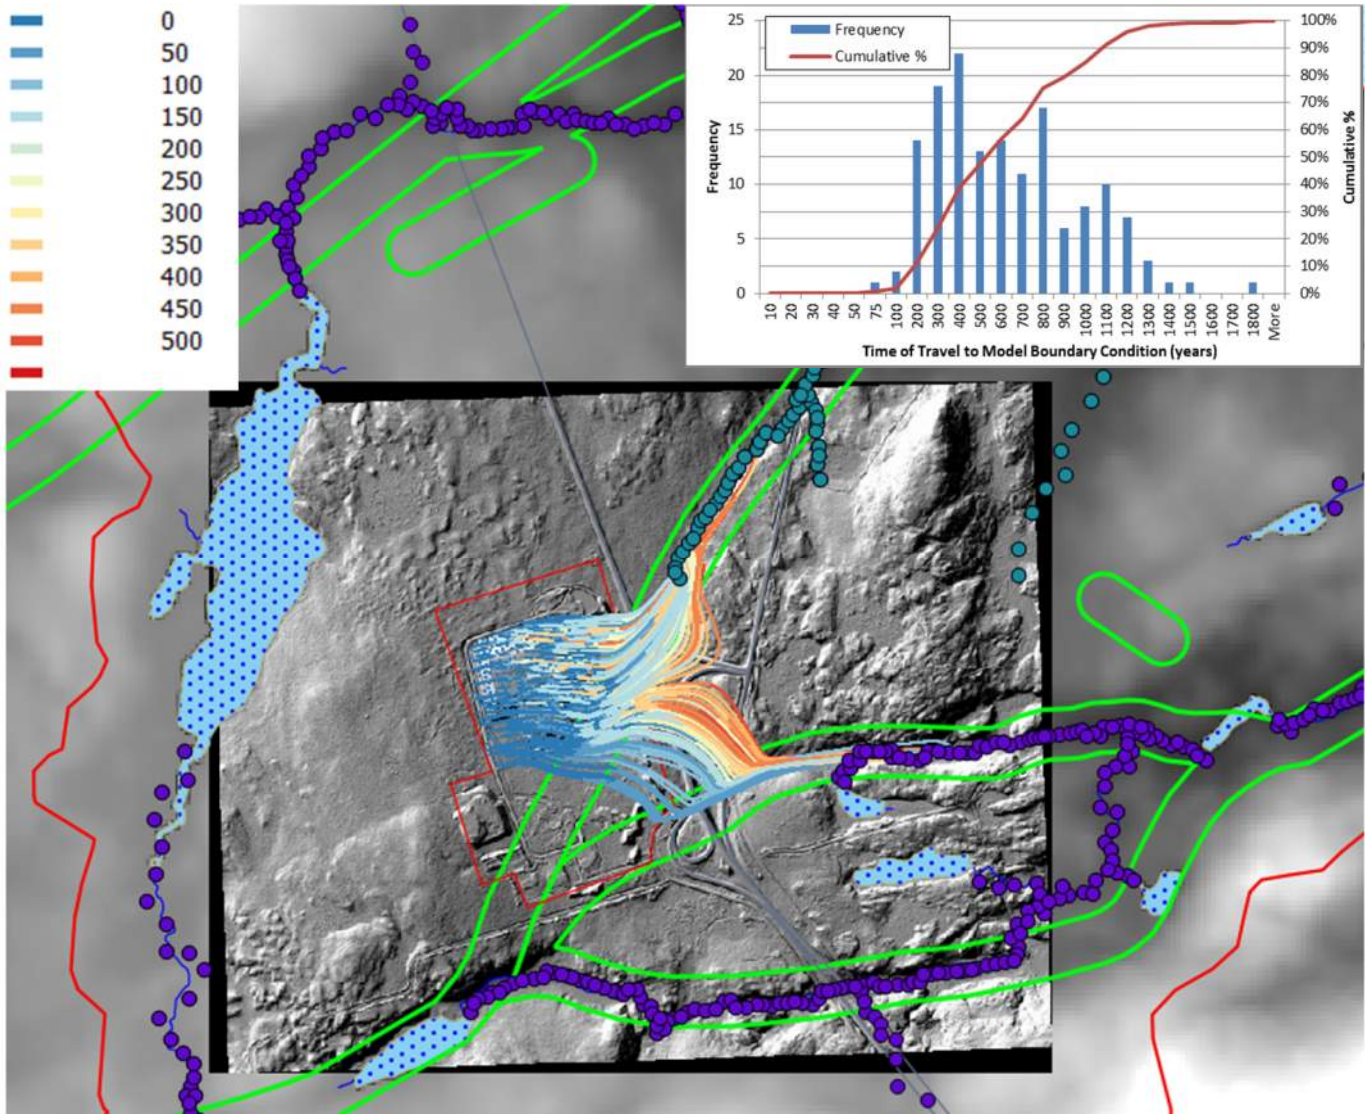
a) Pathlines showing time of travel (years) as particles migrate to surface water discharge locations

- The path line analysis for Grand Bay and domestic wells indicated no predicted water quality impacts from particles released beneath the Landfill liner system. Continued monitoring the water quality of wells in the Grand Bay area was recommended due to the potential presence of an undetected discrete fracture network that could act as a preferential flow path connecting the Landfill area with Grand Bay. The FRSC

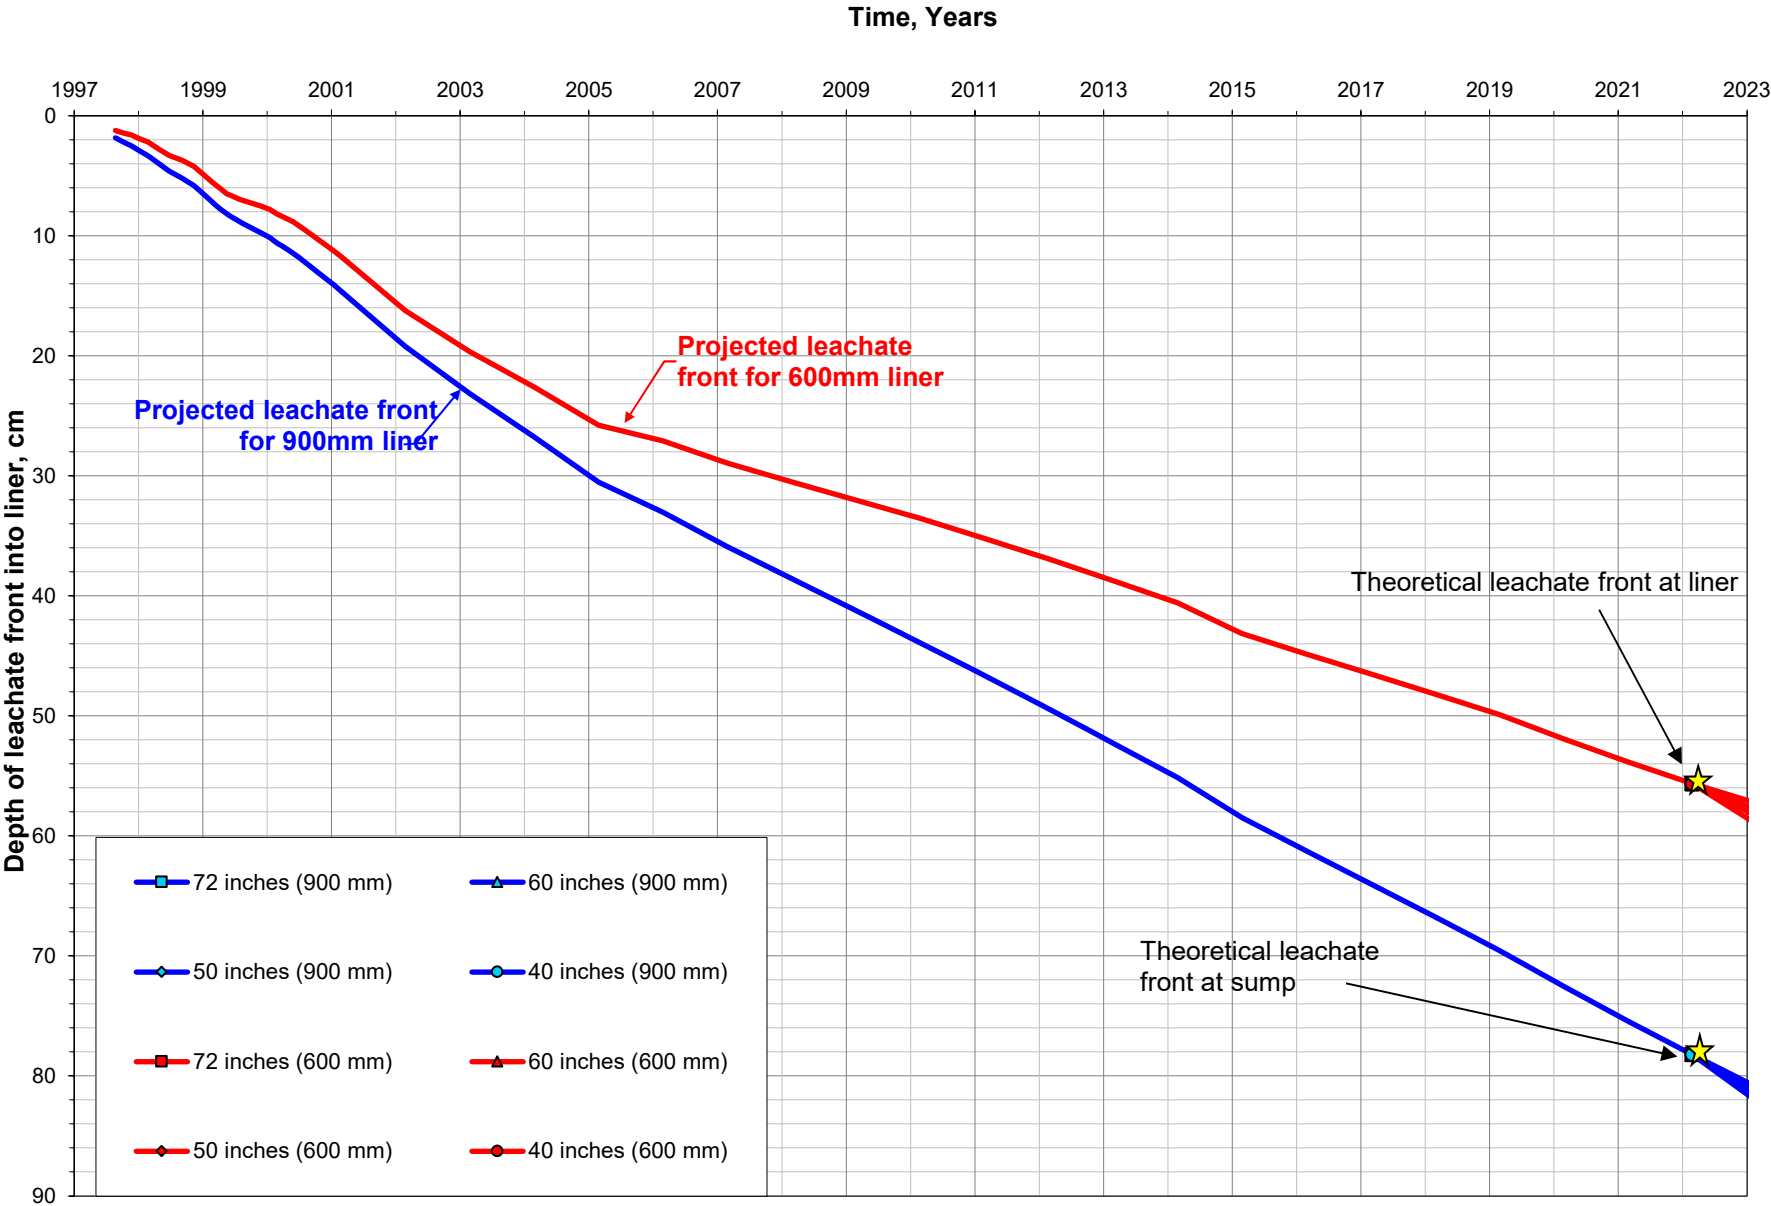
Figure 3: Breakthrough Analysis for Cell 1

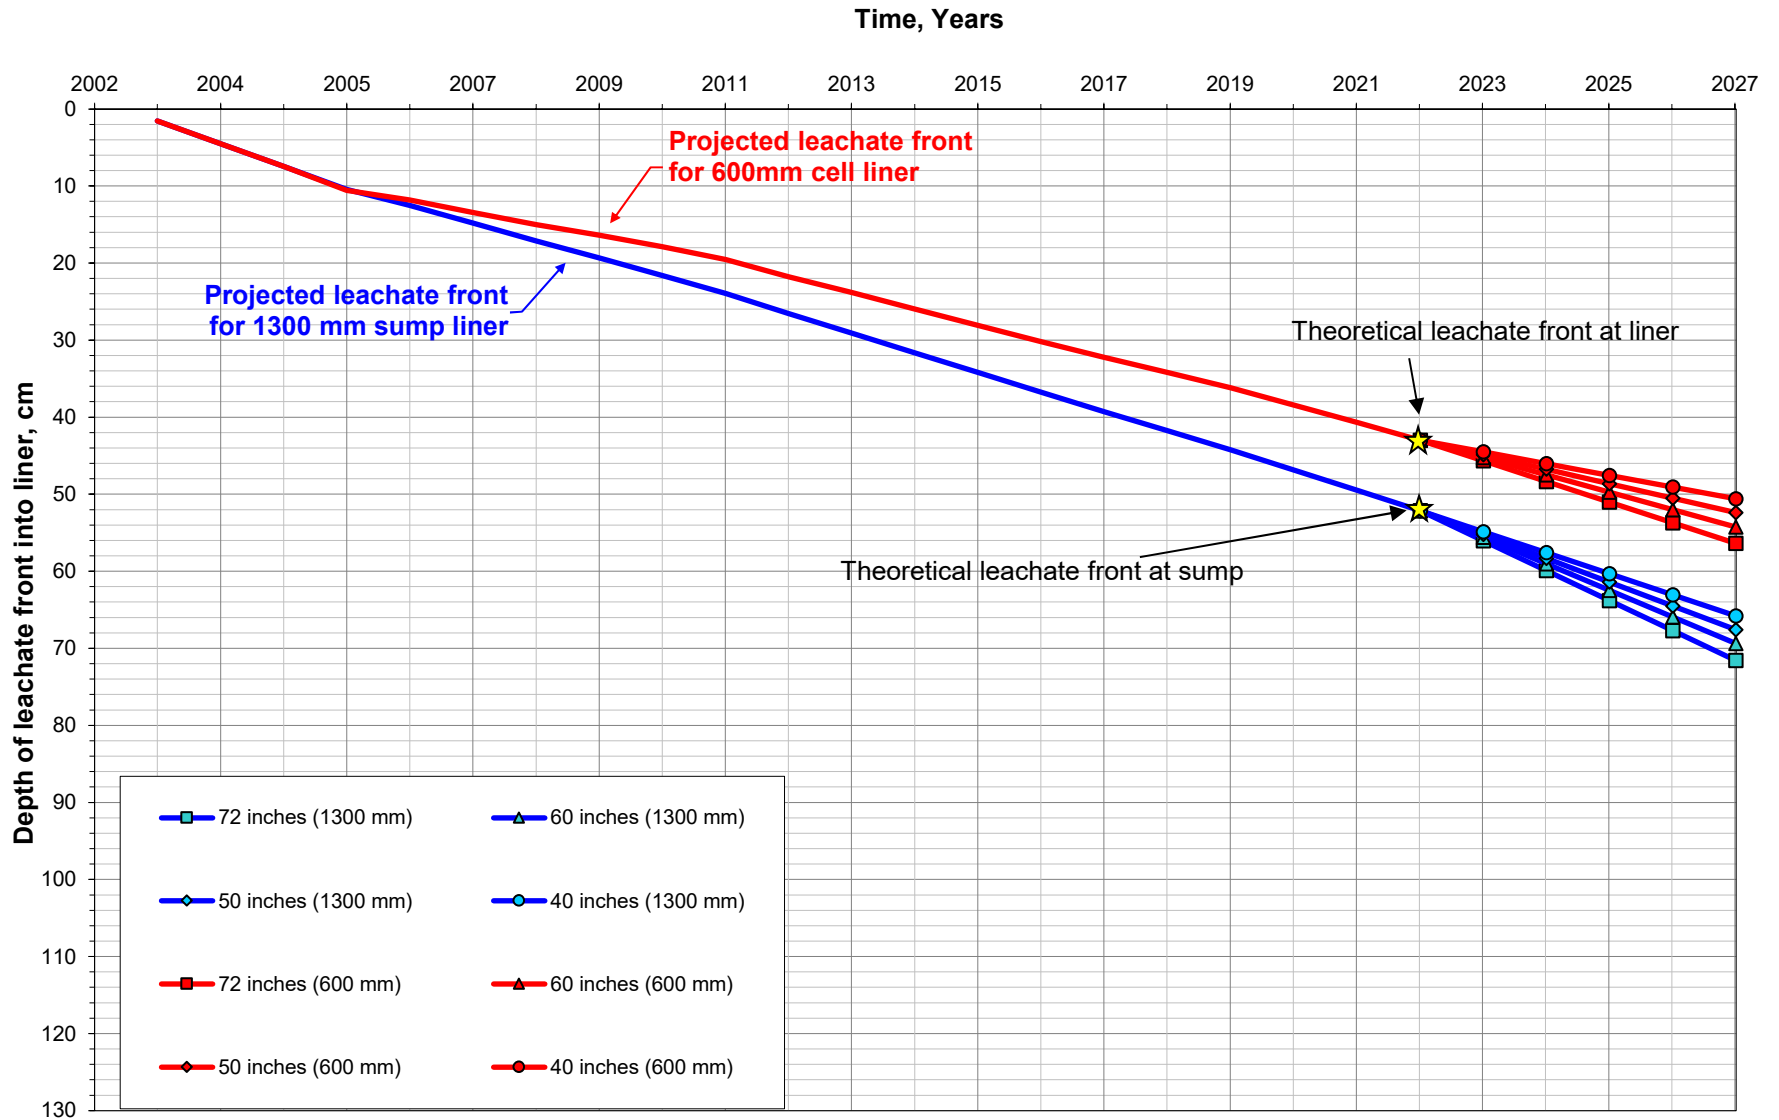
Figure 4: Breakthrough Analysis for Cell 3
