**Environmental Impact Assessment
Registration Document
Fundy Regional Service Commission
Crane Mountain Landfill Capacity
Augmentation and Life Extension Project
Saint John, New Brunswick**

GEMTEC Project: 100018.012

June 21, 2023
GEMTEC Project: 100018.012

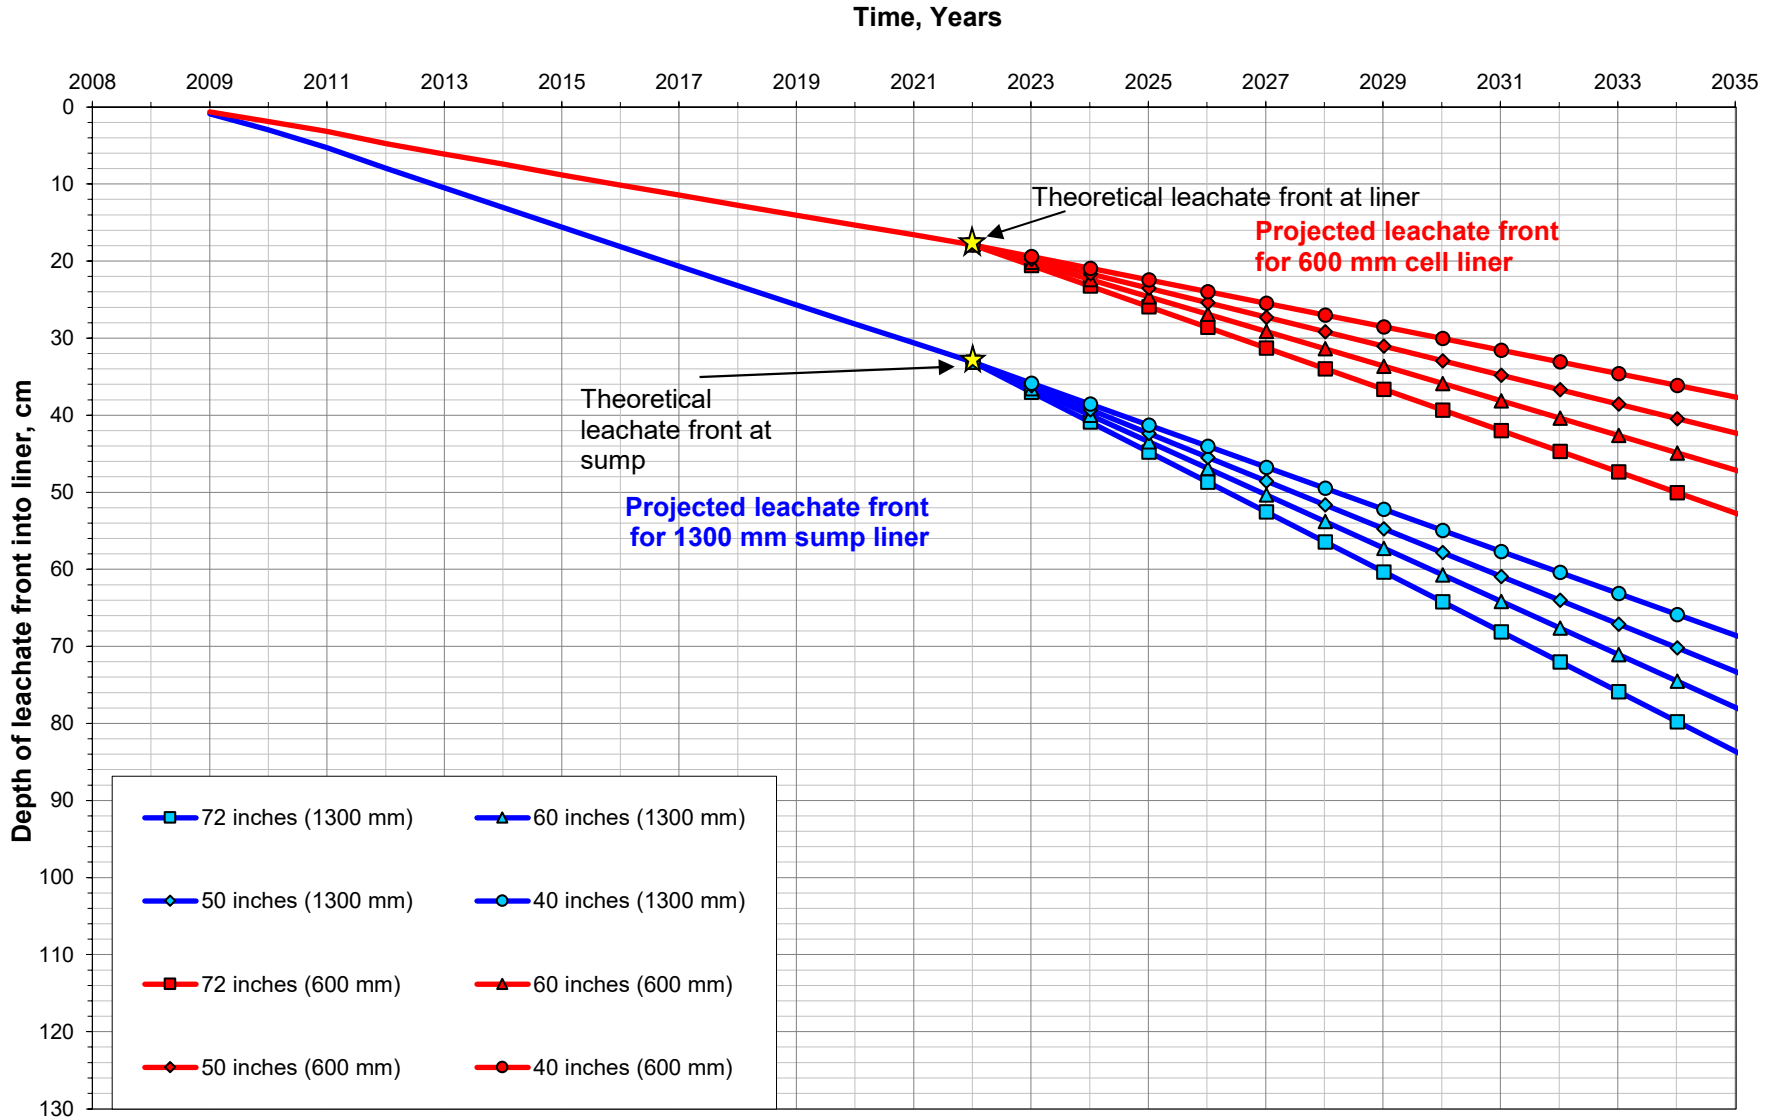
Figure 5: Breakthrough Analysis for Cell 5

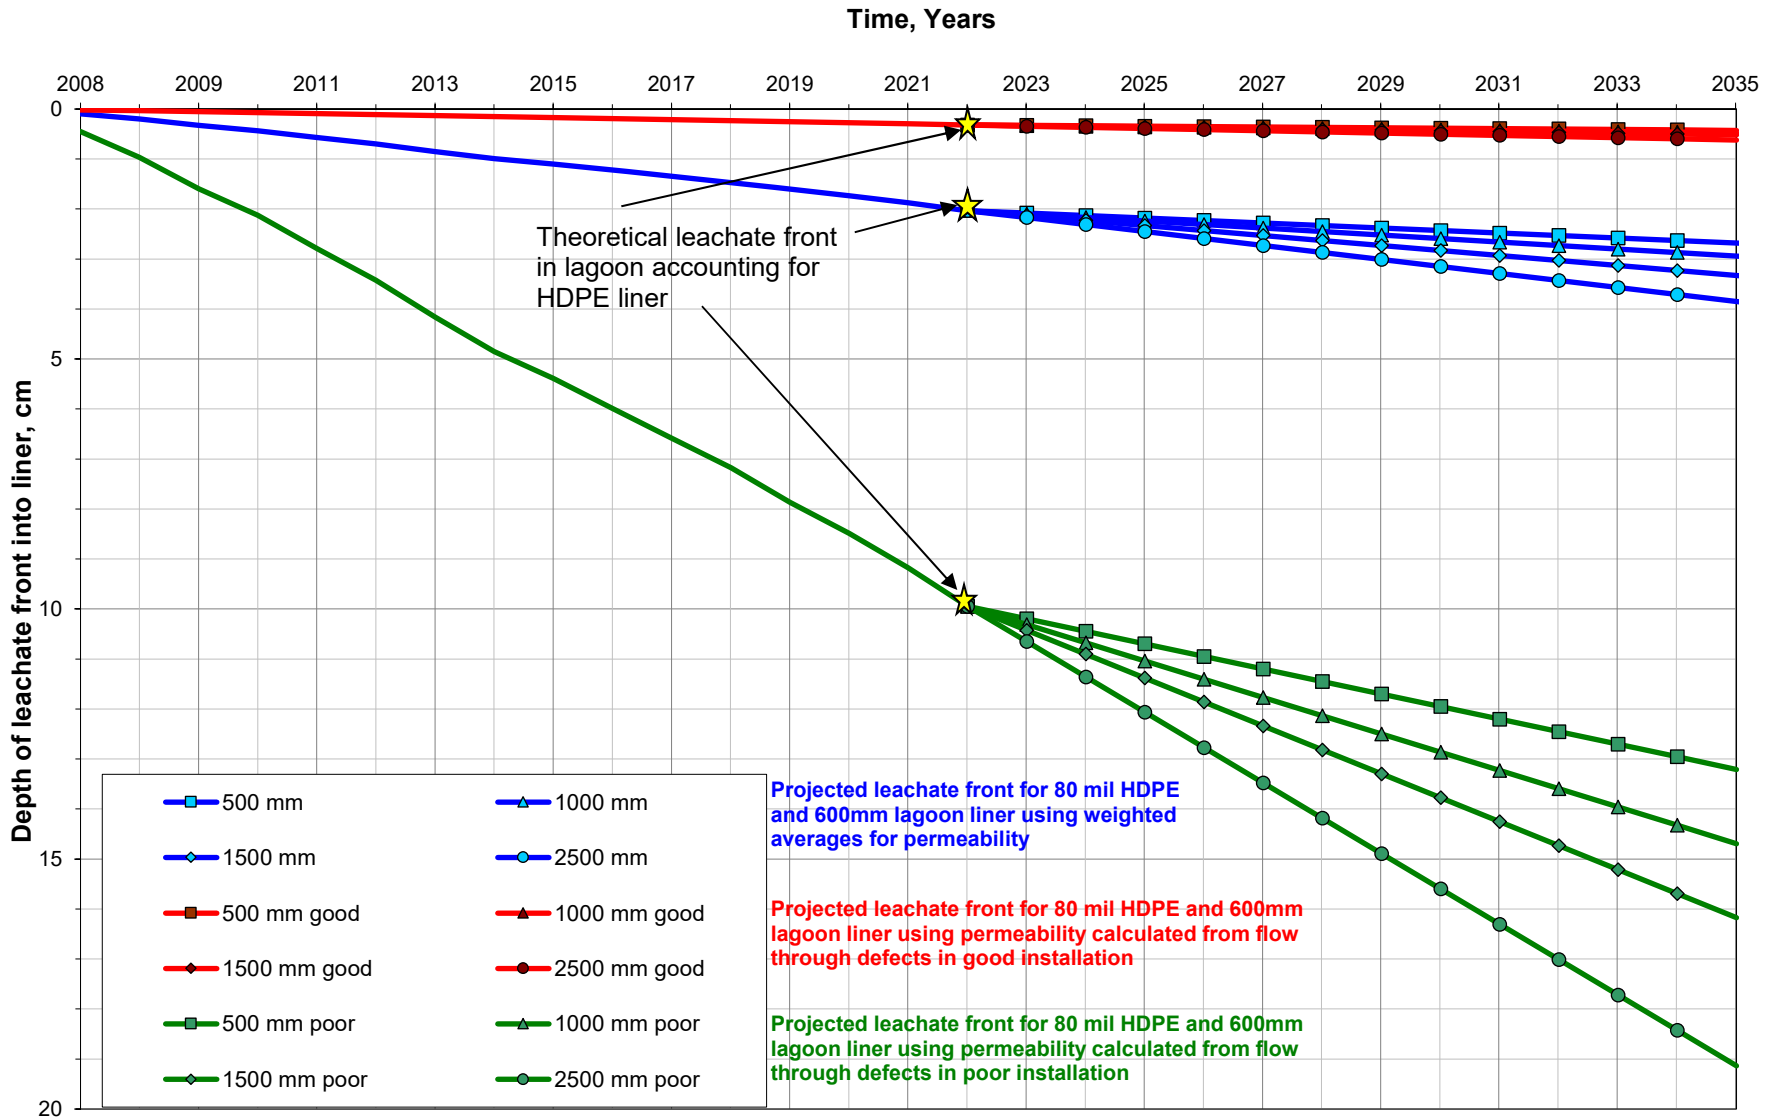
Figure 7: Breakthrough Analysis for Leachate Surge Lagoon
